Prestons Park Subdivision  
GEOTECHNICAL REPORT FOR LOT 1088  
CDL Land NZ Limited

16 September 2021  
Revision: 1  
Reference: 235361

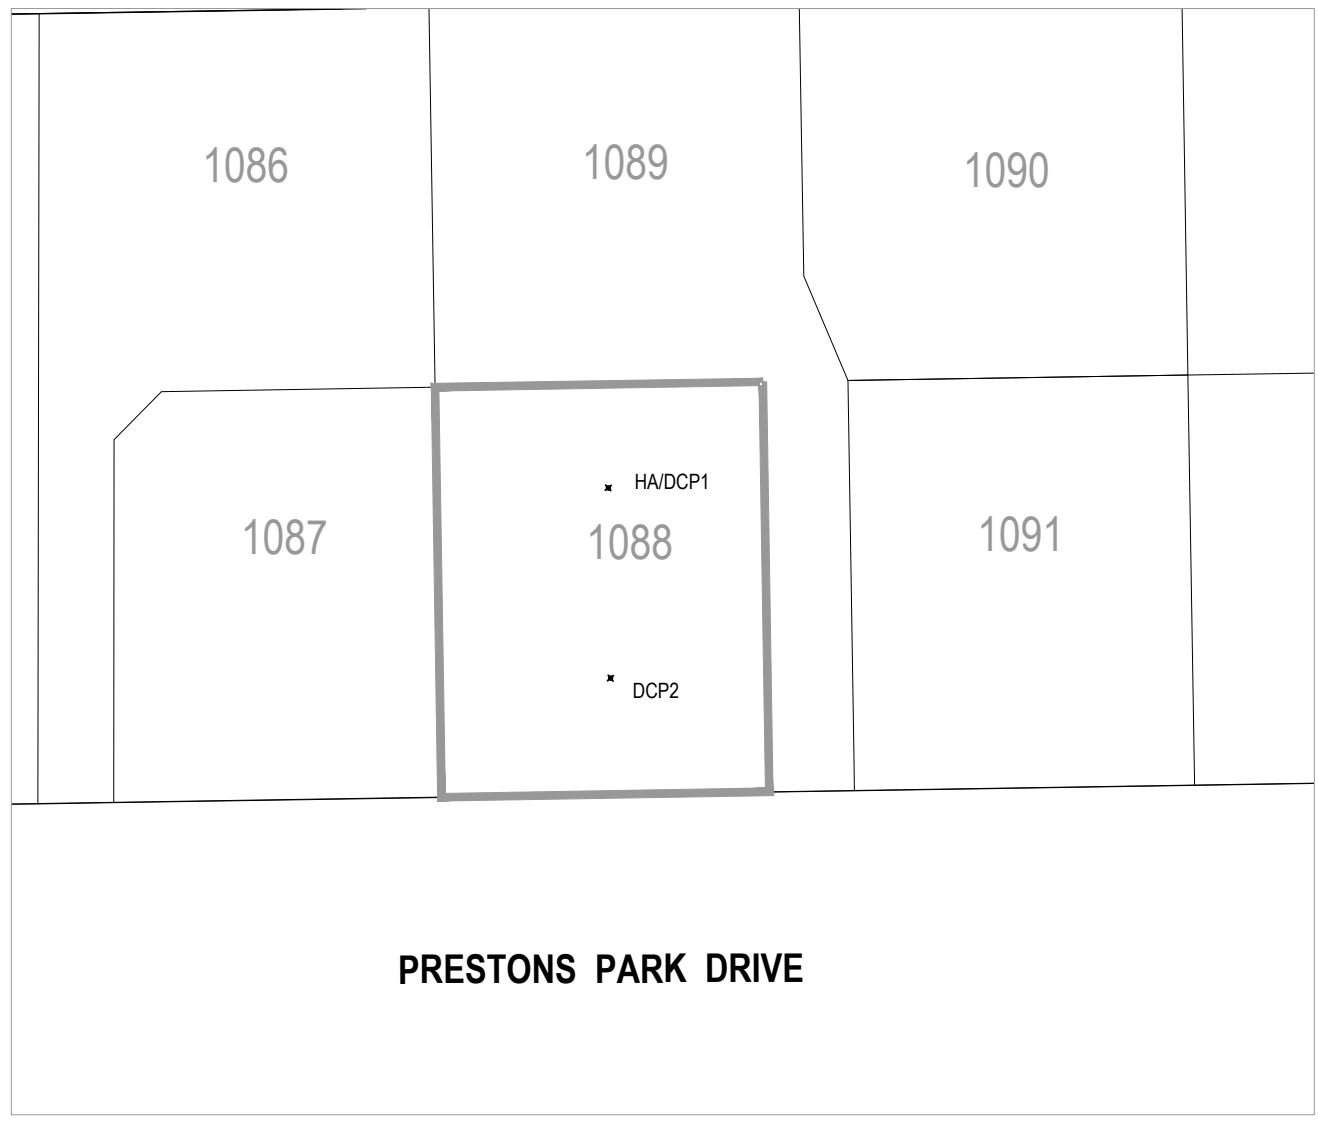
| TITLE<br>LOT 1088<br>SITE LOCATION PLAN<br>FIGURE 1 |

This building consent report is for Lot 1088 which is located in Stage 1 of the Prestons South Subdivision (refer Figure 1 in Appendix A). The lot is bordered by residential lots to the north, south and west, with an access road to the east.
