Prestons Park Subdivision  
GEOTECHNICAL REPORT FOR LOT 1090  
CDL Land NZ Limited

16 September 2021  
Revision: 1  
Reference: 235361

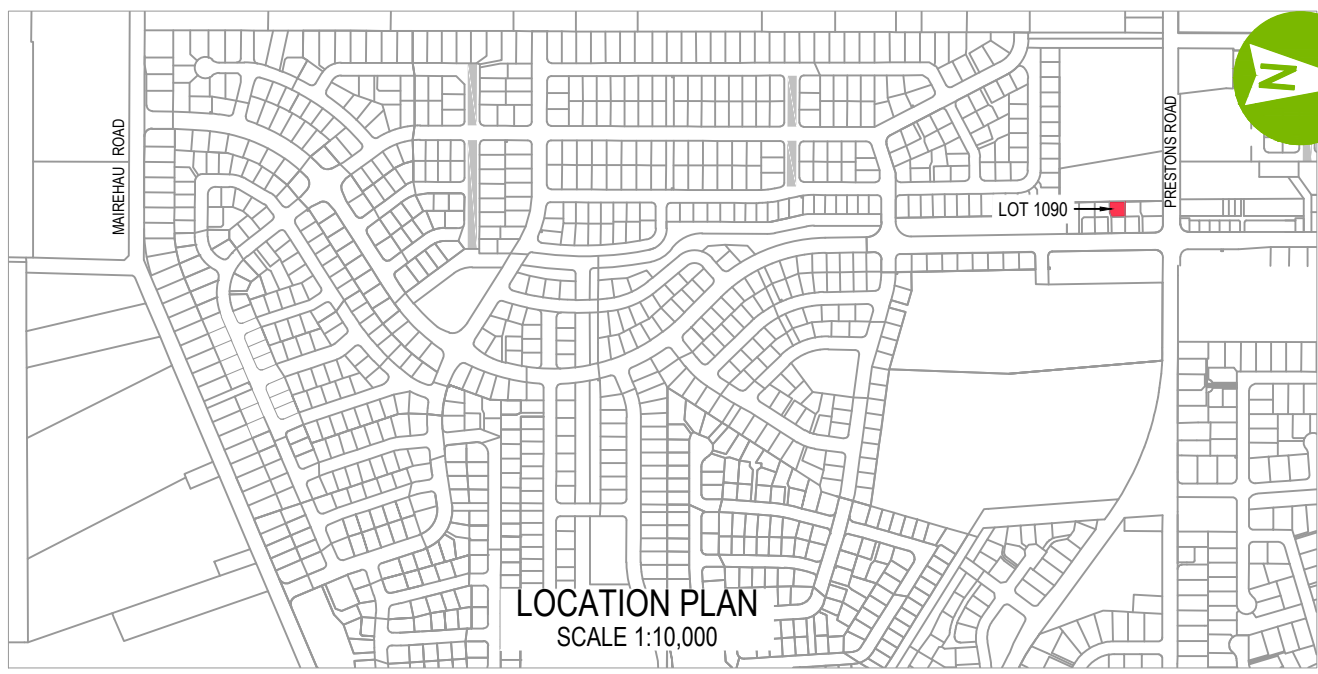
| | | | | | | T BROWNE | FIGURE 1 | | DRAWING No.<br>GO-PS-DC-IN-1090 | REV<br>A |

| | | | | | | DATE<br>28/02/2021 | SITE LOCATION PLAN | | SIZE<br>A4 | |

This building consent report is for Lot 1090 which is located in Stage 1 of the Prestons South Subdivision (refer Figure 1 in Appendix A). The lot is bordered by residential lots to the north, south and east, with a park to the west.
