**Prestons Park Subdivision**  
**GEOTECHNICAL REPORT FOR LOT 1091**  
**CDL Land NZ Limited**

**16 September 2021**  
**Revision: 1**  
**Reference: 235361**

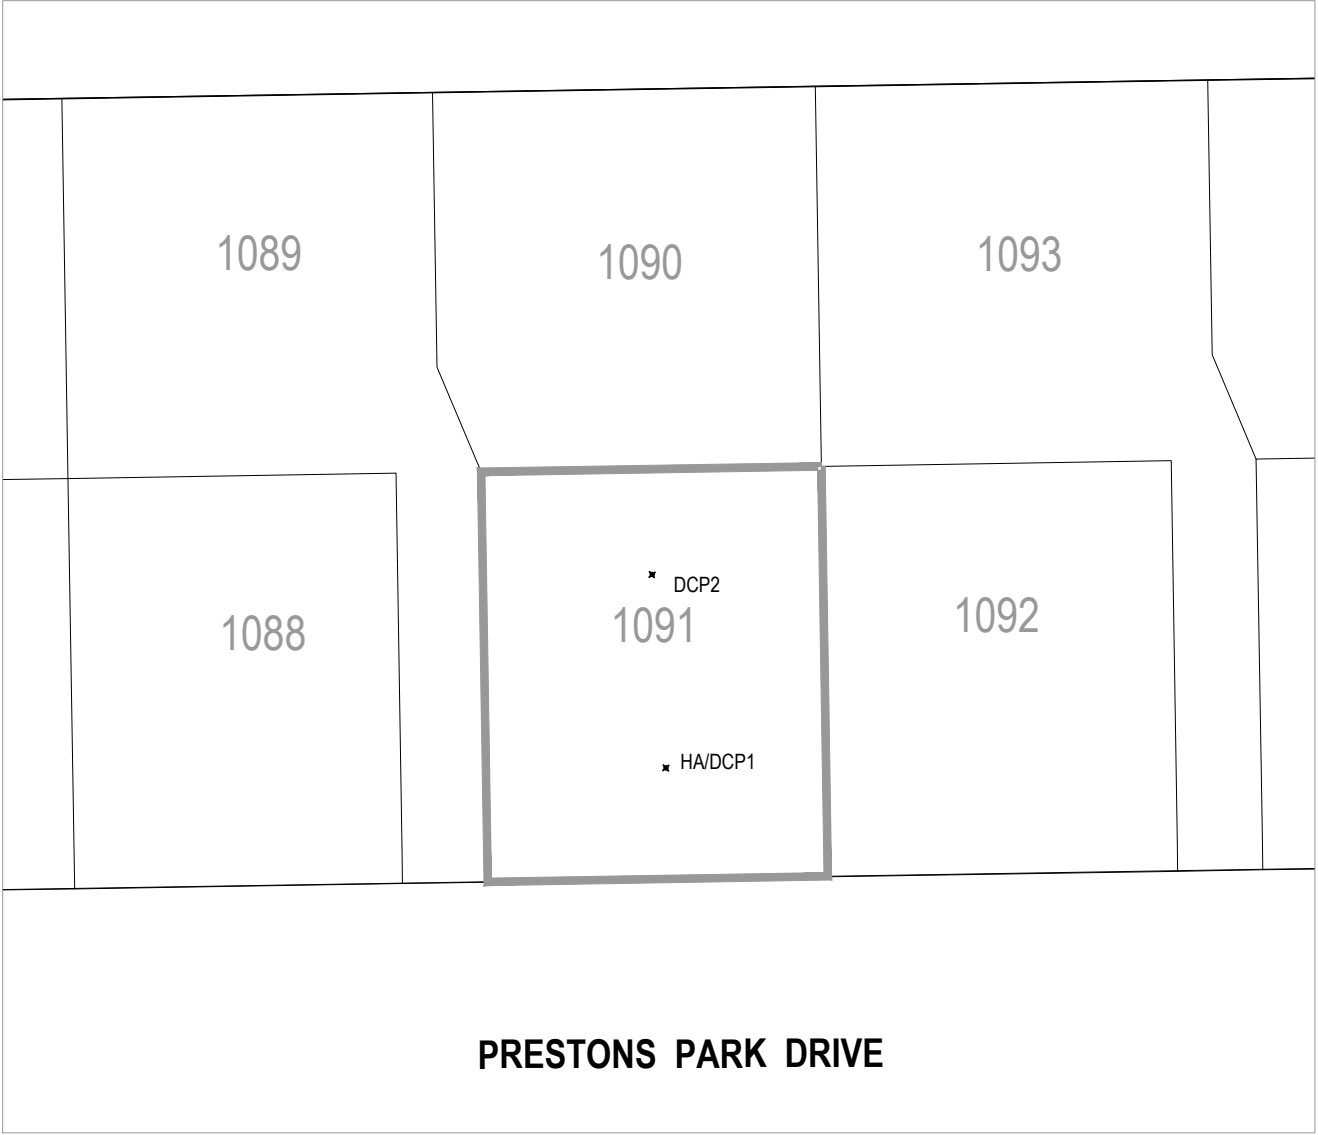
This building consent report is for Lot 1091 which is located in Stage 1 of the Prestons South Subdivision (refer Figure 1 in Appendix A). The lot is bordered by residential lots to the north, south and west, with an access road to the east.

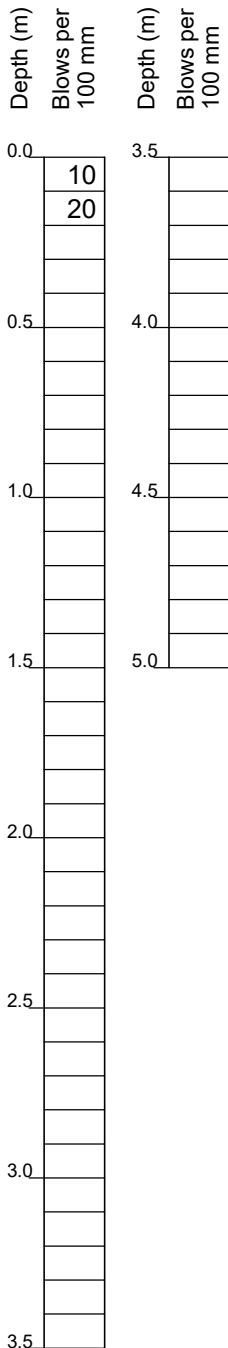
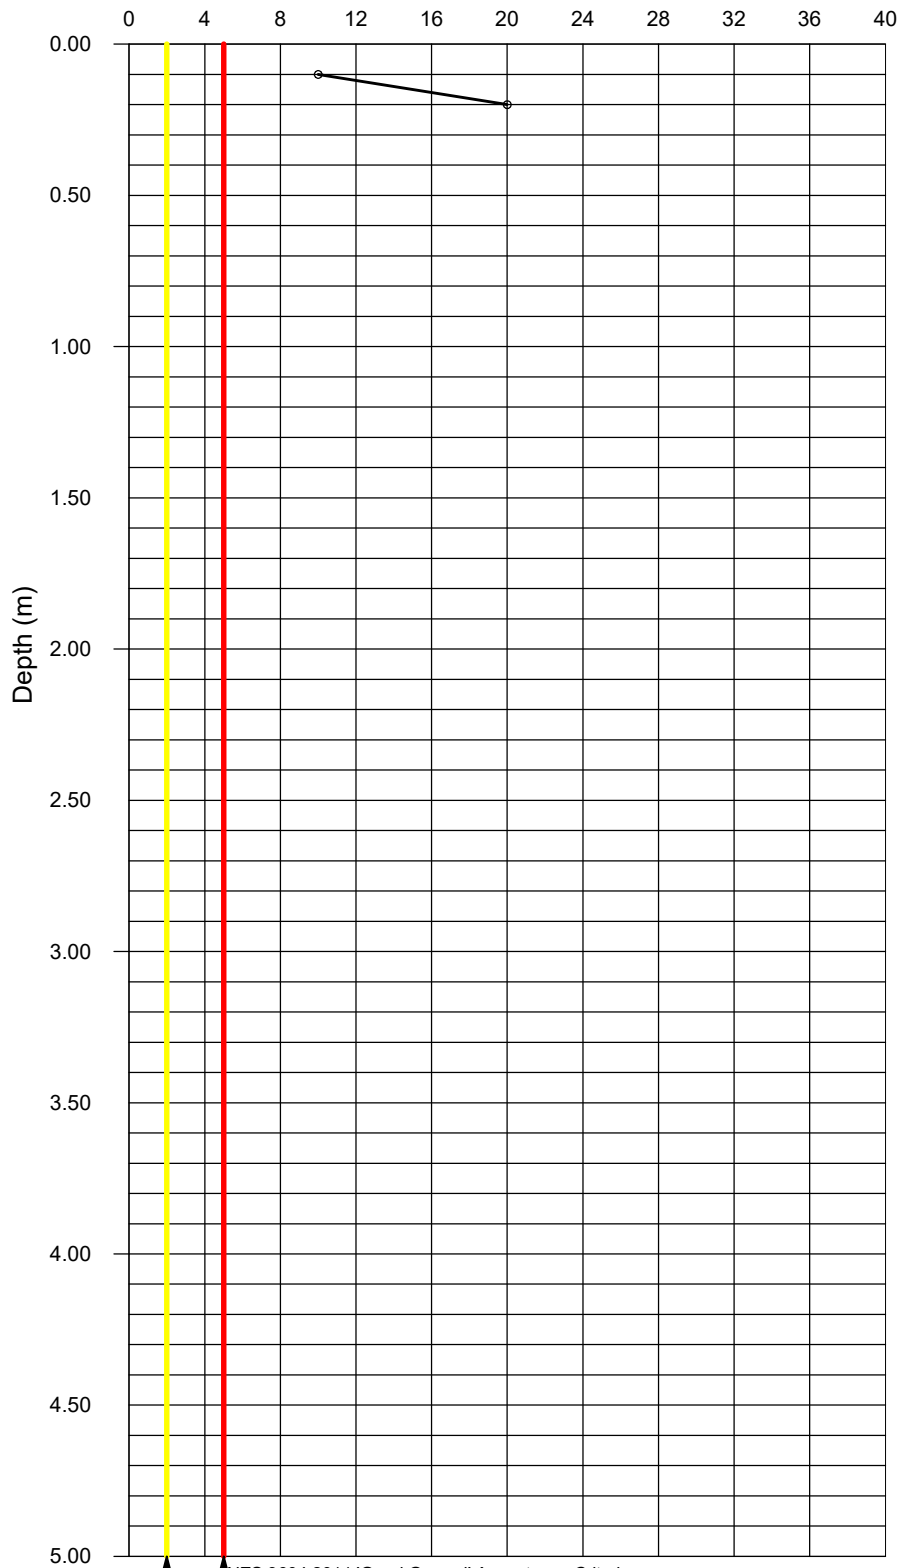
20 blows for 100mm in the last increment.  
Co-ordinates and elevation data from site survey.  
Elevation based on Christchurch Drainage Datum.  
Effective refusal, 20+ blows per 100mm

NZS 3604:2011 'Good Ground' Acceptance Criteria  
MBIE '200kPa geotechnical ultimate bearing capacity' Acceptance Criteria

Two DCPs were carried out with the locations and results uploaded to the NZGD. The DCP test results are attached in Appendix B. One of the DCPs was located adjacent to the hand auger borehole, with the second DCP located on the opposite half of the lot.

DCP logs indicate 5 blows per 100mm penetration, which is equivalent to an ultimate bearing capacity of 300kPa, was encountered from a shallow depth.

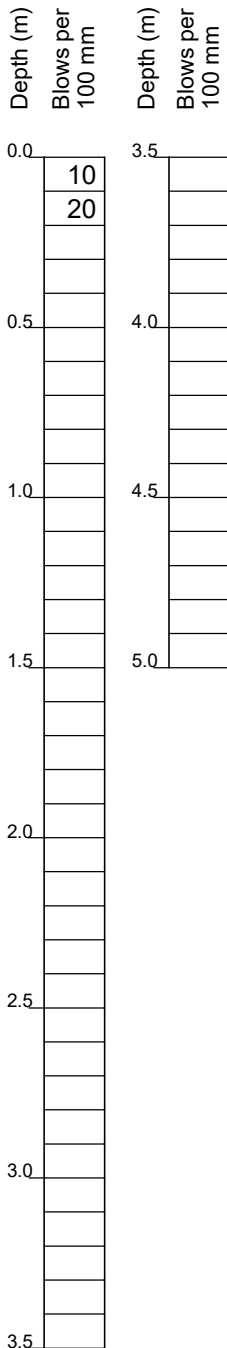
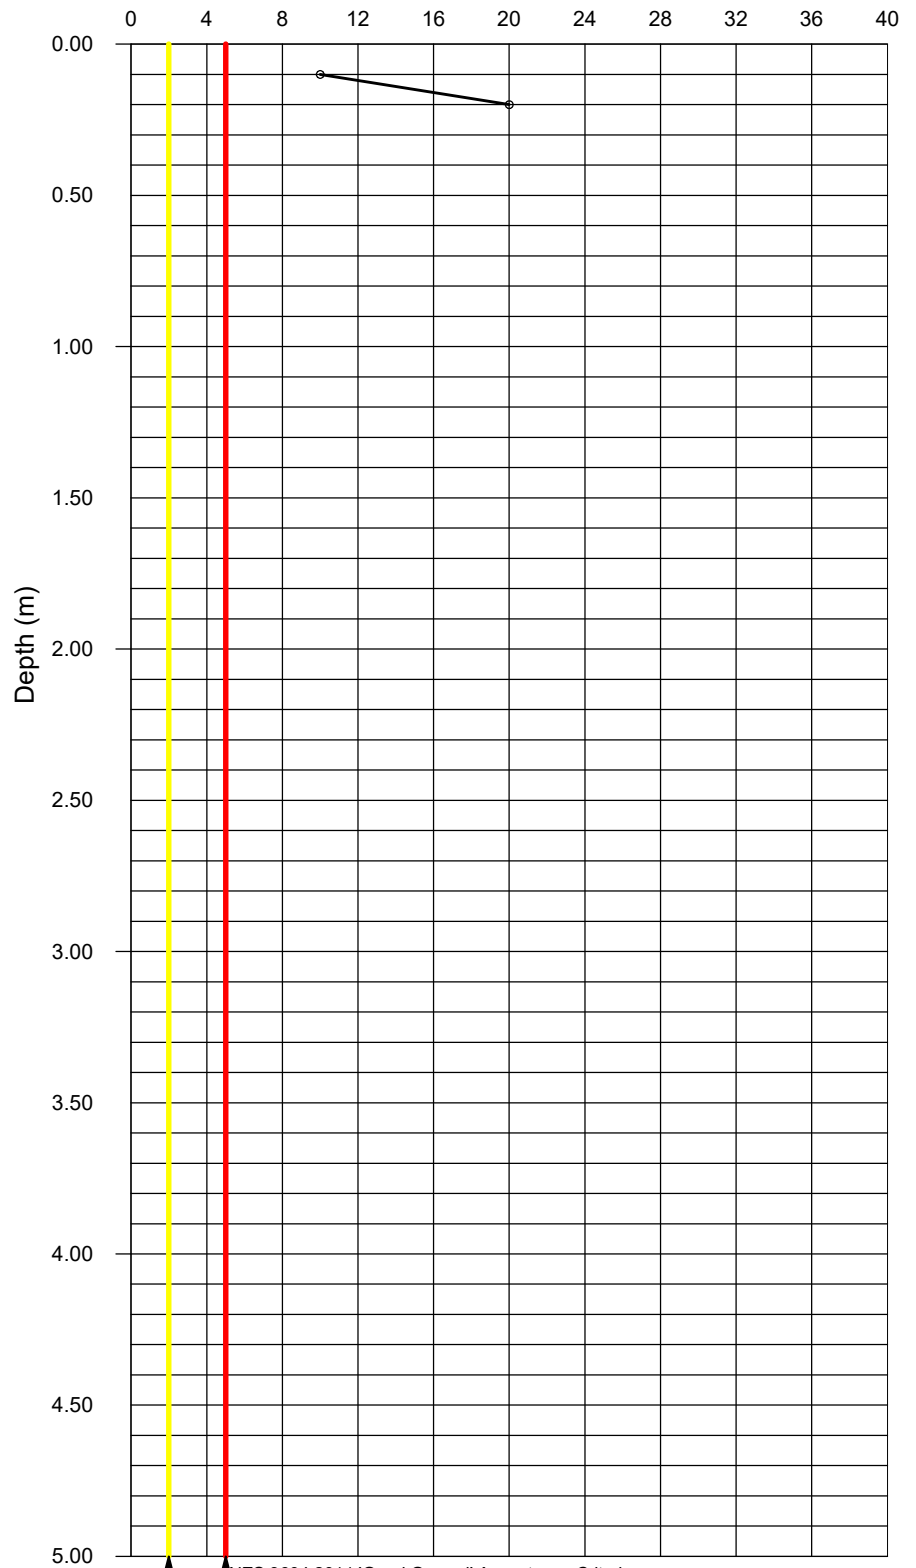
20 blows for 100mm in the last increment.  
Co-ordinates and elevation data from site survey.  
Elevation based on Christchurch Drainage Datum.  
Effective refusal, 20+ blows per 100mm

↑ NZS 3604:2011 'Good Ground' Acceptance Criteria  
↑ MBIE '200kPa geotechnical ultimate bearing capacity' Acceptance Criteria
