Prestons Park Subdivision  
GEOTECHNICAL REPORT FOR LOT 1094  
CDL Land NZ Limited

16 September 2021  
Revision: 1  
Reference: 235361

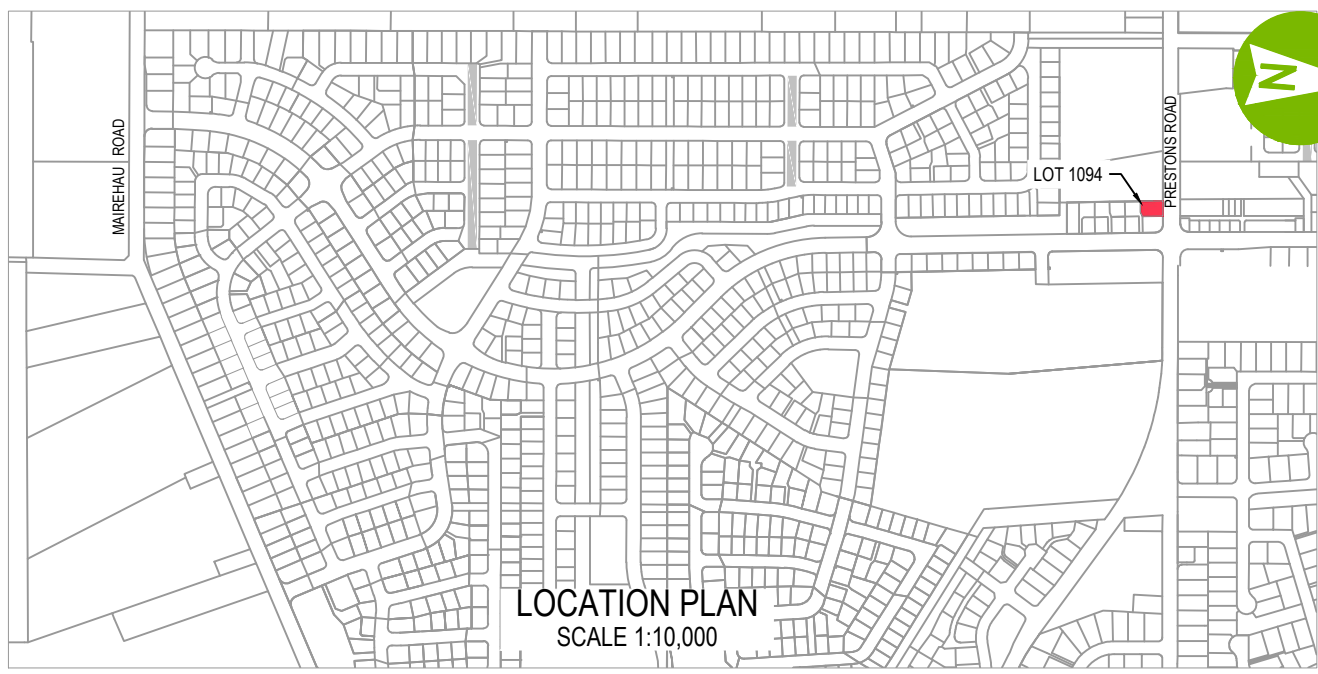
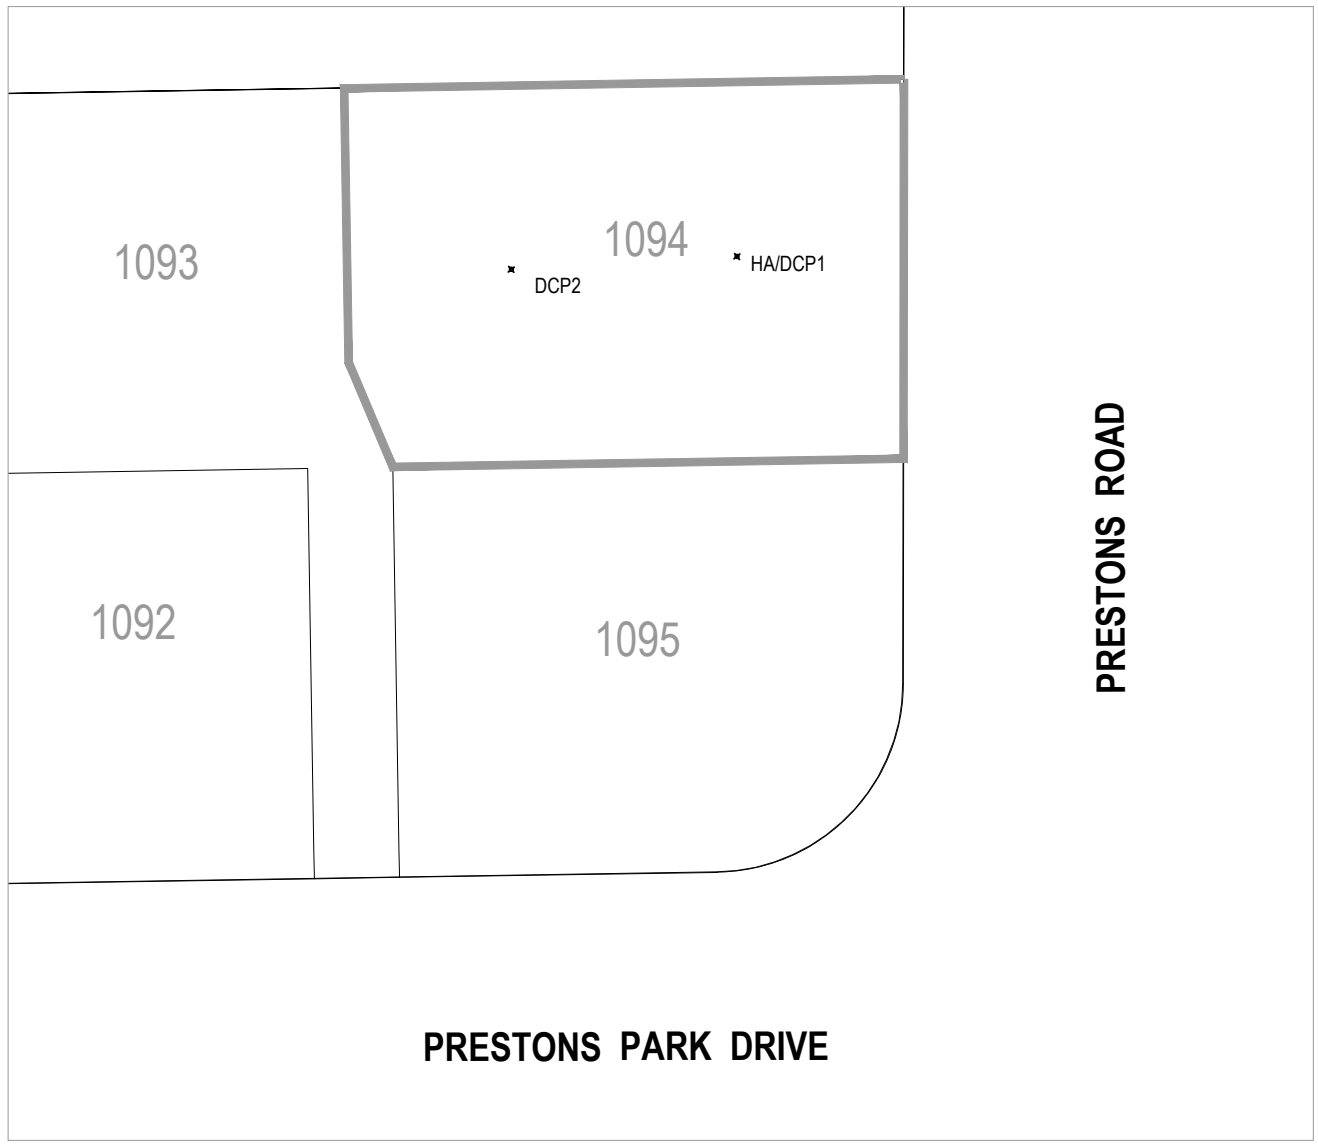
This building consent report is for Lot 1094 which is located in Stage 1 of the Prestons South Subdivision (refer Figure 1 in Appendix A). The lot is bordered by residential lots to the south and east, a road to the north and a park to the west.

| | | | | APPROVED<br>T BROWNE | | DATE<br>28/02/2021 | SITE LOCATION PLAN | | | | DRAWING No.<br>GO-PS-DC-IN-1094 | REV<br>A | | |

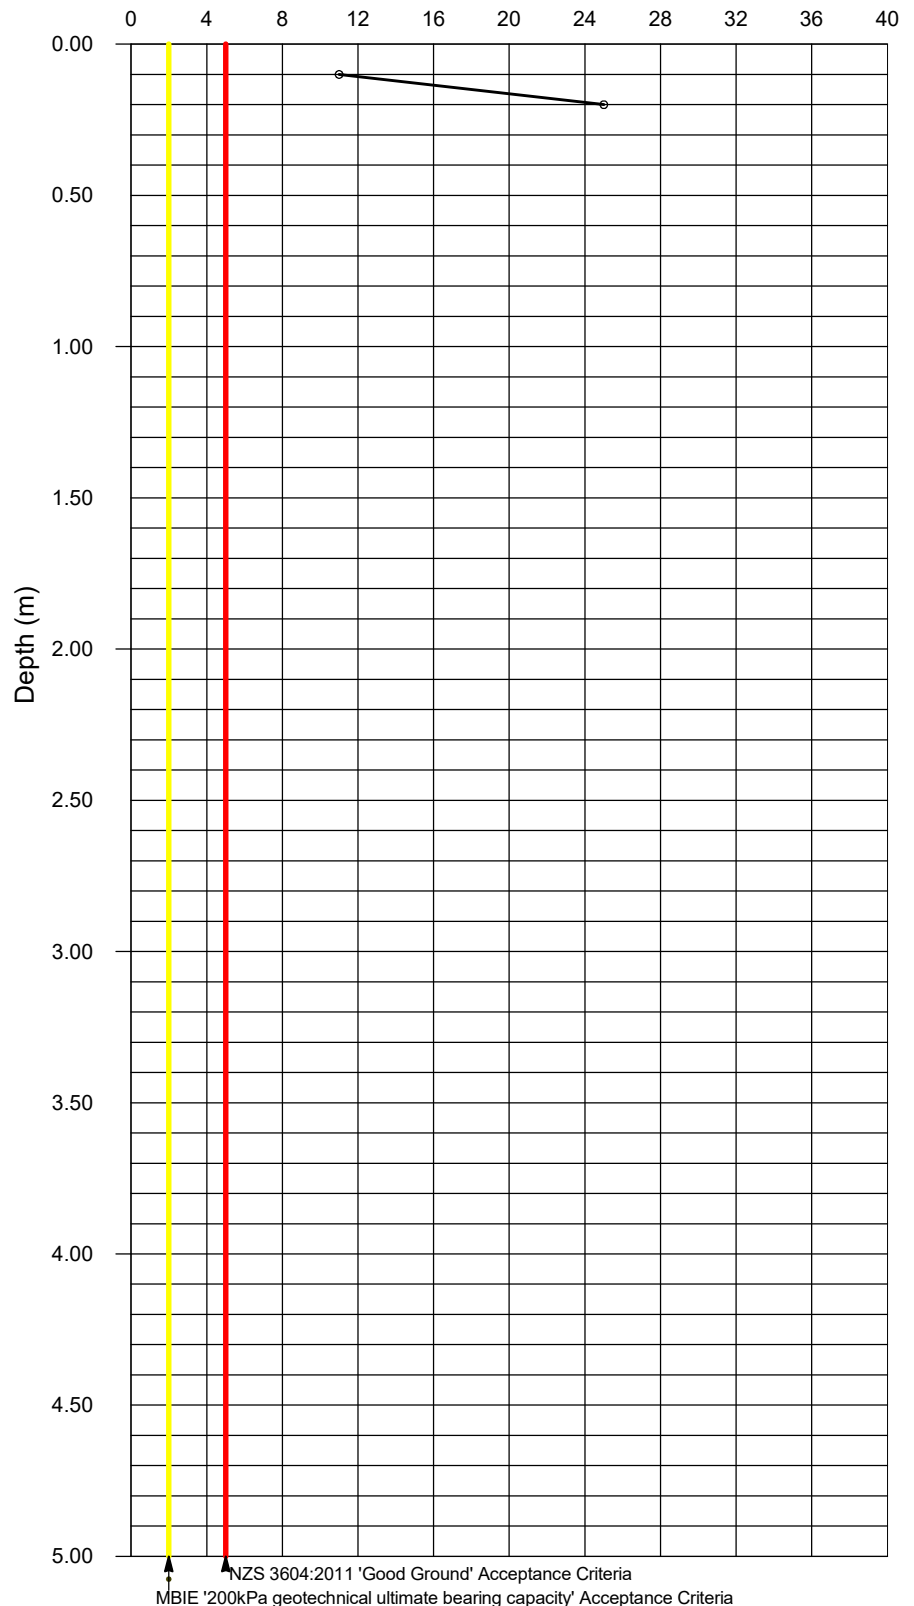
25 blows for 100mm in the last increment.  
Co-ordinates and elevation data from site survey.  
Elevation based on Christchurch Drainage Datum.  
Effective refusal, 20+ blows per 100mm

**Number of blows per 100mm**

Two DCPs were carried out with the locations and results uploaded to the NZGD. The DCP test results are attached in Appendix B. One of the DCPs was located adjacent to the hand auger borehole, with the second DCP located on the opposite half of the lot.

DCP logs indicate 5 blows per 100mm penetration, which is equivalent to an ultimate bearing capacity of 300kPa, was encountered from a shallow depth.

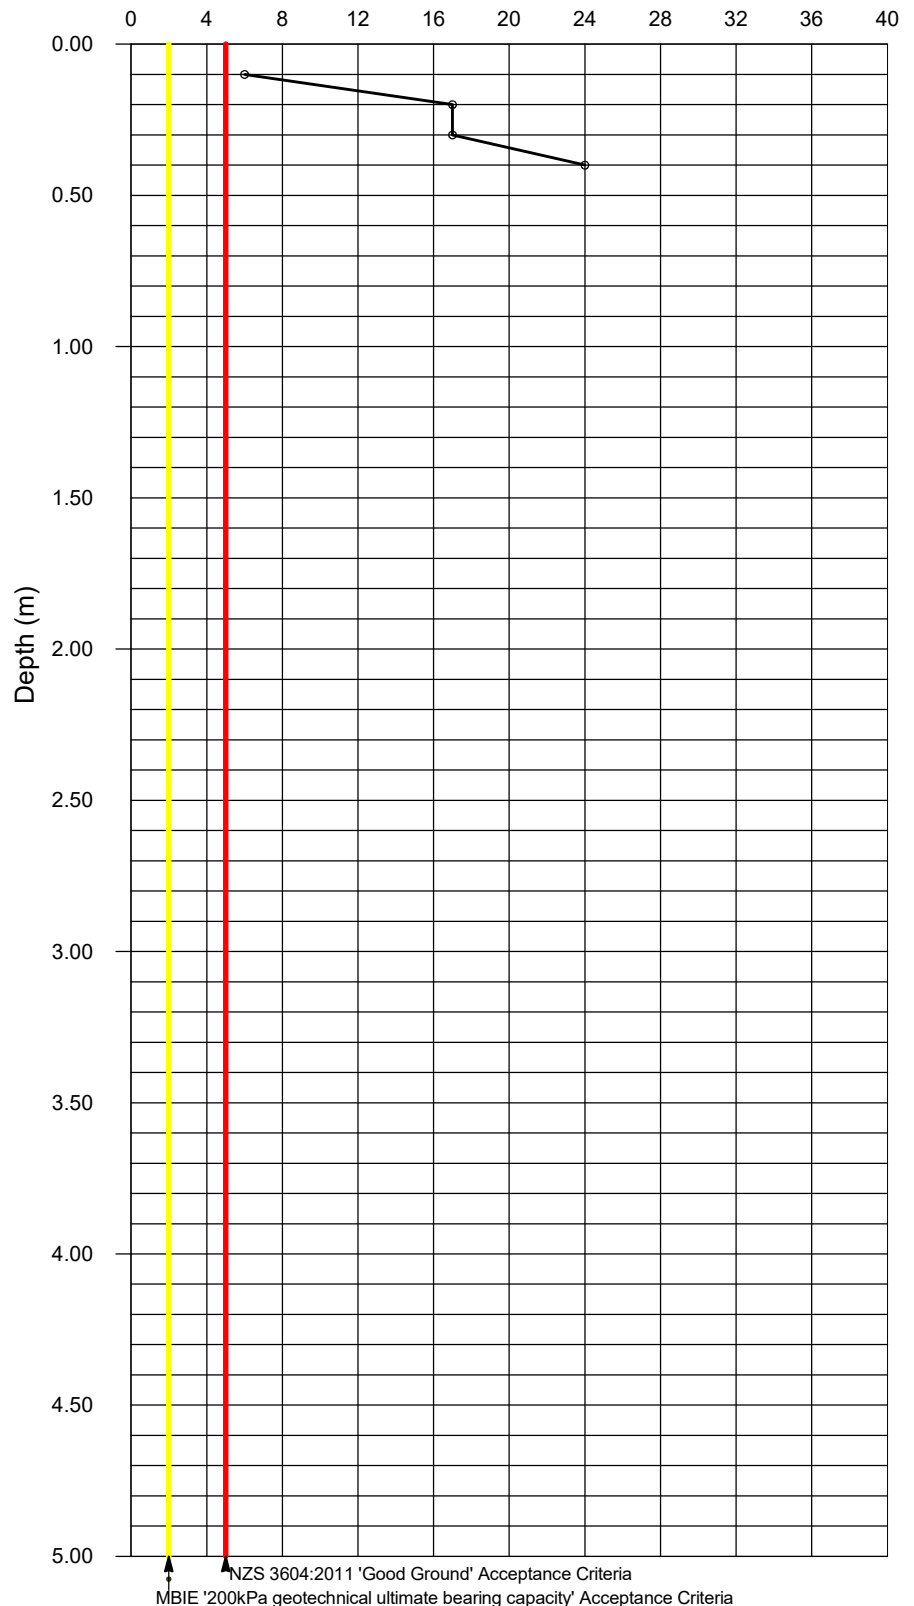
24 blows for 100mm in the last increment.

Effective refusal, 20+ blows per 100mm

**Number of blows per 100mm**
