Prestons Park Subdivision  
GEOTECHNICAL REPORT FOR LOT 1095  
CDL Land NZ Limited

16 September 2021  
Revision: 1  
Reference: 235361

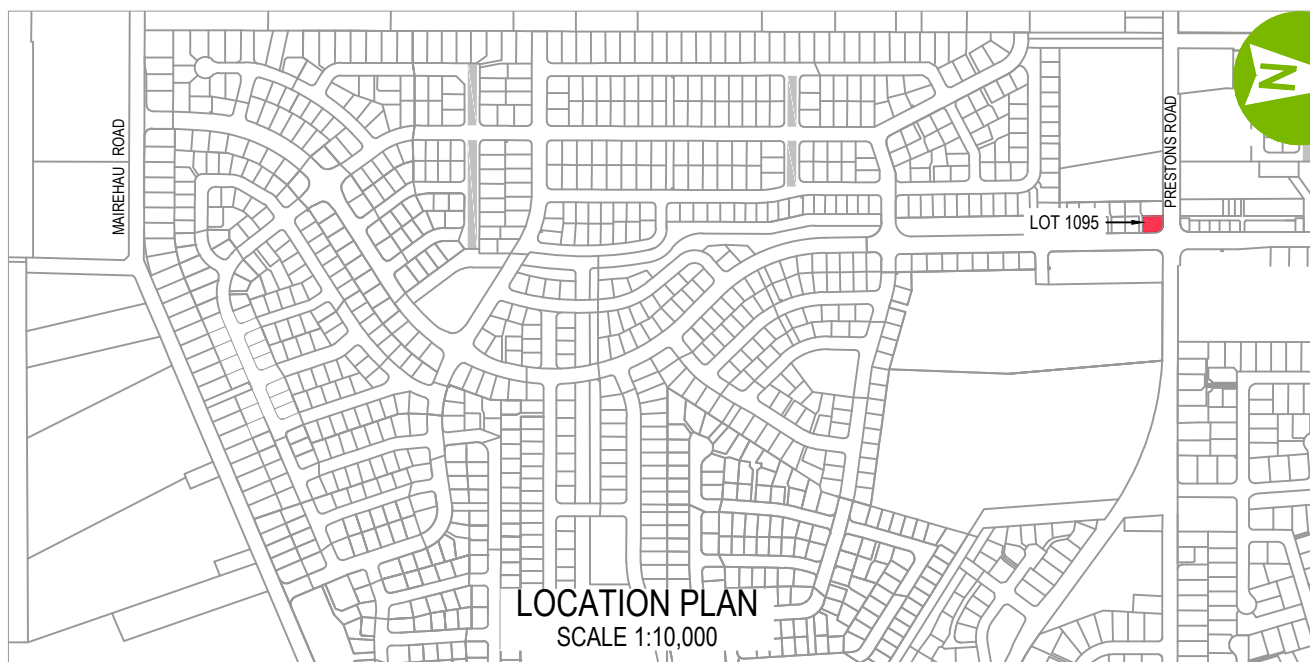
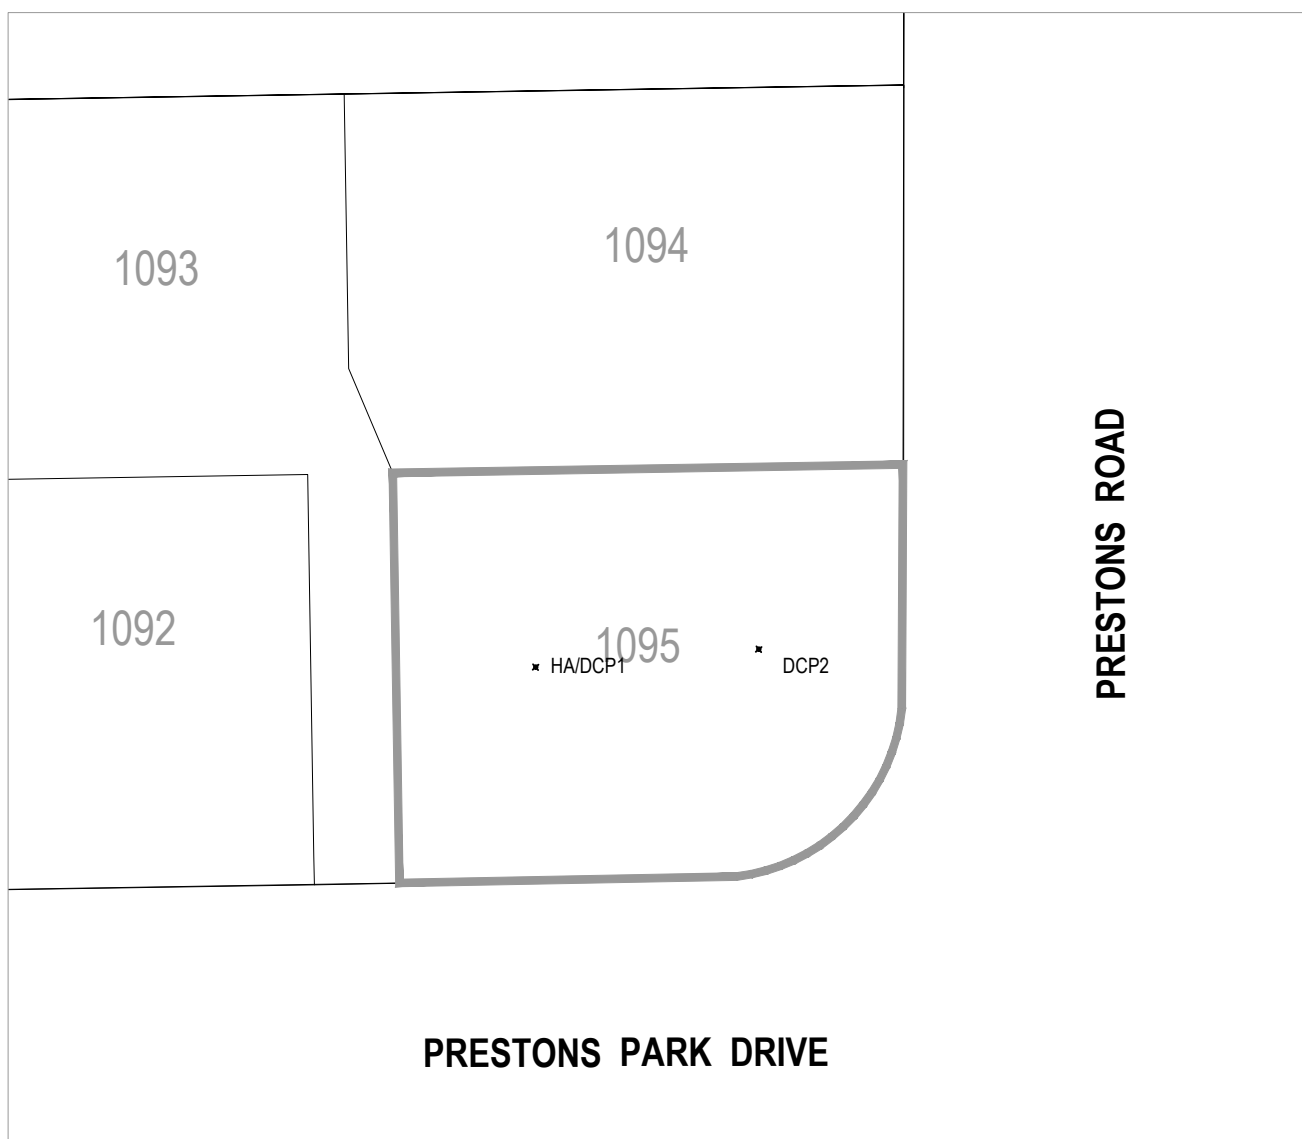
| REV | DATE | REVISION DETAILS | APPROVED | DRAWN | DESIGNED | PROJECT | | INFORMATION | |
|---|---|---|---|---|---|---|--|---|--|
| | | | | T BROWNE | | FIGURE 1 | | DRAWING No. | |

| REV | DATE | REVISION DETAILS | APPROVED | DRAWN | DESIGNED | PROJECT | | INFORMATION | |
|---|---|---|---|---|---|---|--|---|--|
| | | | | T BROWNE | | SITE LOCATION PLAN | | A4 | |

This building consent report is for Lot 1095 which is located in Stage 1 of the Prestons South Subdivision (refer Figure 1 in Appendix A). The lot is bordered by residential lots to the south and west, with roads to the north and east.

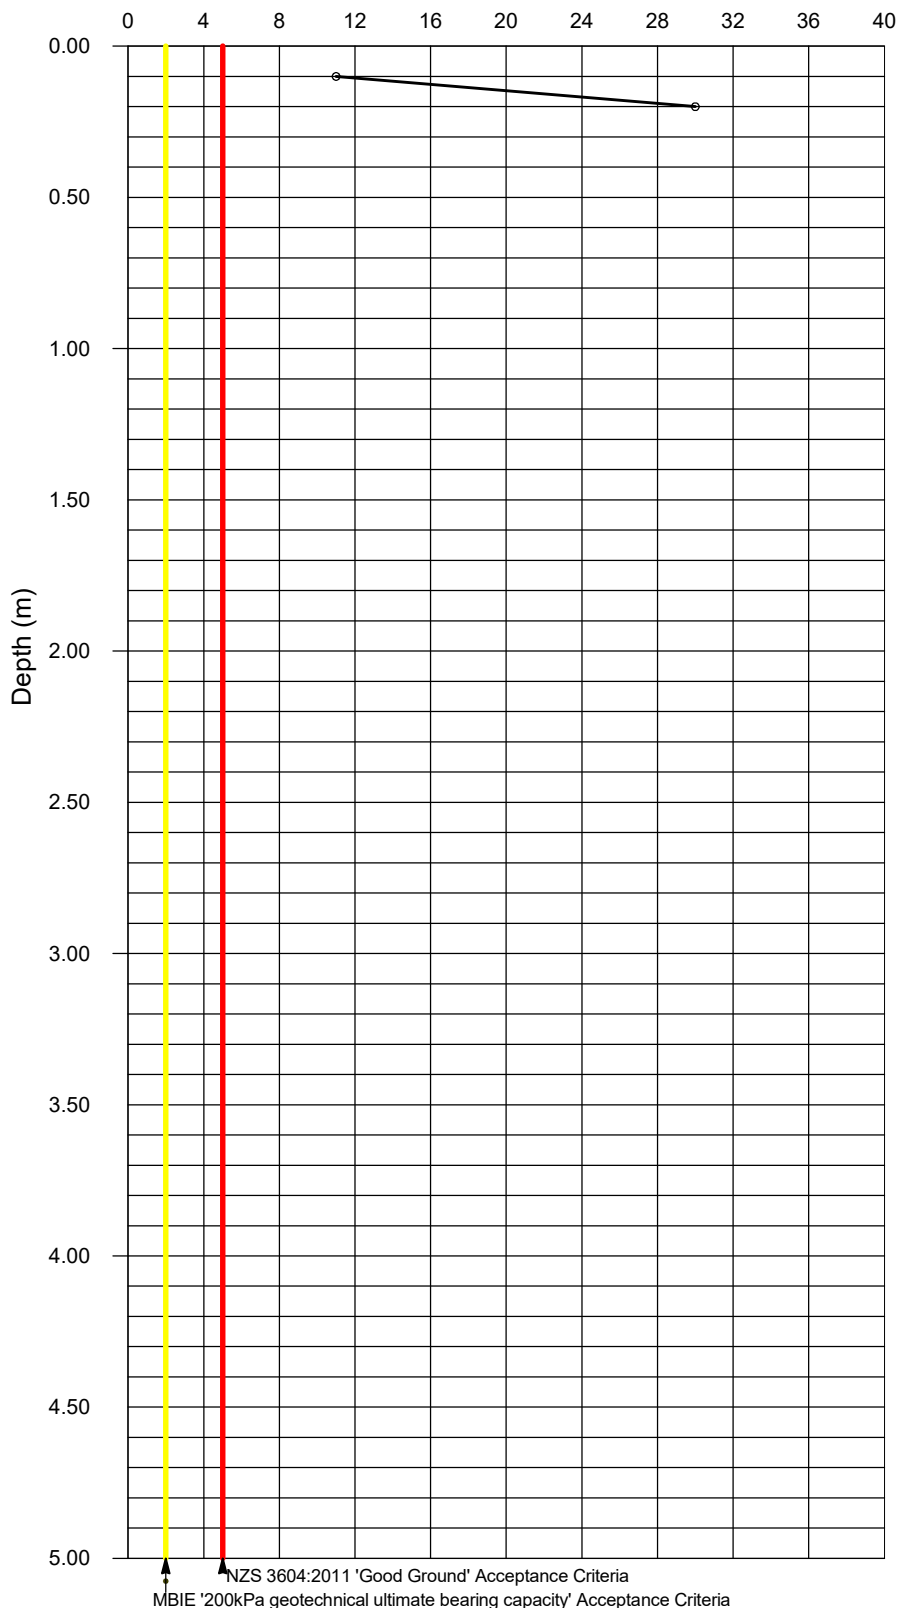
30 blows for 100mm in the last increment.

Effective refusal, 20+ blows per 100mm

**Number of blows per 100mm**

NZS 3604:2011 'Good Ground' Acceptance Criteria  
MBIE '200kPa geotechnical ultimate bearing capacity' Acceptance Criteria

Two DCPs were carried out with the locations and results uploaded to the NZGD. The DCP test results are attached in Appendix B. One of the DCPs was located adjacent to the hand auger borehole, with the second DCP located on the opposite half of the lot.

DCP logs indicate 5 blows per 100mm penetration, which is equivalent to an ultimate bearing capacity of 300kPa, was encountered from a shallow depth.

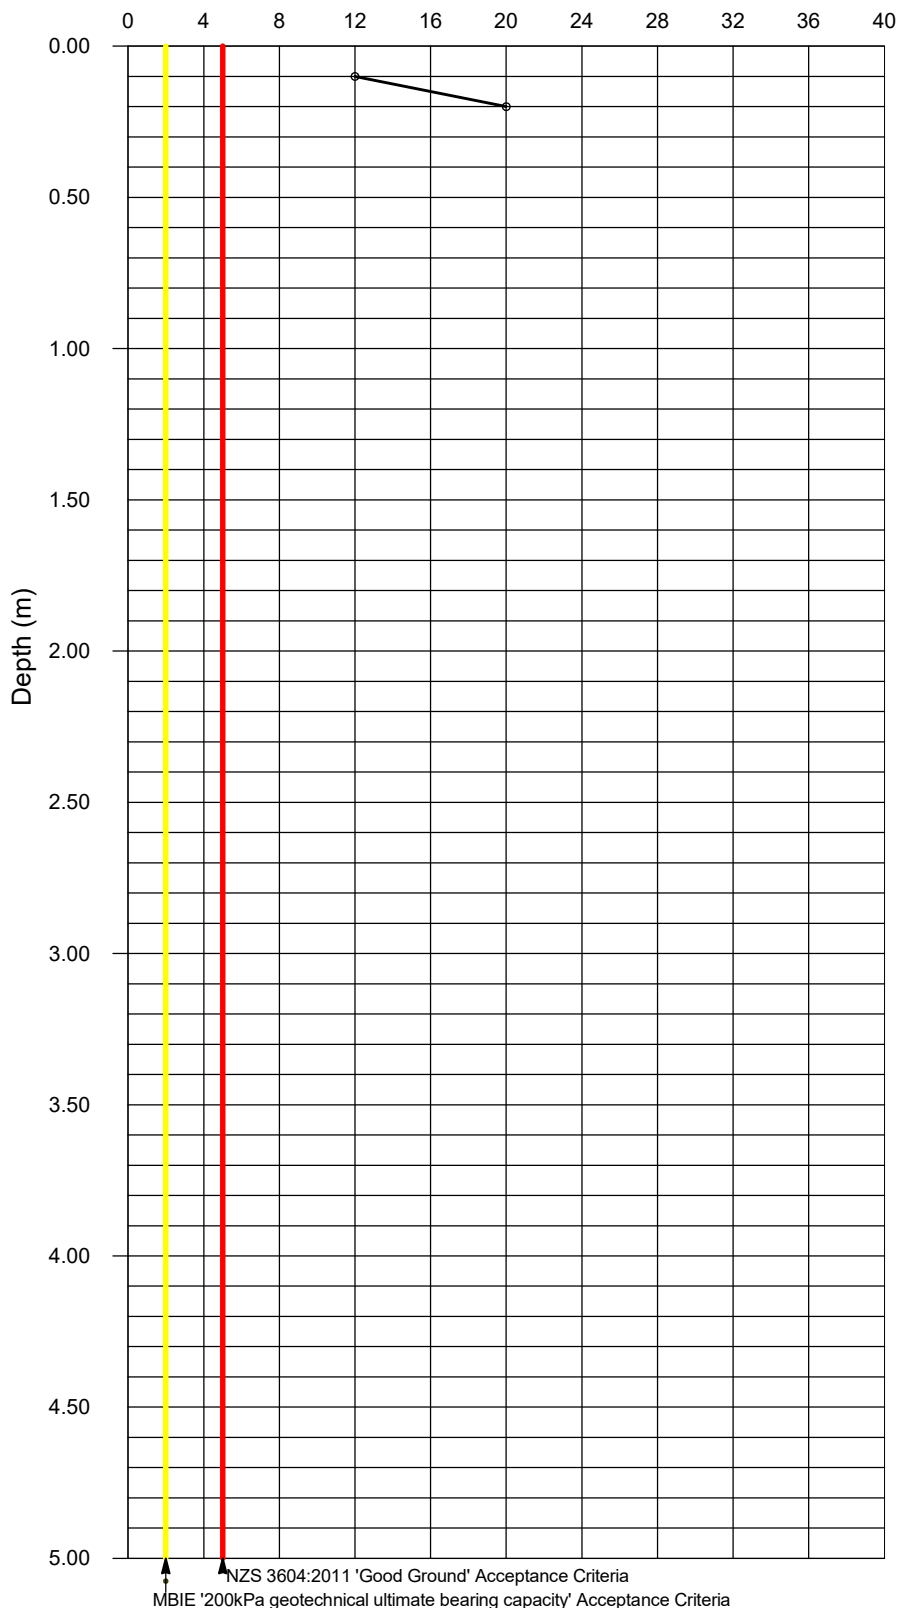
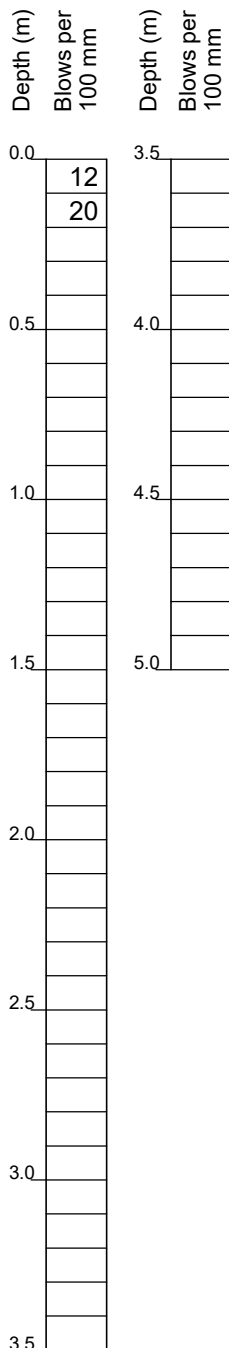
**Number of blows per 100mm**

20 blows for 100mm in the last increment.  
Co-ordinates and elevation data from site survey.  
Elevation based on Christchurch Drainage Datum.  
Effective refusal, 20+ blows per 100mm
