Prestons Park Subdivision
GEOTECHNICAL REPORT FOR LOT 1026
CDL Land NZ Limited

8 December 2023
Revision: 1
Reference: 235361

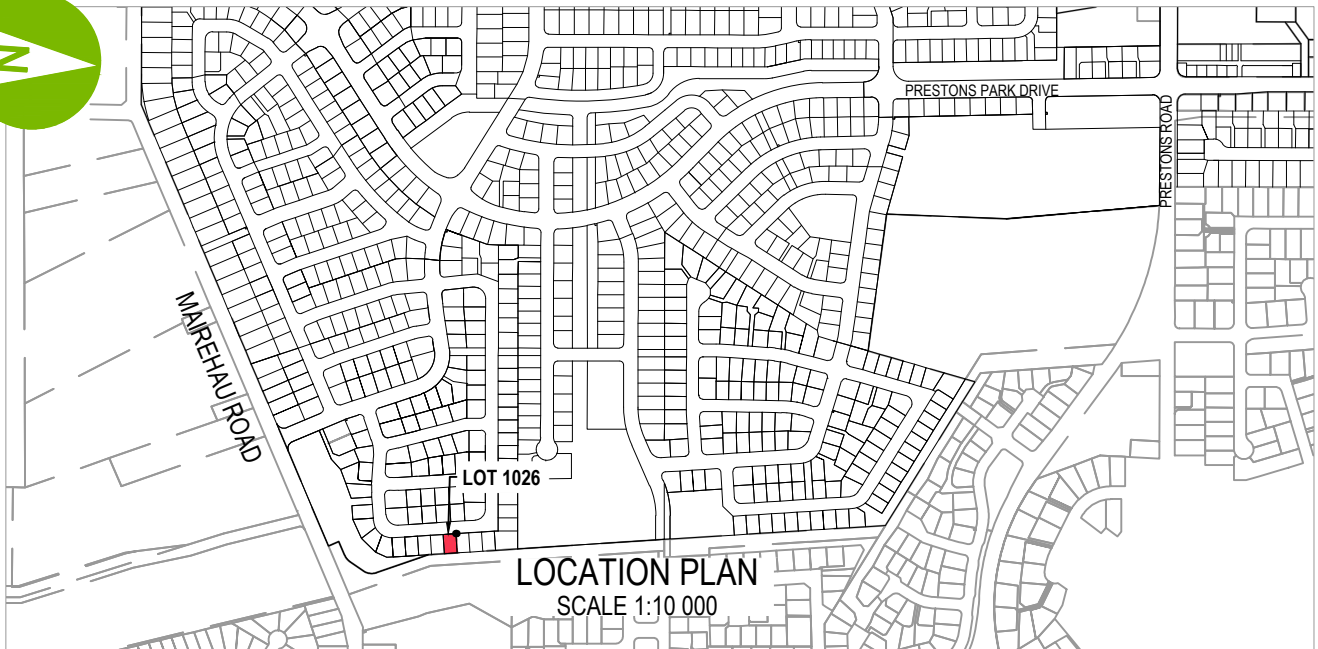
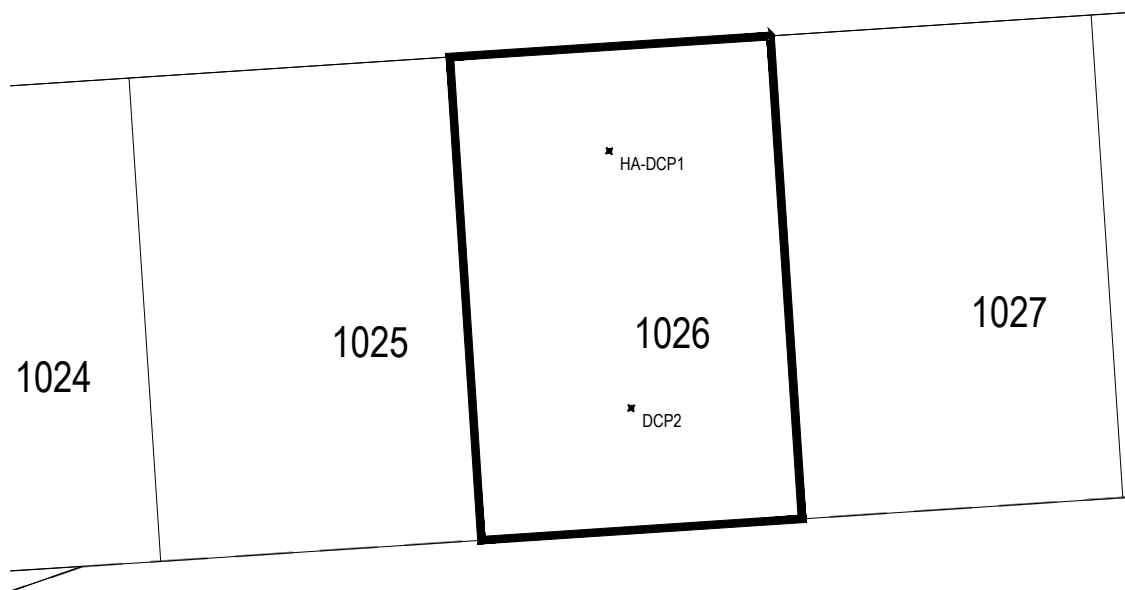
This building consent report is for Lot 1026 which is located in Stage 5 of the Prestons Park Subdivision development (refer Figure 1 in Appendix A). The lot is bordered by residential lots to the north and south and an access road to the west.
