Property address: 26 Cameo Grove

### Law Block Subdivision

Resource Consent Geotechnical Report

RMA Geotechnical Hazard Assessment

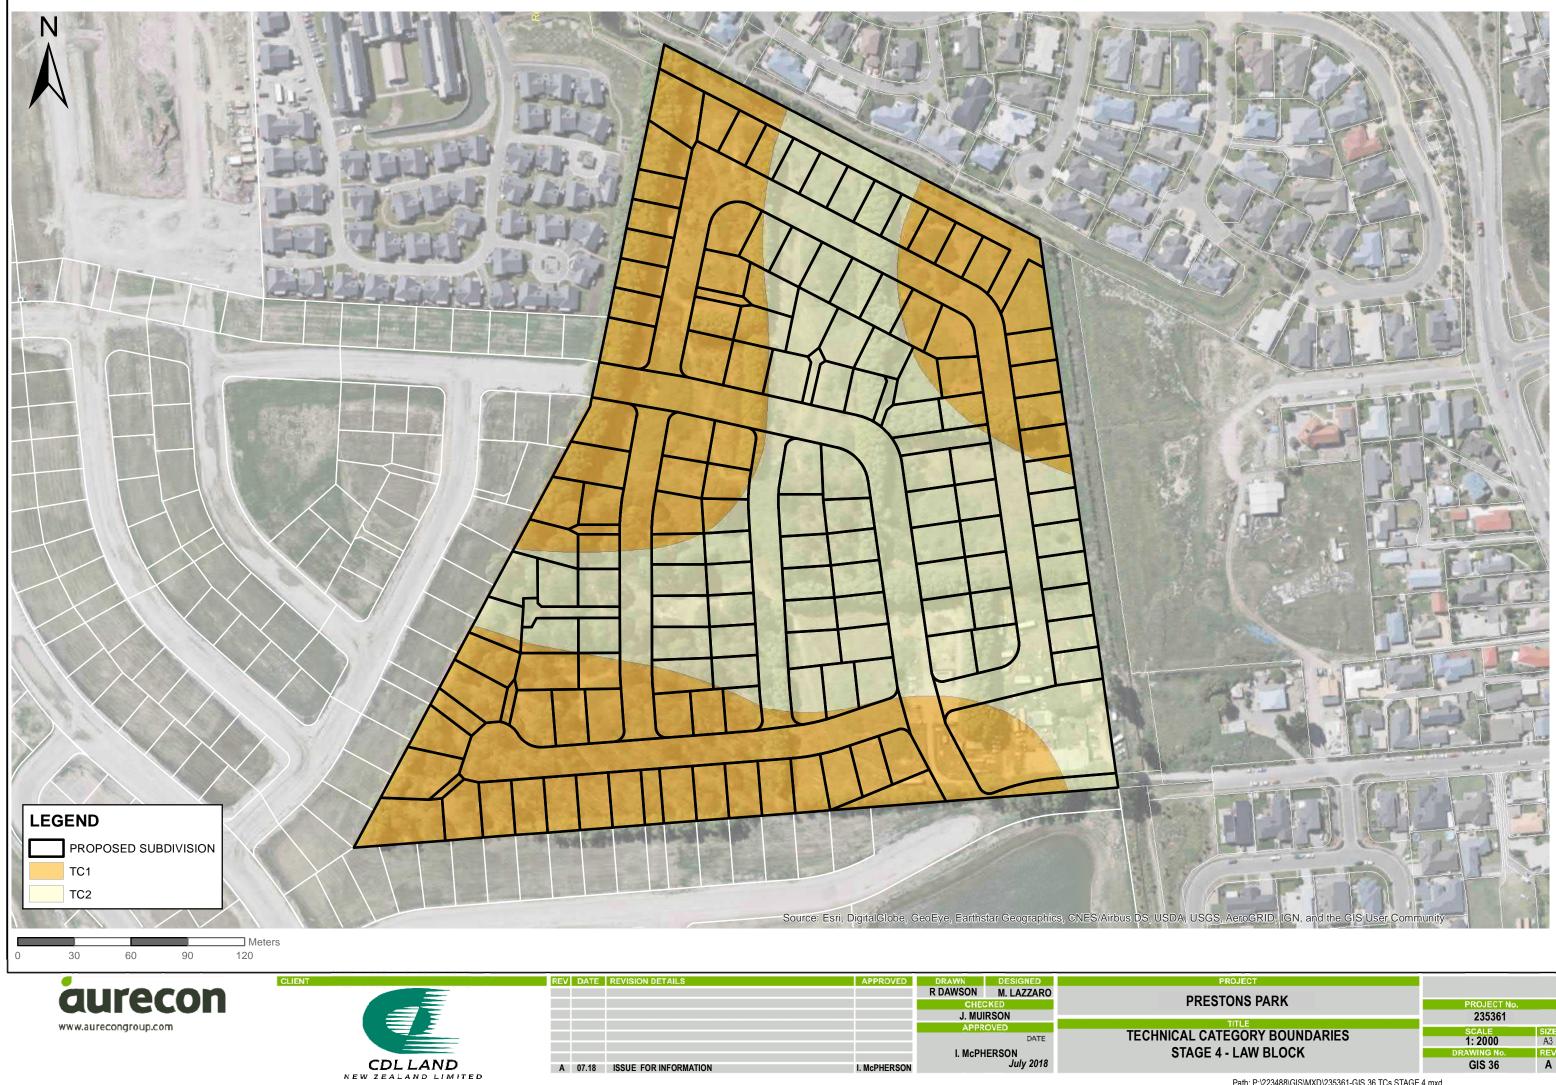
PROJECT	
PRESTONS PARK	
TITLE	
L CATEGORY BOUNDARIES	
AGE 4 - LAW BLOCK

PROJECT No.	
235361	
SCALE	SIZE
1: 2000	A3
DRAWING No.	REV
GIS 36	Α

Based on the liquefaction results, parts of the site can be classified as Technical Category 1 (TC1) while other parts can be classified as Technical Category 2 (TC2). The extent of the liquefaction induced ground damage and settlements in parts of the area classified as TC2 are at a level where we consider that the ground could be improved to a TC1 equivalent performance level.

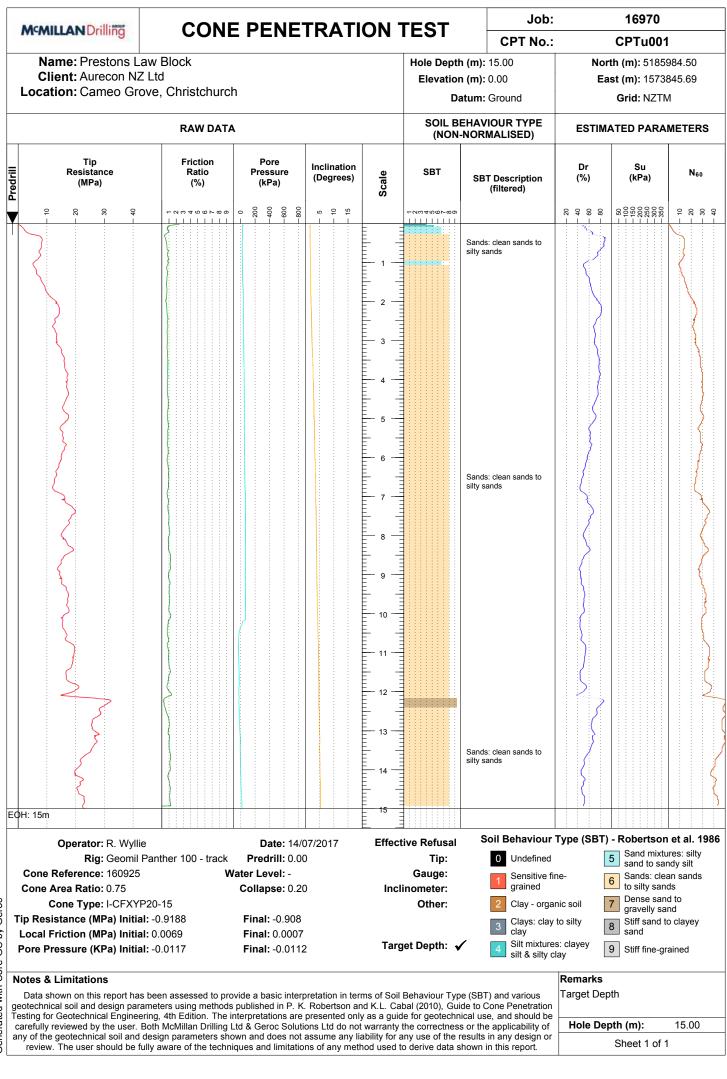
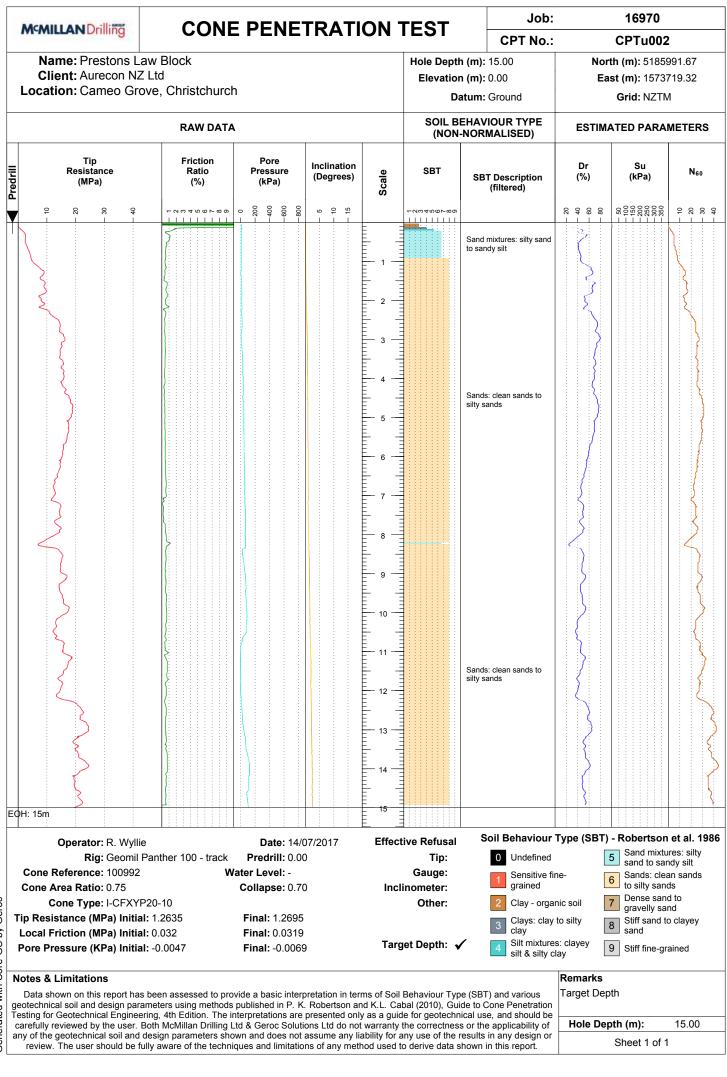
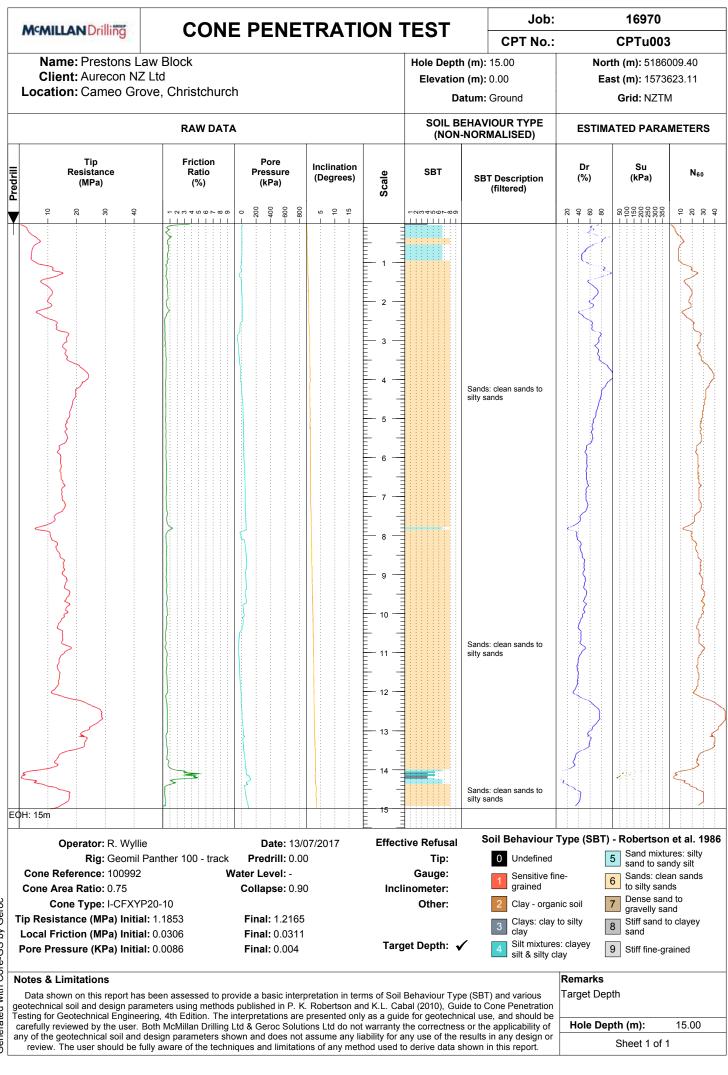
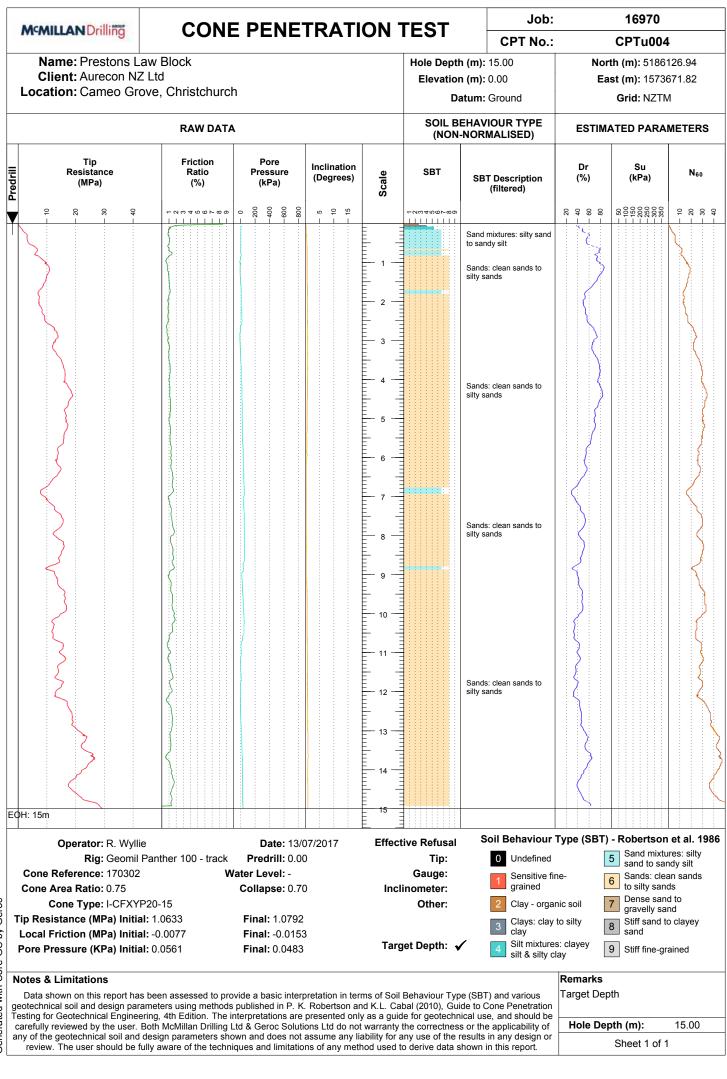
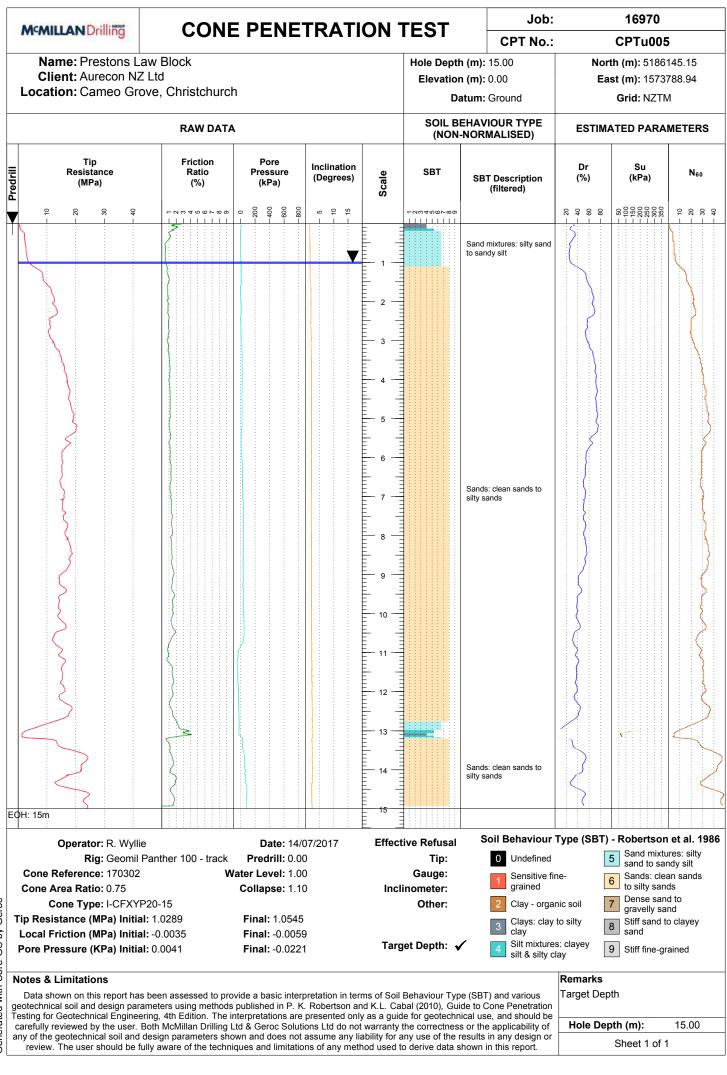
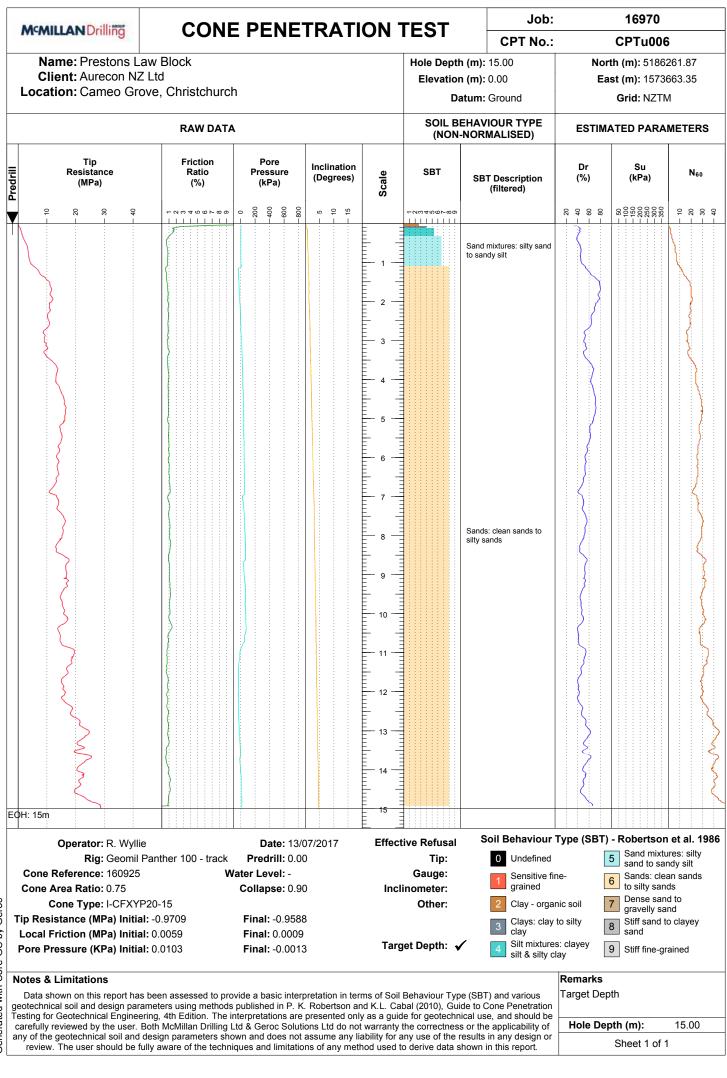
### **TEST DETAIL**

PointID:	CPTu001		
Sounding:	1		
-	Operator: R. Wyllie	Date: 14/07/2017	Effective Refusal
	Cone Reference: 160925	Predrill: 0.00	Tip:
	Cone Area Ratio: 0.75	Water Level: -	Gauge:
	Cone Type: I-CFXYP20-15	Collapse: 0.20	Inclinometer:
			Other:
	Tip Resistance (MPa) Initial: -0.9188	Final: -0.908	
	Local Friction (MPa) Initial: 0.0069	Final: 0.0007	
	Pore Pressure (kPa) Initial: -0.0117	Final: -0.0112	Target Depth: 🗸
PointID:	CPTu002		
Sounding:	2		
	Operator: R. Wyllie	Date: 14/07/2017	Effective Refusal
	Cone Reference: 100992	Predrill: 0.00	Tip:
	Cone Area Ratio: 0.75	Water Level: -	Gauge:
	Cone Type: I-CFXYP20-10	Collapse: 0.70	Inclinometer:
			Other:
	Tip Resistance (MPa) Initial: 1.2635	Final: 1.2695	
	Local Friction (MPa) Initial: 0.032	Final: 0.0319	
	Pore Pressure (kPa) Initial: -0.0047	Final: -0.0069	Target Depth: 🗸
PointID:	CPTu003		
Sounding:	3		
	<b>Operator:</b> R. Wyllie	Date: 13/07/2017	Effective Refusal
