Prestons Subdivision
GEOTECHNICAL REPORT FOR LOT 4011
CDL Land NZ Limited

26 August 2021
Revision: 1
Reference: 235361

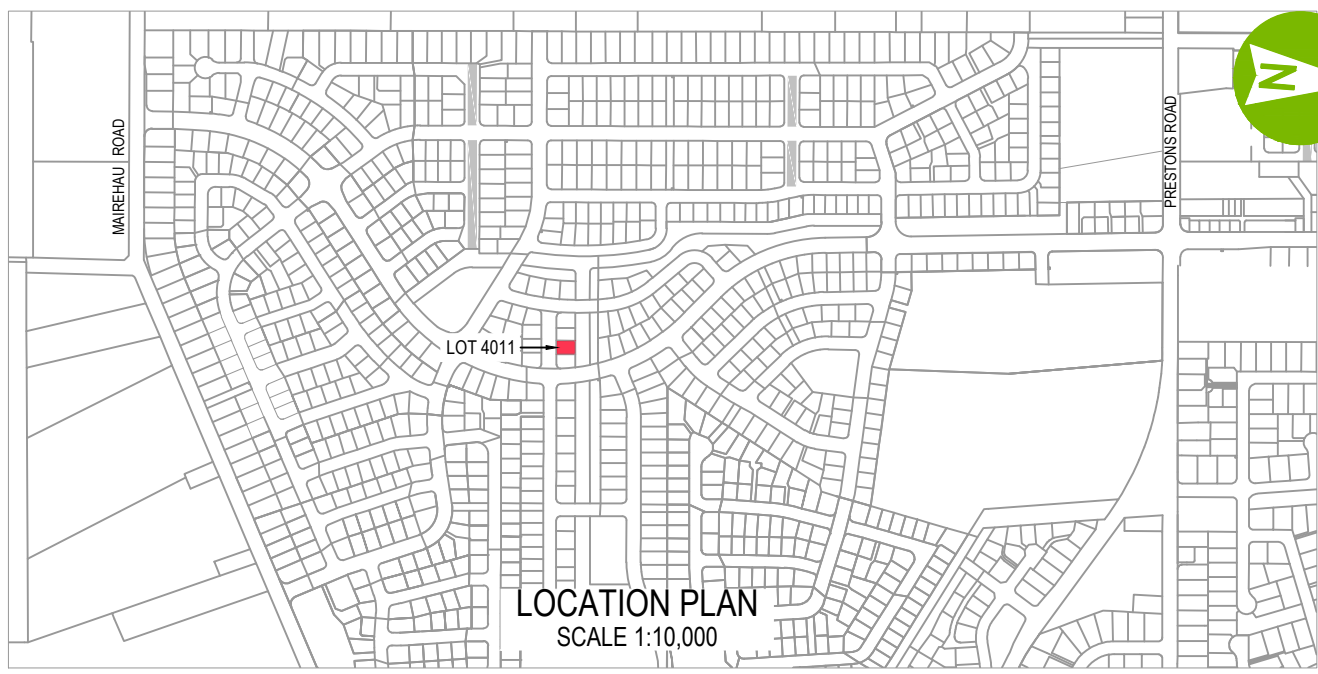
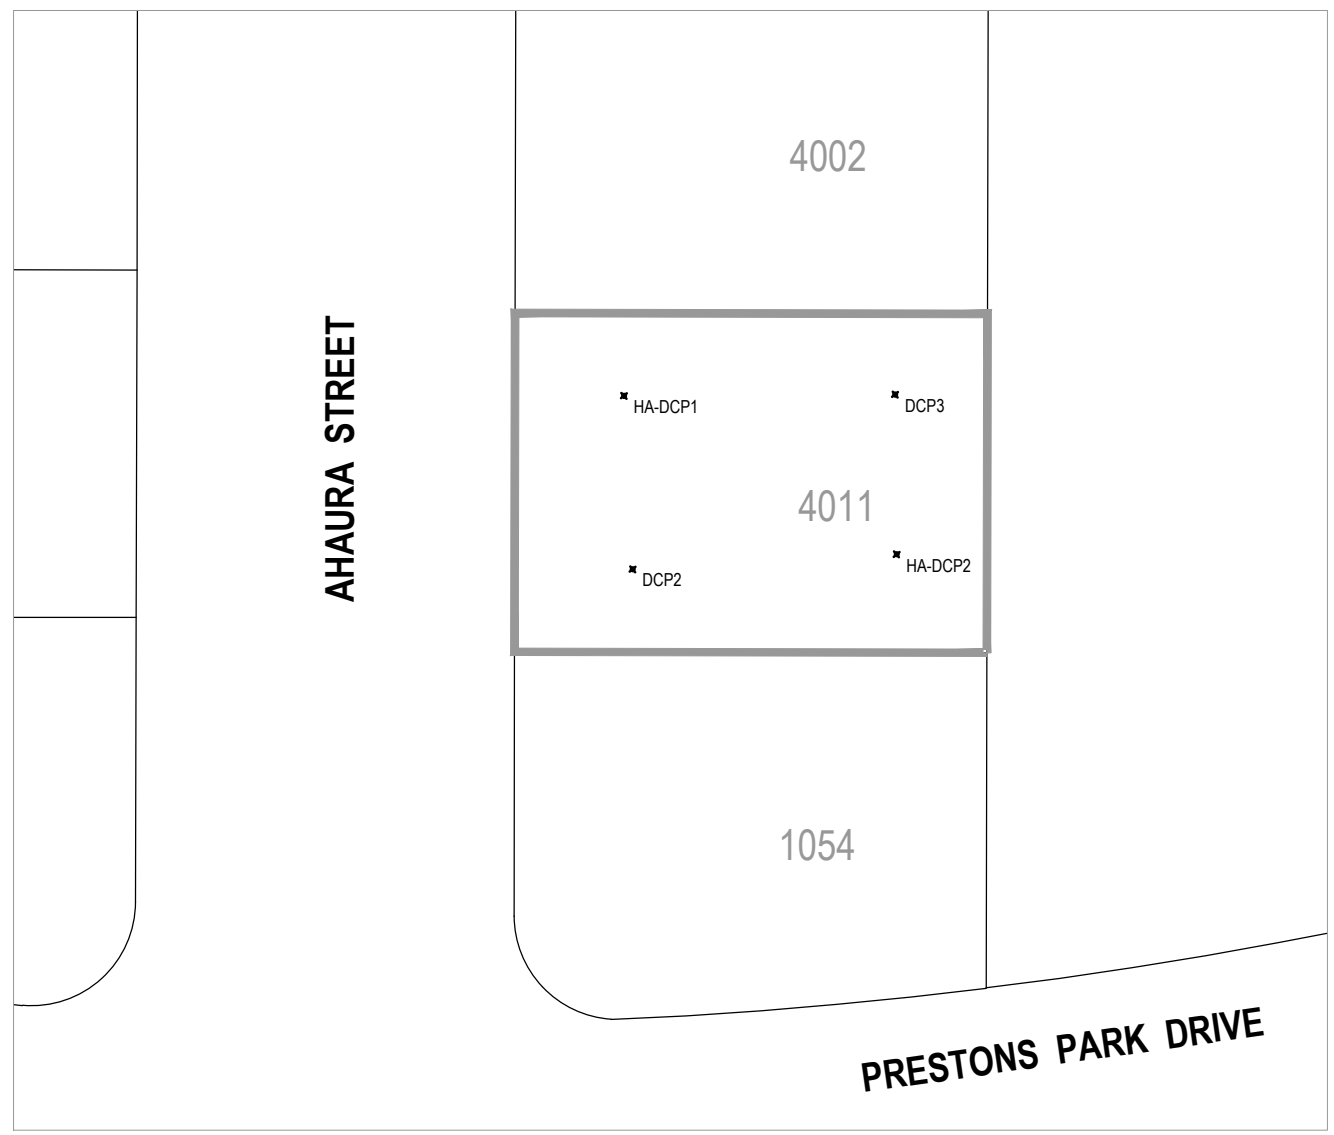
REV		DATE	REVISION DETAILS	APPROVED	DRAWN	DESIGNED	PROJECT		INFORMATION	
A		25/02/21	ISSUE FOR INFORMATION	T BROWNE	R DAWSON	K FOOTE	PRESTONS		PROJECT No. 235361	
				CHECKED J MUIRSON				SCALE 1:400		SIZE A4
				APPROVED T BROWNE		DATE 25/02/2021	TITLE LOT 4011 SITE LOCATION PLAN FIGURE 1		DRAWING No. GO-PS-DC-IN-4011	
				T BROWNE					REV A

This building consent report is for Lot 4011 which is located in Stage 2 of the Prestons South Subdivision development (refer Figure 1 in Appendix A). The lot is bordered by residential lots to the east and west, an access road to the south and an open storm water channel to the north.
