Prestons Park Subdivision
GEOTECHNICAL REPORT FOR LOT 1028
CDL Land NZ Limited

9 November 2022
Revision: 1
Reference: 235361

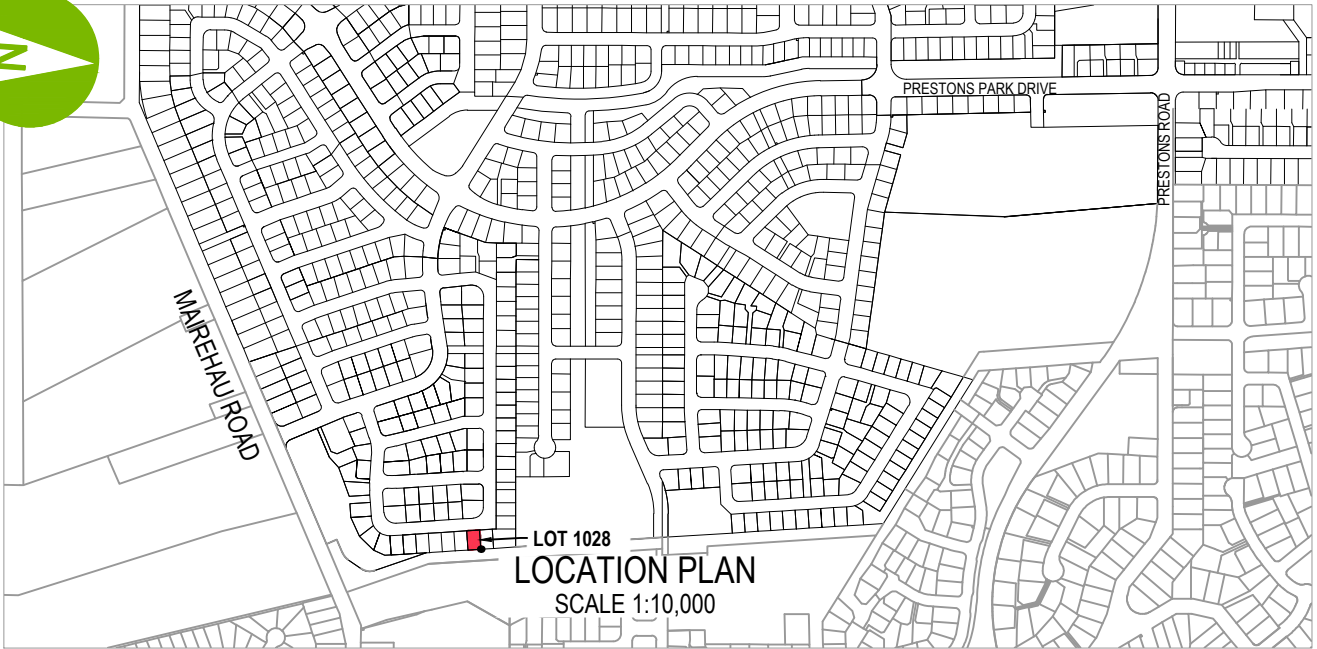
<small>www.aurecongroup.com</small>	REV	DATE	REVISION DETAILS	APPROVED	DRAWN	DESIGNED	PROJECT	INFORMATION	
	A	13/05/22	ISSUE FOR INFORMATION	T BROWNE	R DAWSON	C DOHERTY		PRESTONS PARK	NOT FOR CONSTRUCTION
CLIENT PRESTONS PARK					CHECKED			PROJECT No.	
					J MUIRSON			235361	
					APPROVED		TITLE	SCALE	SIZE
					T BROWNE	DATE 03/05/22	LOT 1028 SITE LOCATION PLAN FIGURE 1	1:400	A4
							DRAWING No.	REV	
							GO-PS-S5-IN-1028	A
