Prestons Park Subdivision  
GEOTECHNICAL REPORT FOR LOT 1029  
CDL Land NZ Limited

9 November 2022  
Revision: 1  
Reference: 235361

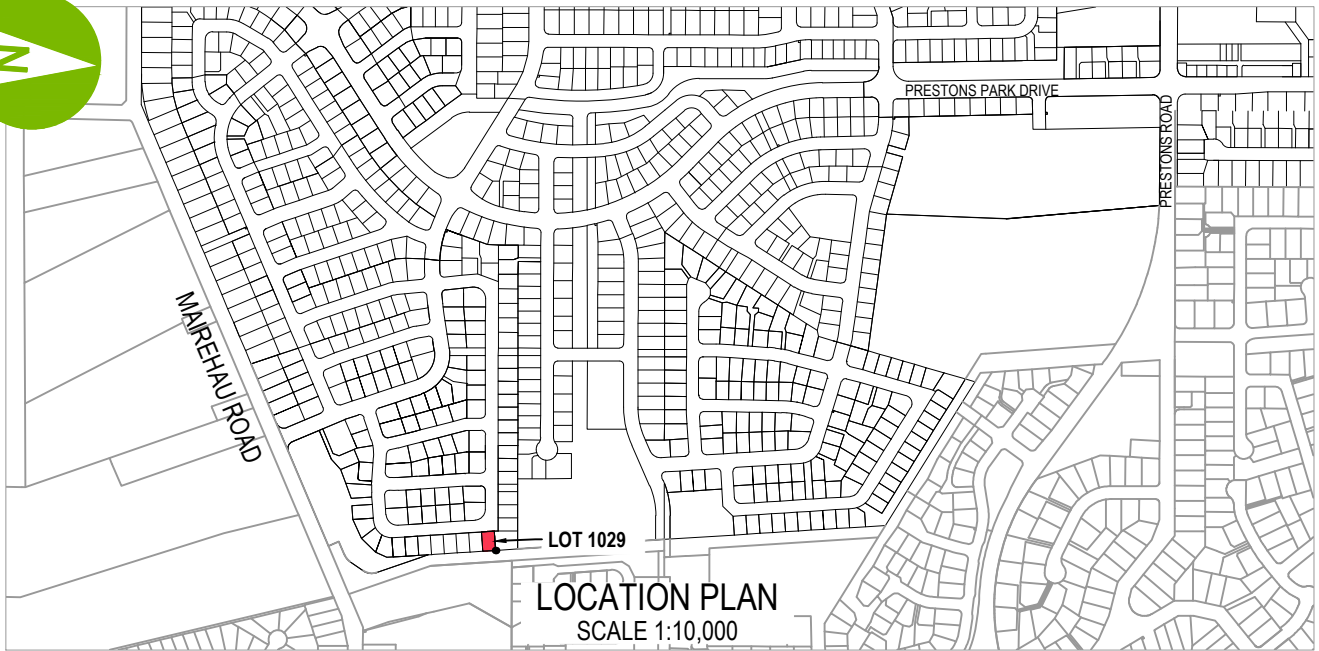
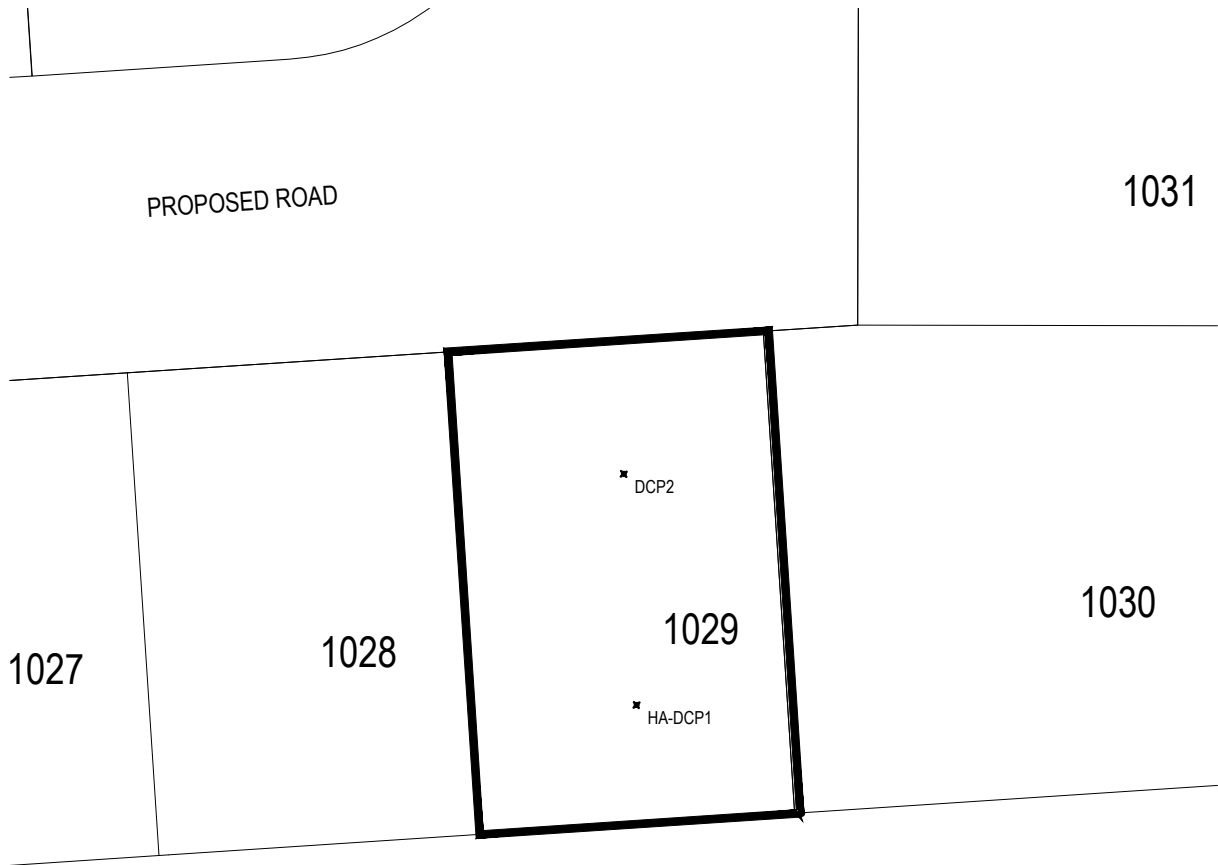
<small>www.aurecon.co.nz</small>	<b>REV</b>	<b>DATE</b>	<b>REVISION DETAILS</b>	<b>APPROVED</b>	<b>DRAWN</b>	<b>DESIGNED</b>	<b>PROJECT</b>	<b>INFORMATION</b>	
	A	13/05/22	ISSUE FOR INFORMATION	T BROWNE	R DAWSON	C DOHERTY	PRESTONS PARK	NOT FOR CONSTRUCTION	
<b>CLIENT</b> <b>PRESTONS PARK</b>					<b>CHECKED</b>			<b>PROJECT No.</b>	
					J MUIRSON			235361	
					<b>APPROVED</b>		<b>TITLE</b>	<b>SCALE</b>	<b>SIZE</b>
					T BROWNE	DATE 03/05/22	LOT 1029 SITE LOCATION PLAN FIGURE 1	1:400	A4
							<b>DRAWING No.</b>	<b>REV</b>	
							GO-PS-S5-IN-1029	A
