Prestons Park Subdivision
GEOTECHNICAL REPORT FOR LOT 982
CDL Land NZ Limited

21 November 2022
Revision: 1
Reference: 235361

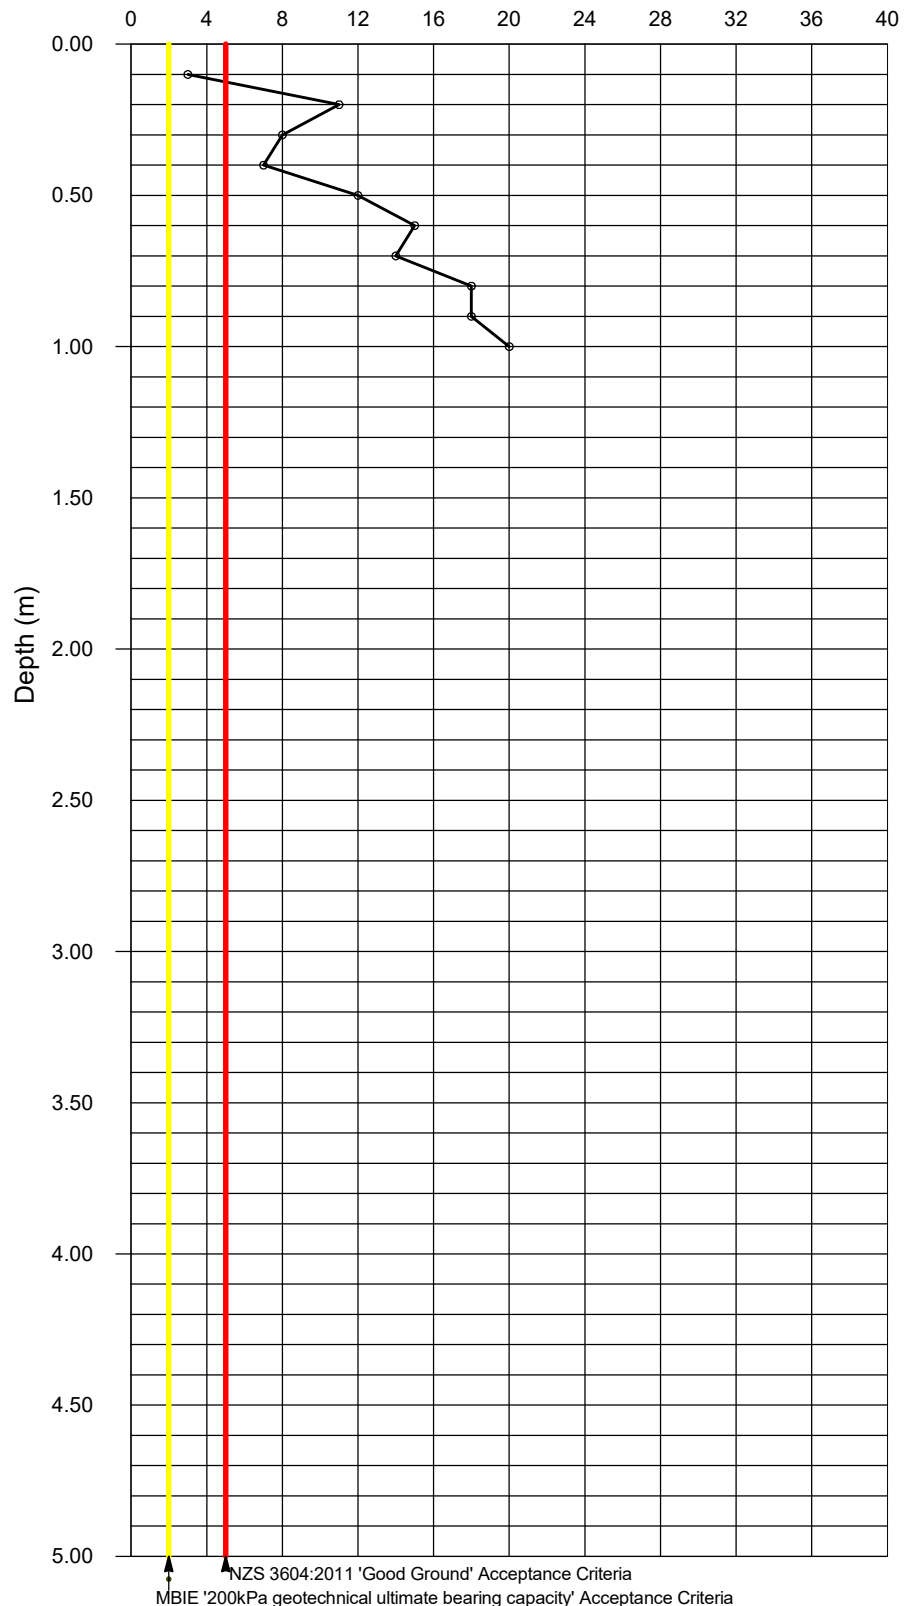
PROJECT **Prestons Park Subdivision
Stage 5**

Number of blows per 100mm

The depth of topsoil has been determined from the single hand auger and two DCPs undertaken on site. We note that the topsoil depths may vary by +/- 100mm between the testing locations and hence it is recommended that at least a 100mm tolerance should be allowed for building foundation excavations.

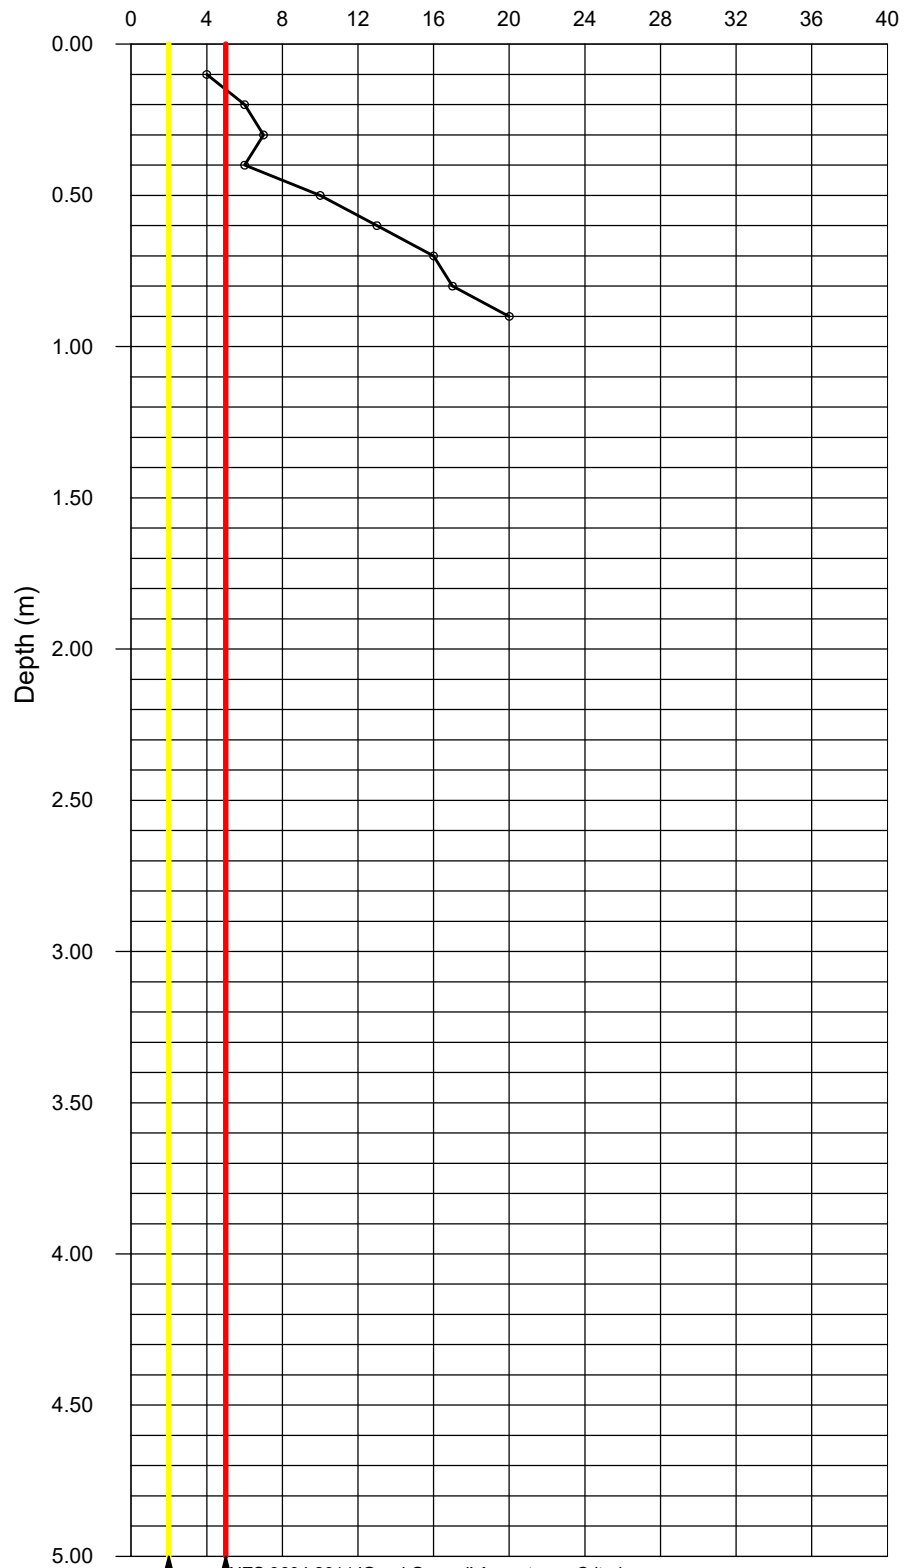
Number of blows per 100mm

Remarks:

20 blows for 100mm in the last increment.
Co-ordinates and elevation data from site survey.
Elevation based on Christchurch Drainage Datum.
Effective refusal, 20+ blows per 100mm
