**Prestons Park Subdivision**  
**GEOTECHNICAL REPORT FOR LOT 1038**  
**CDL Land NZ Limited**

**21 November 2022**  
**Revision: 1**  
**Reference: 235361**

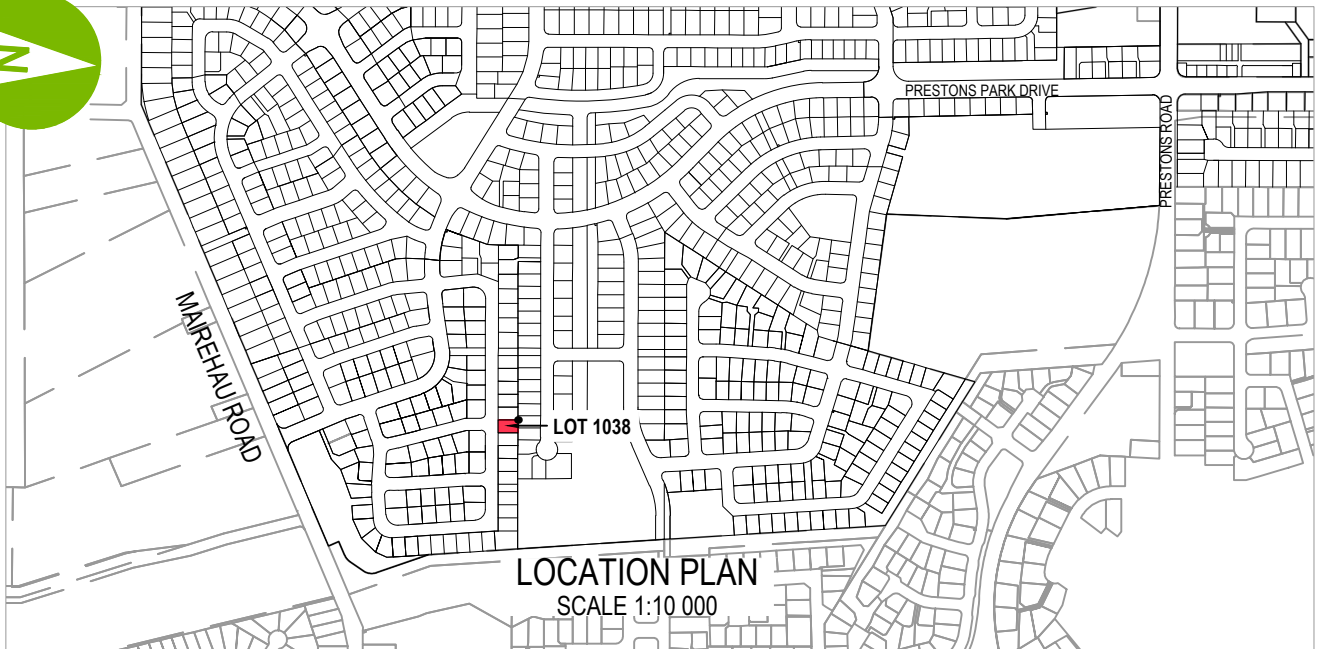
<small>www.aurecon.co.nz</small>	<b>REV</b>	<b>DATE</b>	<b>REVISION DETAILS</b>	<b>APPROVED</b>	<b>DRAWN</b>	<b>DESIGNED</b>	<b>PROJECT</b>	<b>INFORMATION</b>	
	A	13/05/22	ISSUE FOR INFORMATION	T BROWNE	R DAWSON	C DOHERTY	PRESTONS PARK	PROJECT No.	235361
<b>CLIENT</b> <b>PRESTONS PARK</b>					<b>CHECKED</b>			SCALE	SIZE
					J MUIRSON			1:400	A4
					<b>APPROVED</b>		<b>TITLE</b>	DRAWING No.	REV
					T BROWNE	DATE 03/05/22	LOT 1038 SITE LOCATION PLAN FIGURE 1	GO-PS-S5-IN-1038	A
