Prestons Park Subdivision
GEOTECHNICAL REPORT FOR LOT 936
CDL Land NZ Limited

30 June 2023
Revision: 1
Reference: 235361

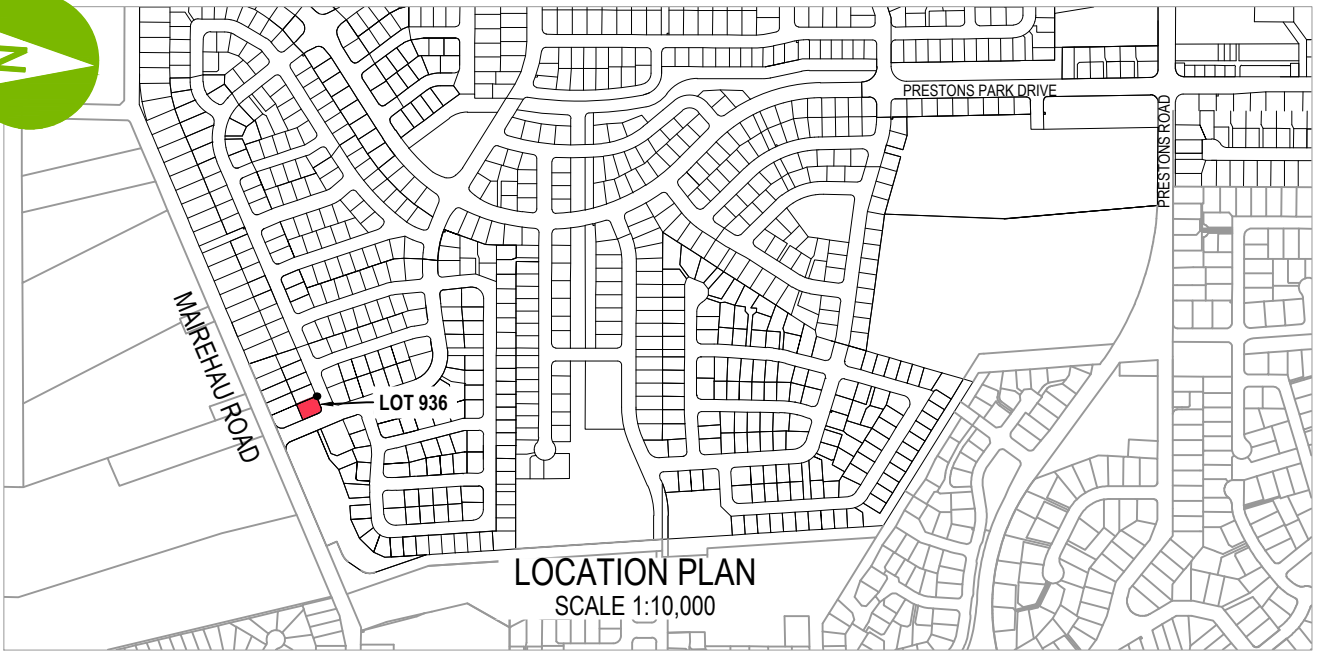
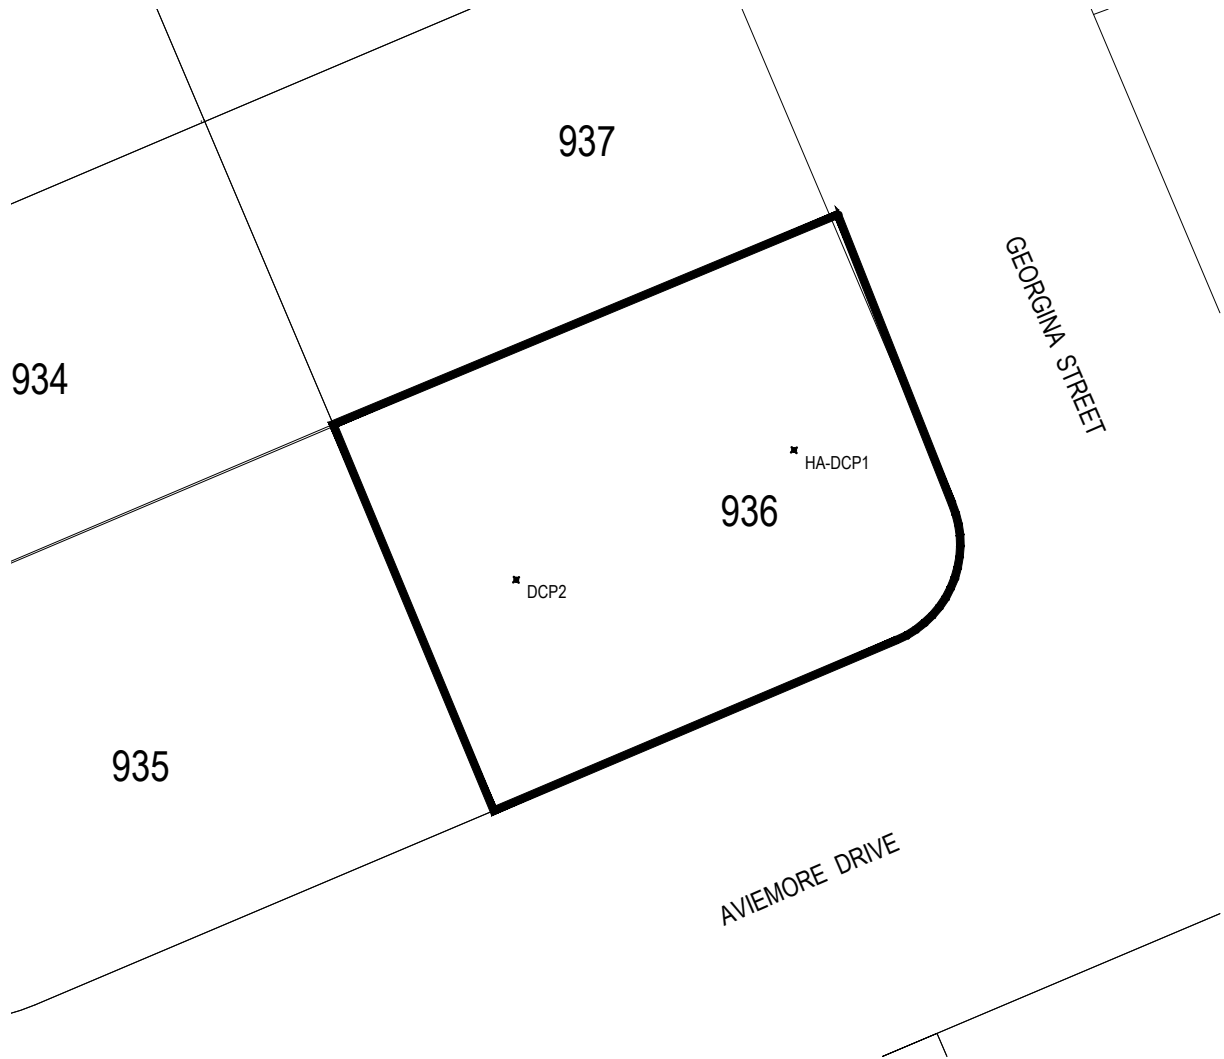
<small>www.aurecon.co.nz</small>	REV	DATE	REVISION DETAILS	APPROVED	DRAWN	DESIGNED	PROJECT	INFORMATION	
	A	13/05/22	ISSUE FOR INFORMATION	T BROWNE	M KORAKO	O DOHERTY	PRESTONS PARK	PROJECT No.	235361
CLIENT PRESTONS PARK					CHECKED			SCALE	SIZE
					J MUIRSON			1:400	A4
					APPROVED			DRAWING No.	REV
					T BROWNE	DATE		GO-PS-S5-IN-936	A
				T BROWNE			TITLE		
							LOT 936		
							SITE LOCATION PLAN		
							FIGURE 1

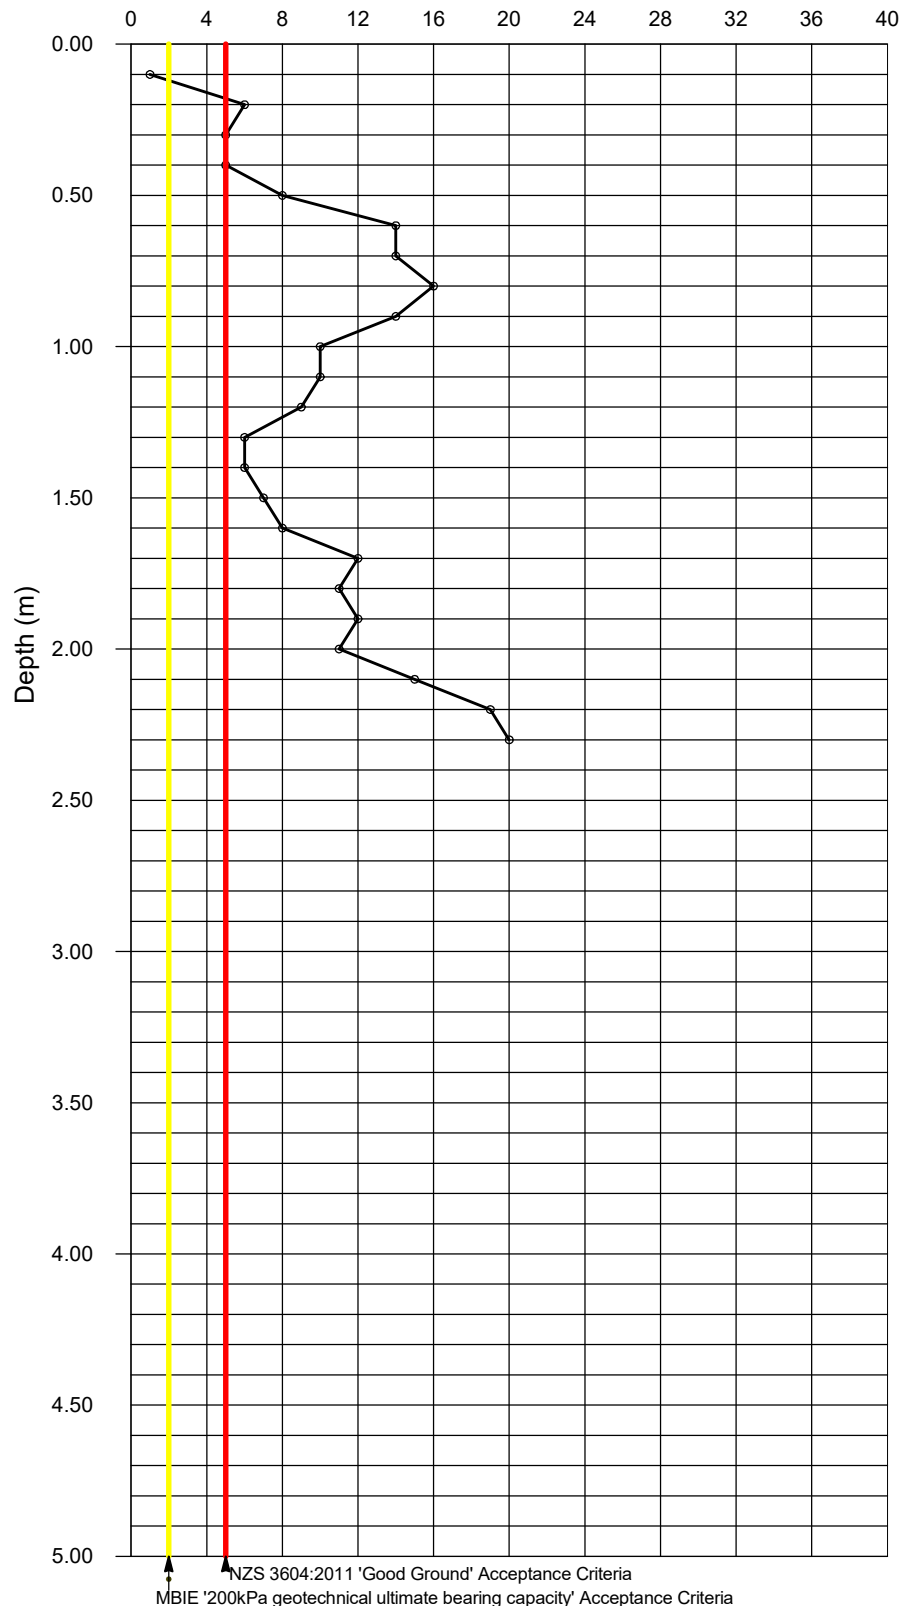
Number of blows per 100mm

Depth (m)	Blows per 100 mm	Depth (m)	Blows per 100 mm
0.0	1	3.5	
	6		
	5		
	5		
0.5	8	4.0	
	14		
	14		
	16		
	14		
1.0	10	4.5	
	10		
	9		
	6		
	6		
1.5	7	5.0	
	8		
	12		
	11		
	12		
2.0	11		
	15		
	19		
	20		
2.5			
3.0			
3.5

20 blows for 100mm in the last increment.
Co-ordinates and elevation data from site survey.
Elevation based on Christchurch Drainage Datum.
Effective refusal, 20+ blows per 100mm

The depth of topsoil has been determined from the single hand auger and two DCPs undertaken on site. We note that the topsoil depths may vary by +/- 100mm between the testing locations and hence it is recommended that at least a 100mm tolerance should be allowed for building foundation excavations.

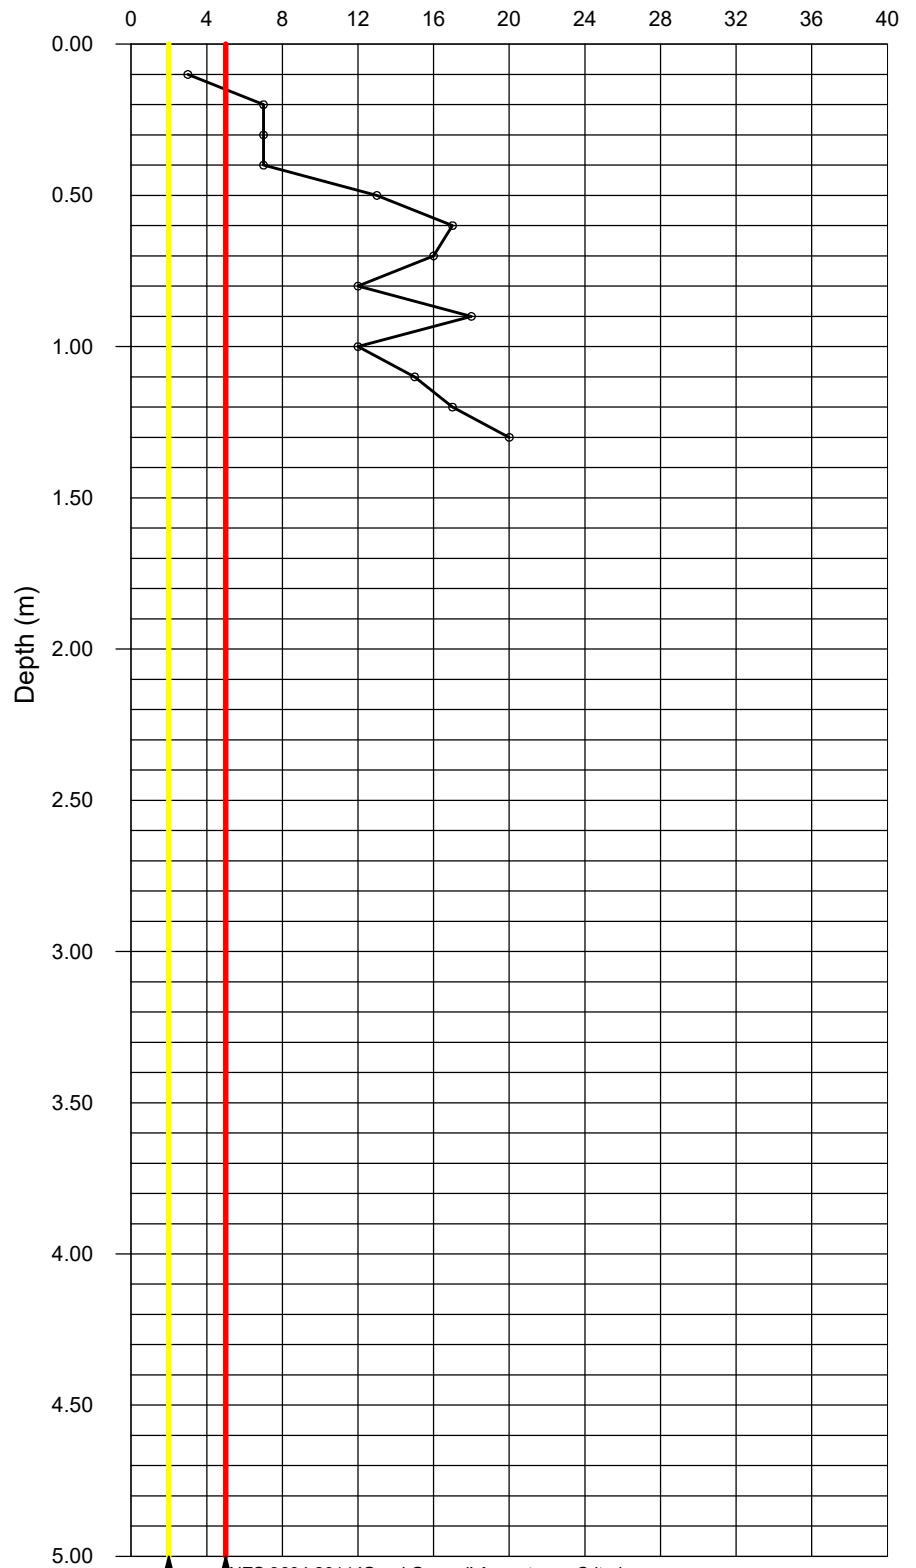
Number of blows per 100mm

Depth (m)	Blows per 100 mm	Depth (m)	Blows per 100 mm
0.0	3	0.0	
	7		
	7		
	7		
0.5	13	4.0	
	17		
	16		
	12		
	18		
1.0	12	4.5	
	15		
	17		
	20		
1.5		5.0	
2.0			
2.5			
3.0			
3.5

20 blows for 100mm in the last increment.
Co-ordinates and elevation data from site survey.
Elevation based on Christchurch Drainage Datum.
Effective refusal, 20+ blows per 100mm
