**Prestons Park Subdivision**  
**GEOTECHNICAL REPORT FOR LOT 1011**  
**CDL Land NZ Limited**

**28 June 2023**  
**Revision: 1**  
**Reference: 235361**

CDL Land NZ Ltd has commissioned Aurecon New Zealand Ltd to undertake site specific geotechnical investigations and assessments for individual residential lots for building consent purposes for the Prestons Park Subdivision Stage 5. This report documents the results of the geotechnical assessment and presents geotechnical comments together with foundation recommendations for the residential building on Lot 1011 at the Prestons Park Subdivision.

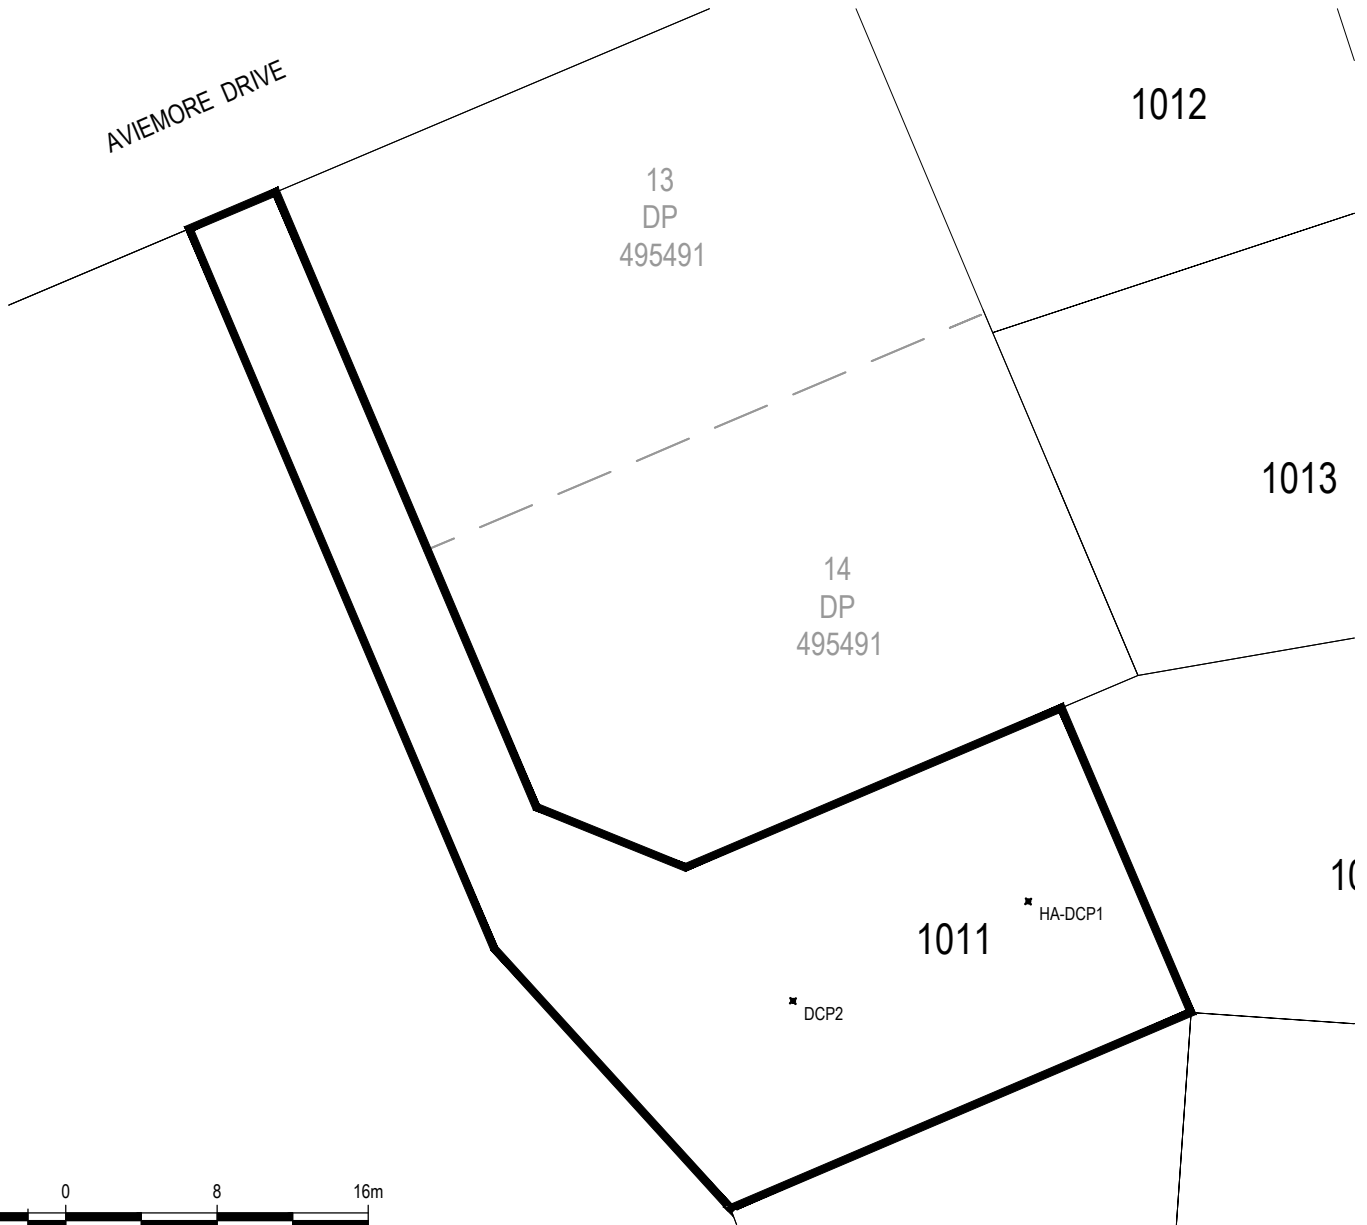
<small>www.aurecon.co.nz</small>	<b>REV</b>	<b>DATE</b>	<b>REVISION DETAILS</b>	<b>APPROVED</b>	<b>DRAWN</b>	<b>DESIGNED</b>	<b>PROJECT</b>	<b>INFORMATION</b>	
	A	20-06-23	ISSUE FOR INFORMATION	T BROWNE	M KORAKO	C DOHERTY		PRESTONS PARK	NOT FOR CONSTRUCTION
<b>CLIENT</b> <b>PRESTONS PARK</b>					<b>CHECKED</b>			<b>PROJECT No.</b>	
					J MUIRSON			235361	
					<b>APPROVED</b>		<b>TITLE</b>	<b>SCALE</b>	<b>SIZE</b>
					T BROWNE	DATE 20/06/23	LOT 1011 SITE LOCATION PLAN FIGURE 1	1:400	A4
					T BROWNE			<b>DRAWING No.</b>	<b>REV</b>
								GO-PS-S5-IN-1011	A

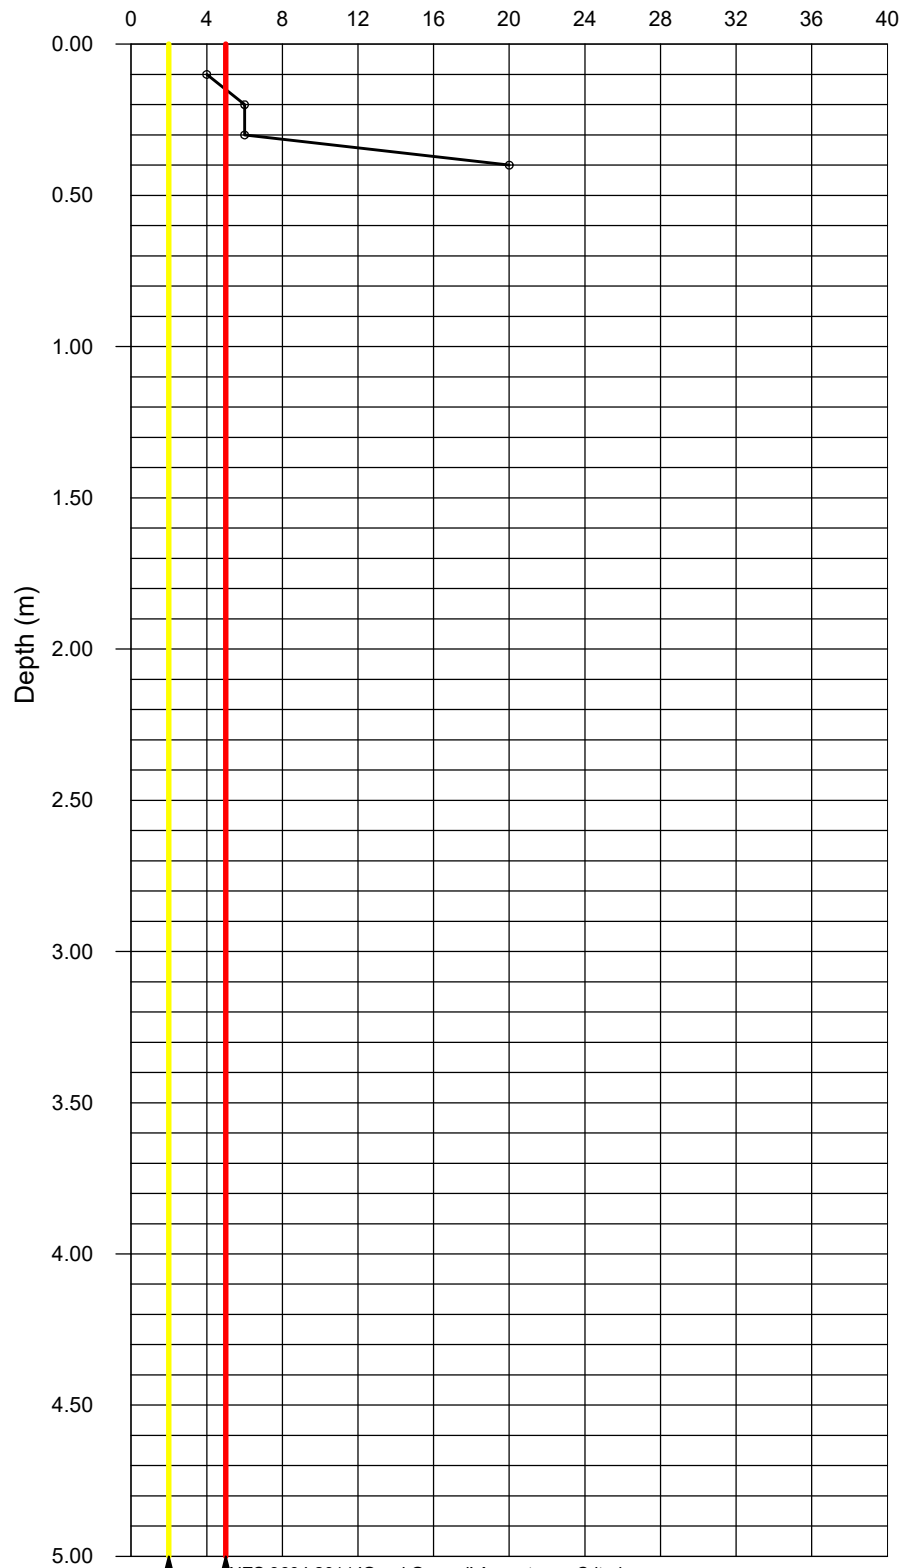
### Number of blows per 100mm

Depth (m)	Blows per 100 mm	Depth (m)	Blows per 100 mm
0.0	4	3.5	
0.1	6		
0.2	6		
0.3	20		
0.4		4.0	
0.5			
1.0		4.5	
1.5		5.0	
2.0			
2.5			
3.0			
3.5

20 blows for 100mm in the last increment.  
Co-ordinates and elevation data from site survey.  
Elevation based on Christchurch Drainage Datum.  
Effective refusal, 20+ blows per 100mm

The depth of topsoil has been determined from the single hand auger and two DCPs undertaken on site. We note that the topsoil depths may vary by +/- 100mm between the testing locations and hence it is recommended that at least a 100mm tolerance should be allowed for building foundation excavations.

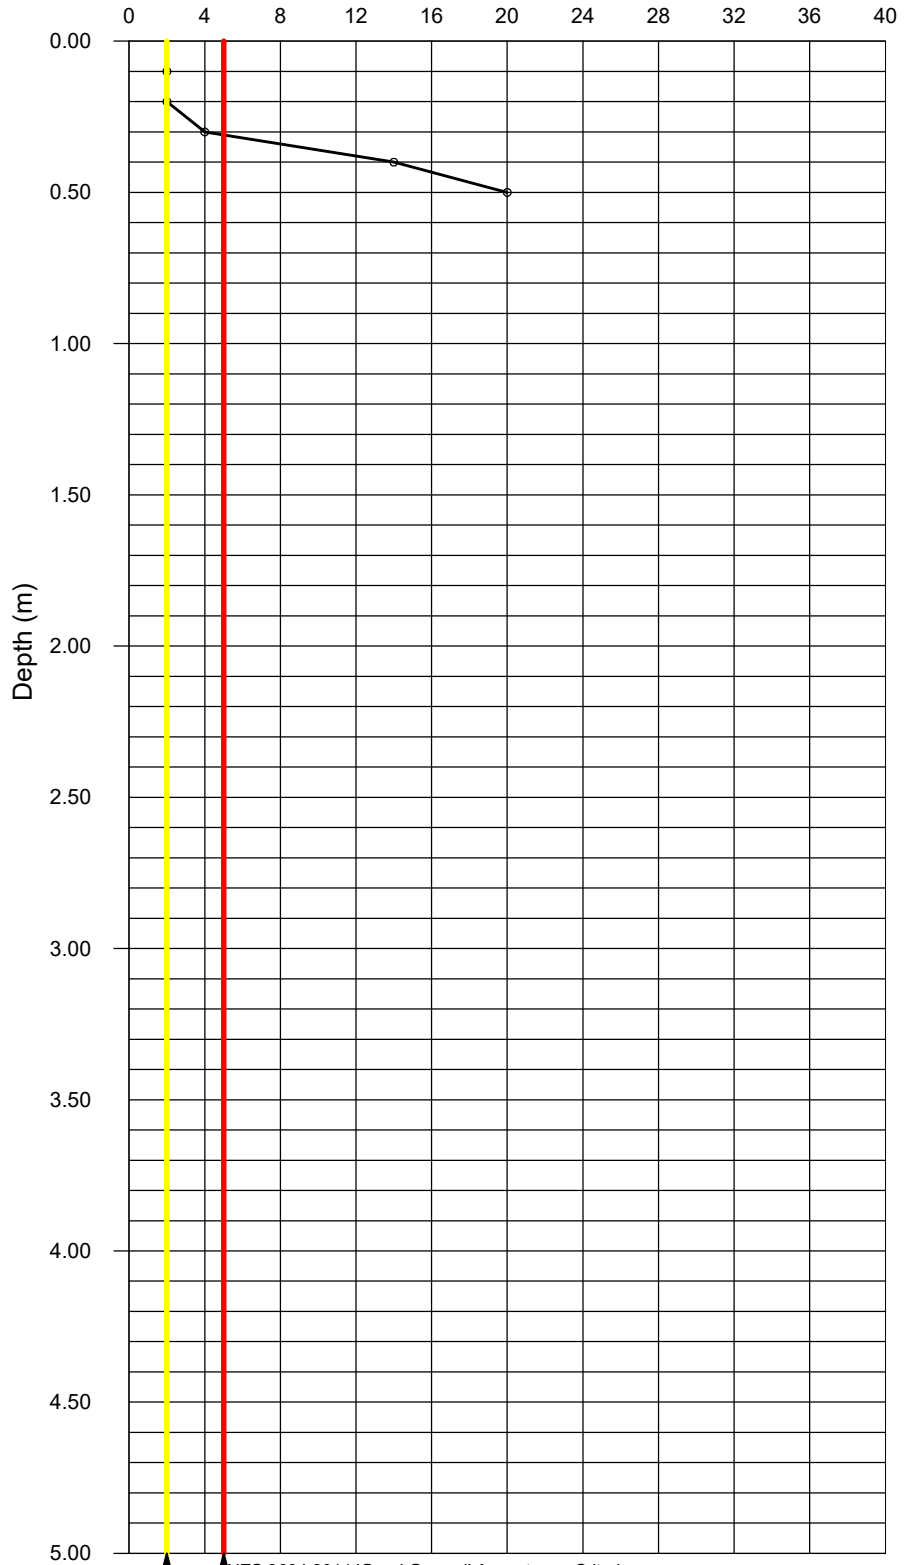
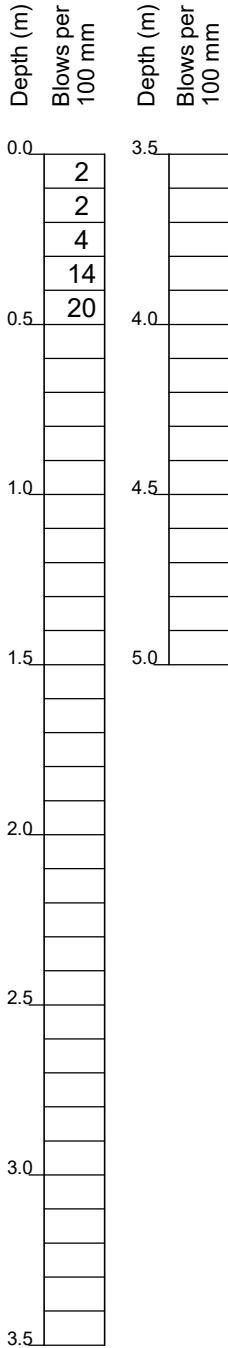
### Number of blows per 100mm

20 blows for 100mm in the last increment.  
Co-ordinates and elevation data from site survey.  
Elevation based on Christchurch Drainage Datum.  
Effective refusal, 20+ blows per 100mm
