Prestons Park Subdivision
GEOTECHNICAL REPORT FOR LOT 1021
CDL Land NZ Limited

8 December 2023
Revision: 1
Reference: 235361

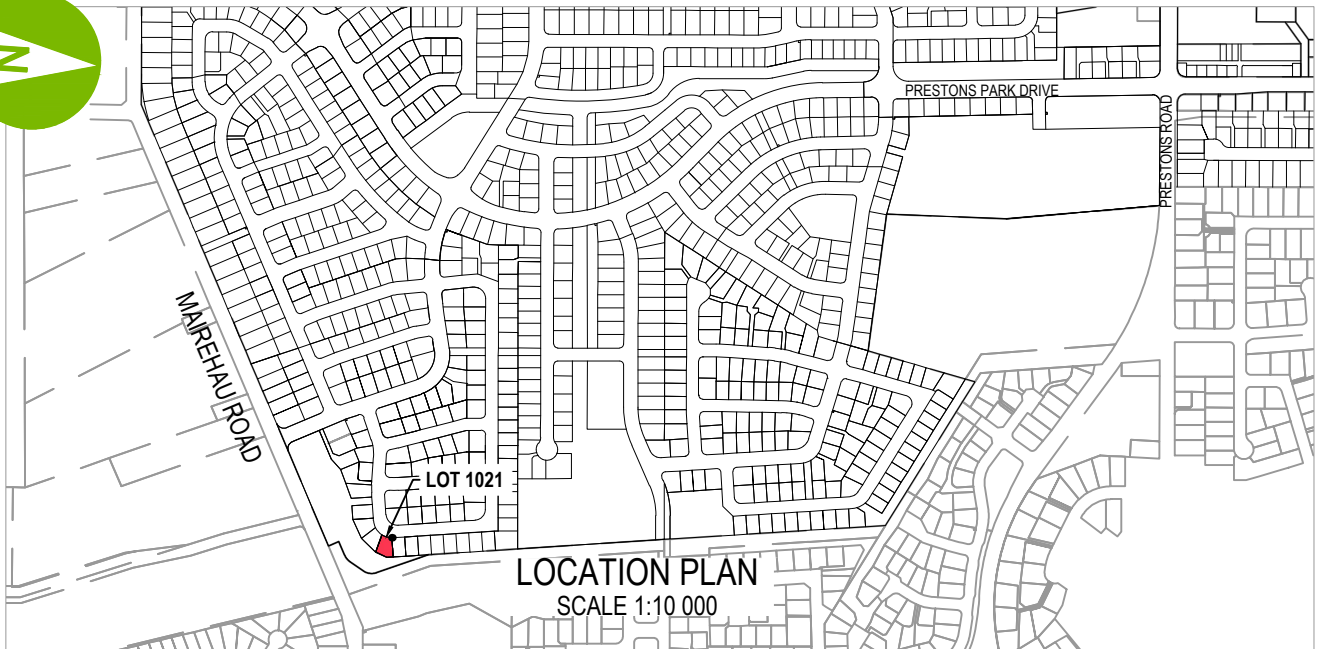
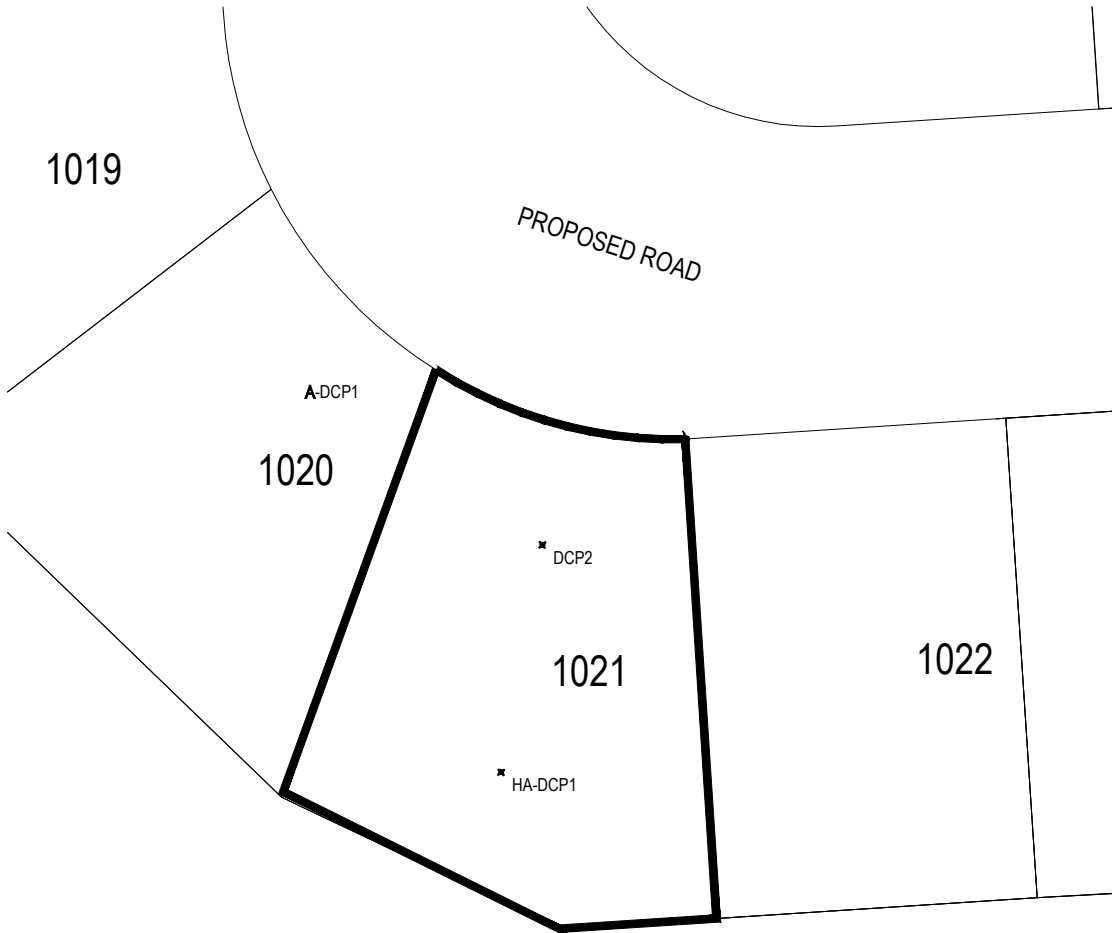
<small>www.aurecon.co.nz</small>	REV	DATE	REVISION DETAILS	APPROVED	DRAWN	DESIGNED	PROJECT	INFORMATION	
	A	20/11/23	ISSUE FOR INFORMATION	T BROWNE	R DAWSON	C DOHERTY	PRESTONS PARK	PROJECT No. 235361	
CLIENT PRESTONS PARK					CHECKED			SCALE	SIZE
					J MUIRSON			1:400	A4
					APPROVED			DRAWING No.	REV
					T BROWNE	DATE		GO-PS-S5-IN-1021	A
					T BROWNE		TITLE		
							LOT 1021 SITE LOCATION PLAN FIGURE 1

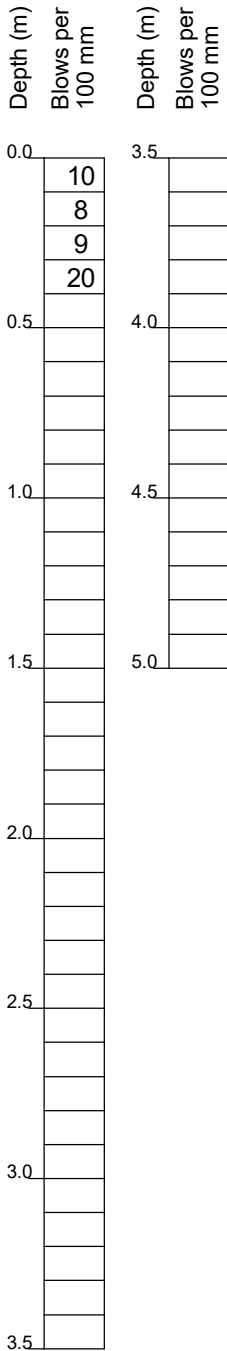
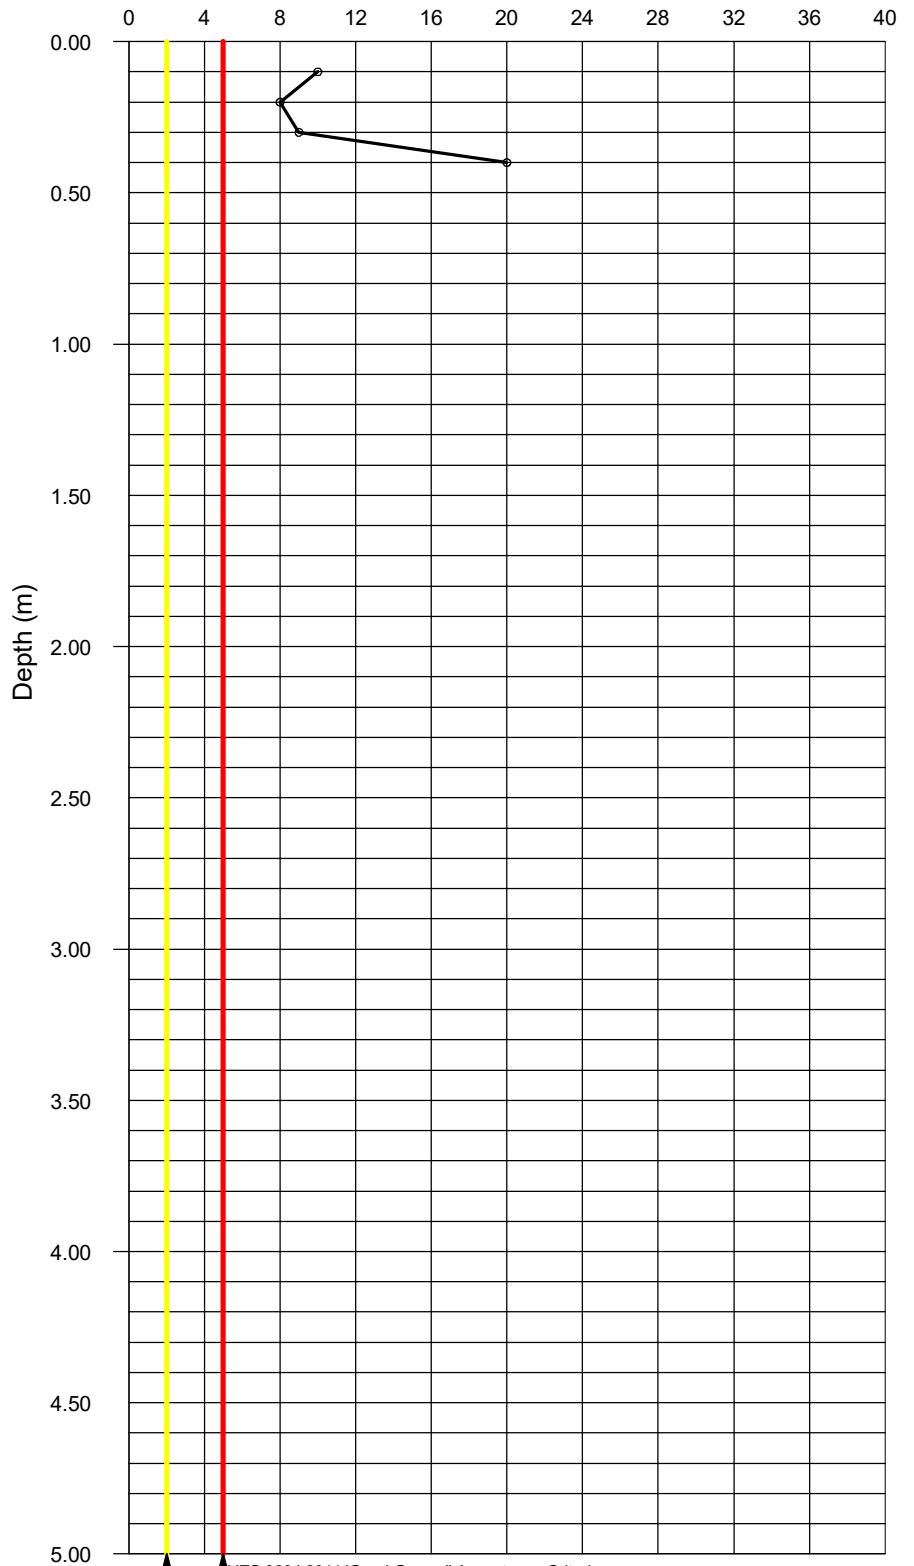
Number of blows per 100mm

20 blows for 100mm in the last increment.
Co-ordinates recorded in the field with a mobile device.
RL from data survey based on design contours (Christchurch drainage datum).
Effective refusal, 20+ blows per 100mm

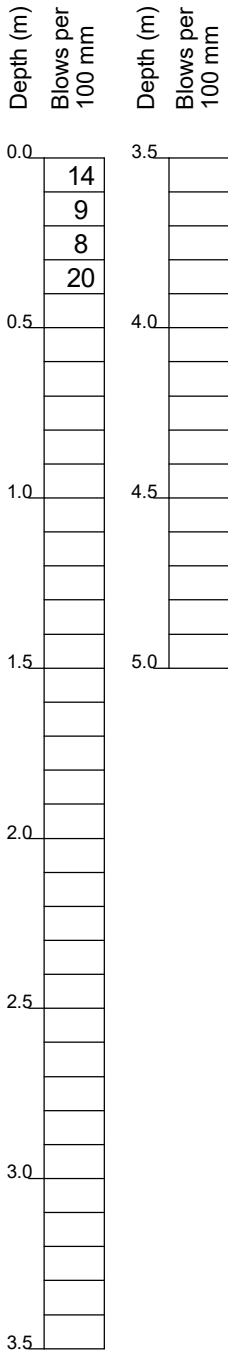
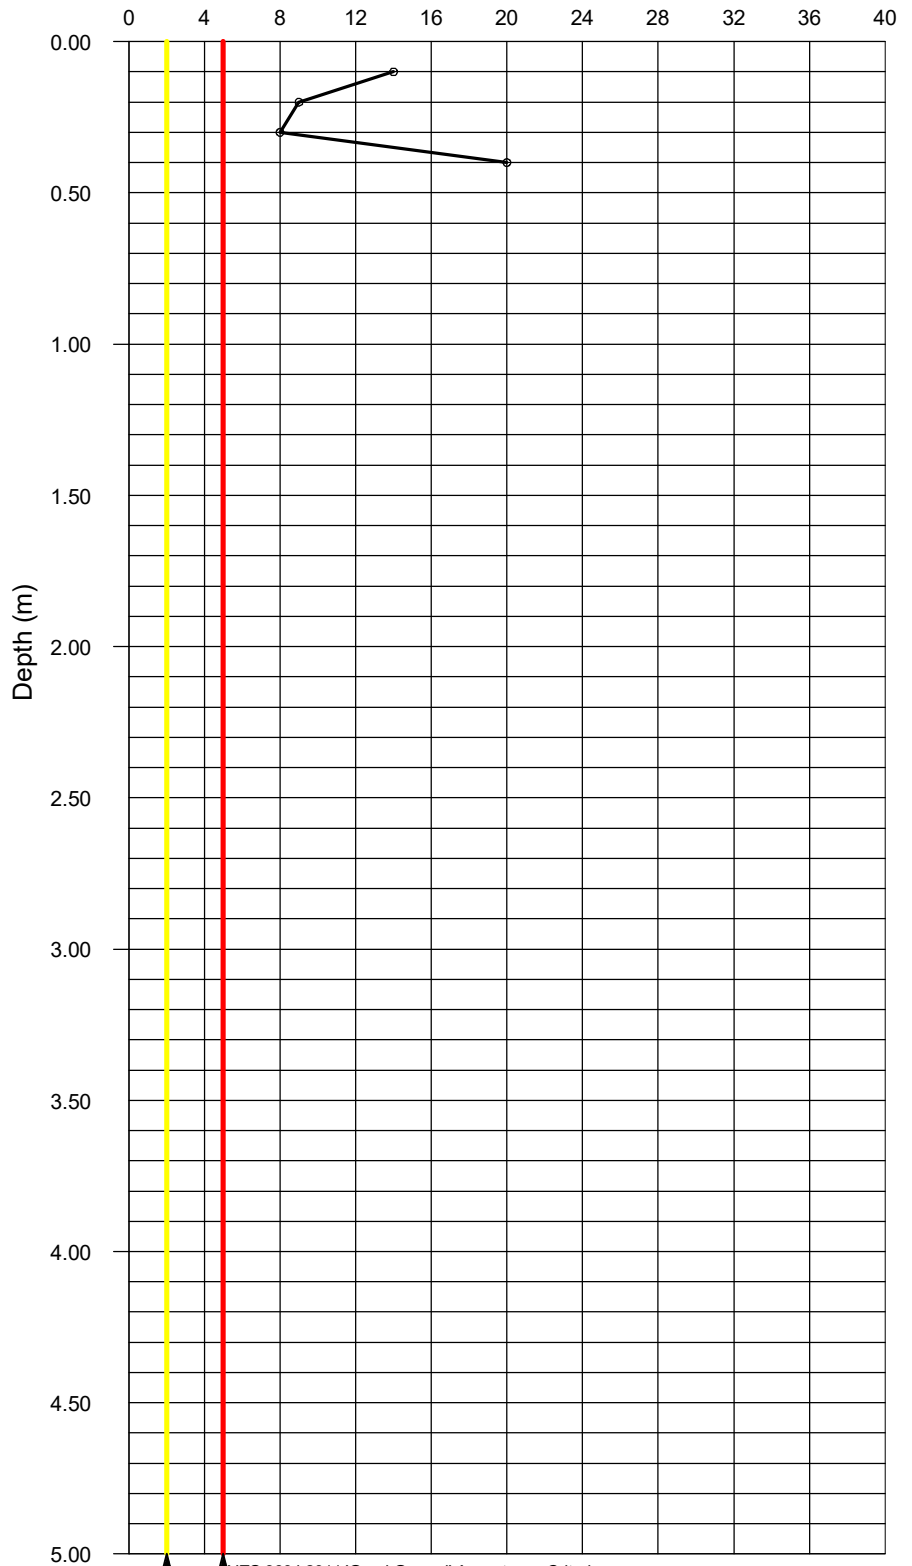
Number of blows per 100mm

20 blows for 100mm in the last increment.
Co-ordinates recorded in the field with a mobile device.
RL from data survey based on design contours (Christchurch drainage datum).
Effective refusal, 20+ blows per 100mm
