**Prestons Park Subdivision**  
**GEOTECHNICAL REPORT FOR LOT 1025**  
**CDL Land NZ Limited**

**8 December 2023**  
**Revision: 1**  
**Reference: 235361**

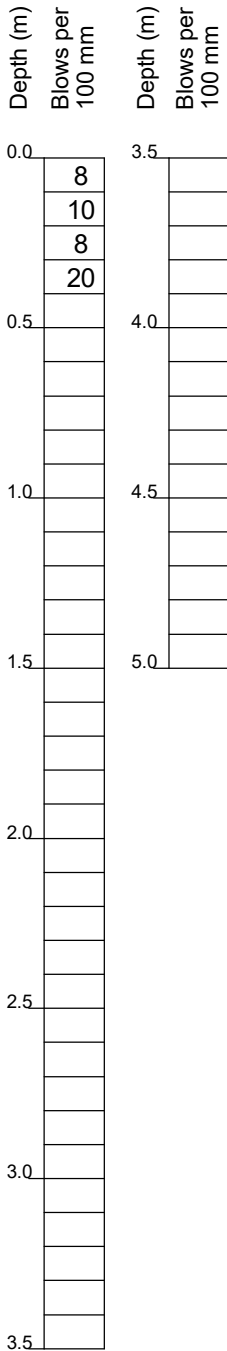
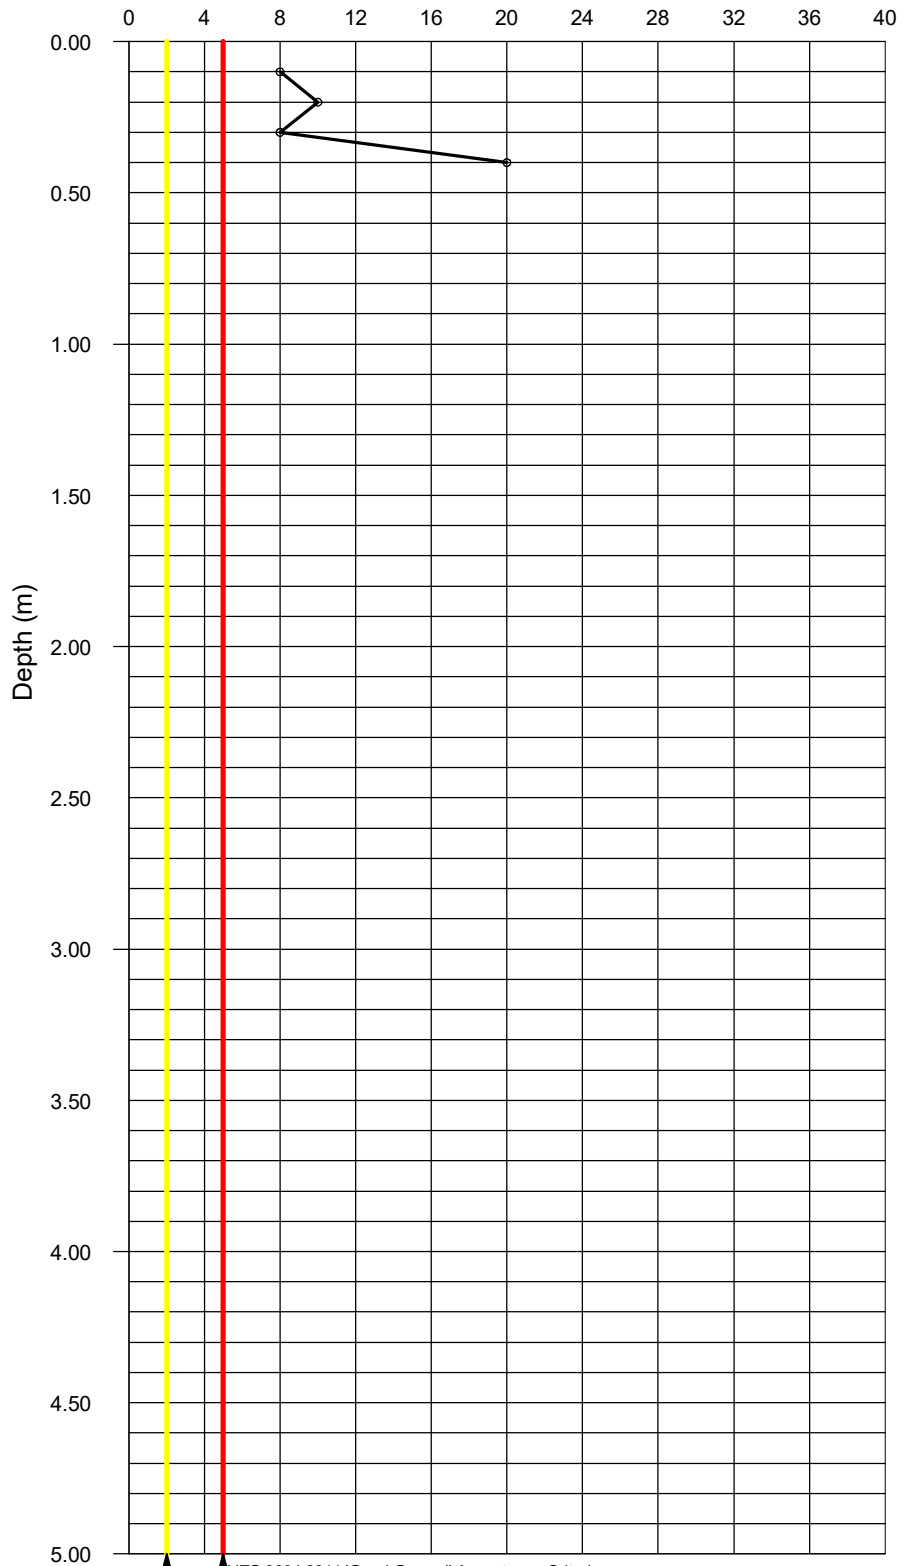
### Results

### Number of blows per 100mm

### Remarks:

20 blows for 100mm in the last increment.  
Co-ordinates recorded in the field with a mobile device.  
RL from data survey based on design contours (Christchurch drainage datum).  
Effective refusal, 20+ blows per 100mm

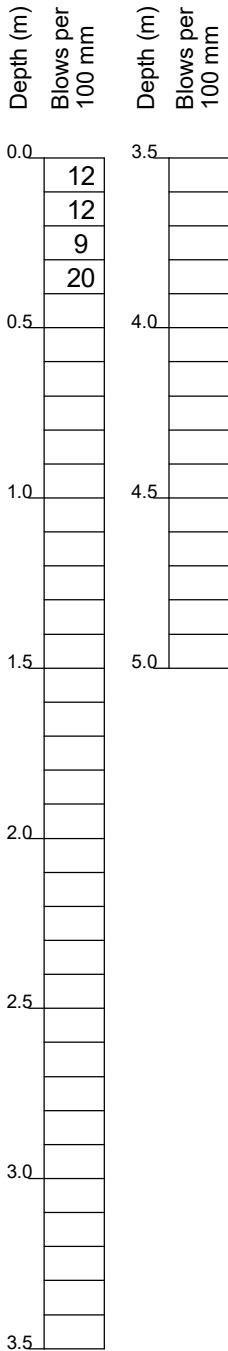
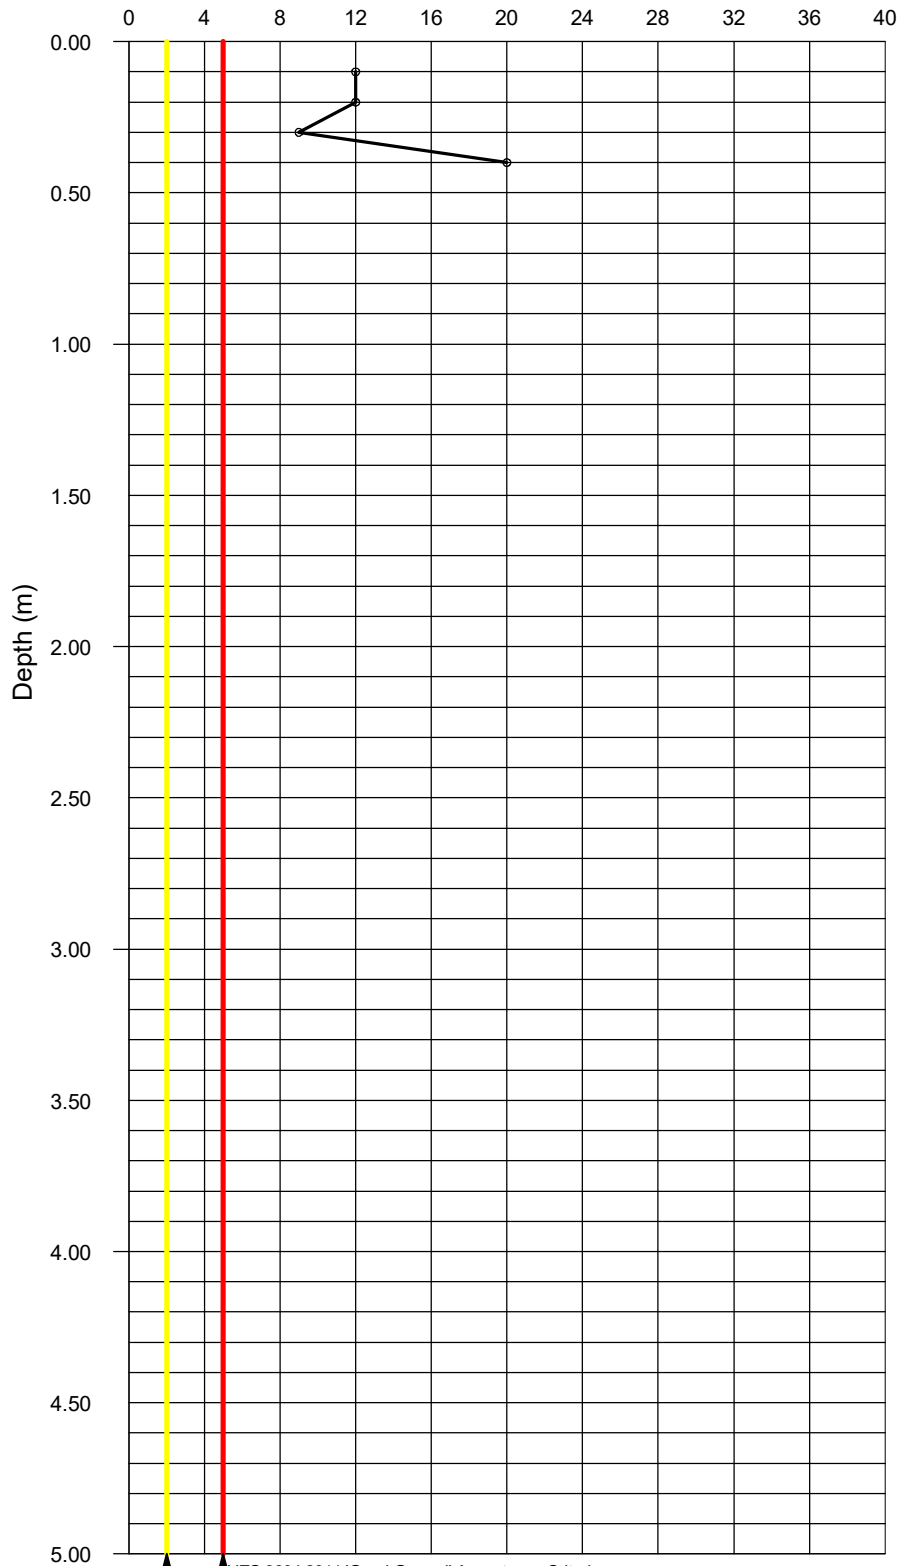
**Results**

**Number of blows per 100mm**

**Remarks:**

20 blows for 100mm in the last increment.  
Co-ordinates recorded in the field with a mobile device.  
RL from data survey based on design contours (Christchurch drainage datum).  
Effective refusal, 20+ blows per 100mm
