Prestons Park Subdivision
GEOTECHNICAL REPORT FOR LOT 1027
CDL Land NZ Limited

8 December 2023
Revision: 1
Reference: 235361

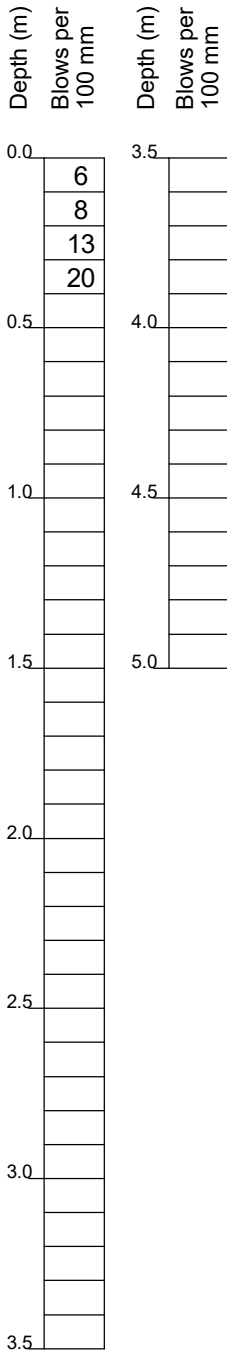
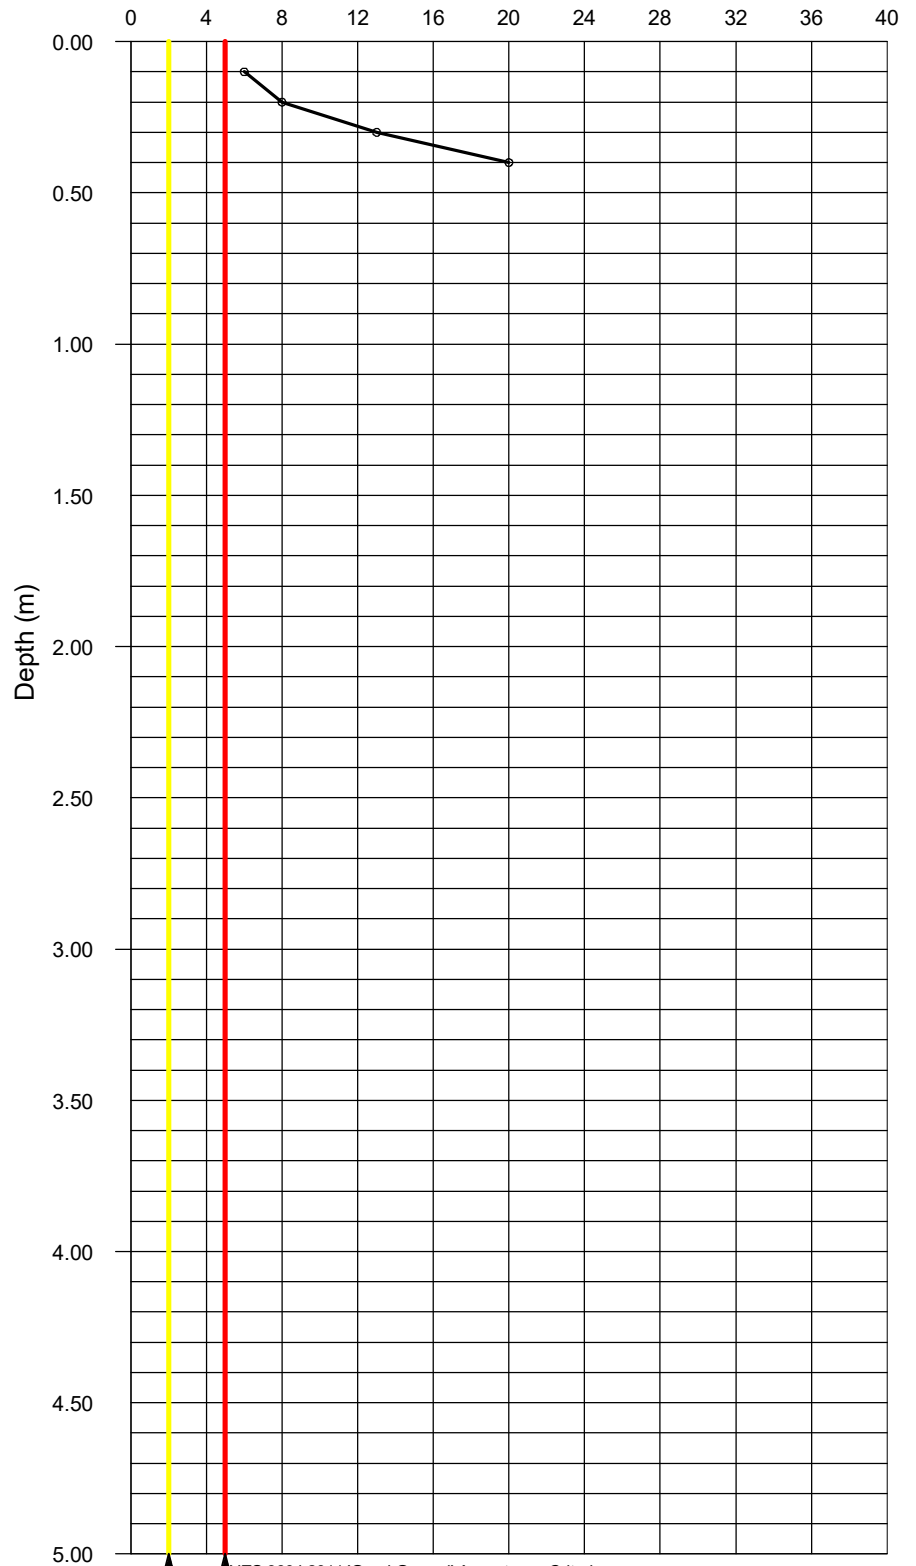
Number of blows per 100mm

20 blows for 100mm in the last increment.
Co-ordinates recorded in the field with a mobile device.
RL from data survey based on design contours (Christchurch drainage datum).
Effective refusal, 20+ blows per 100mm

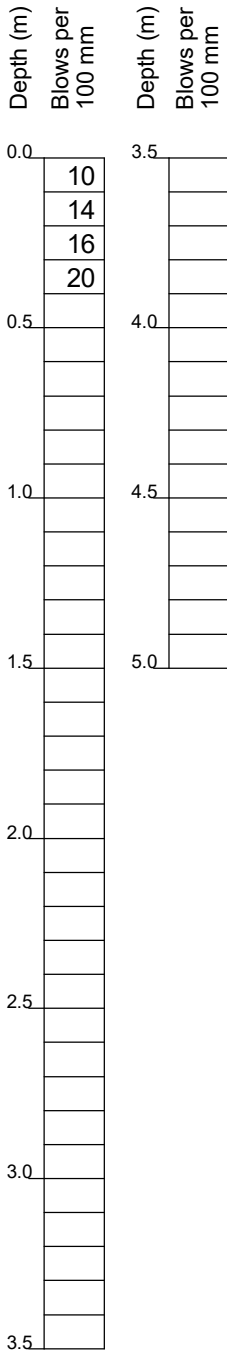
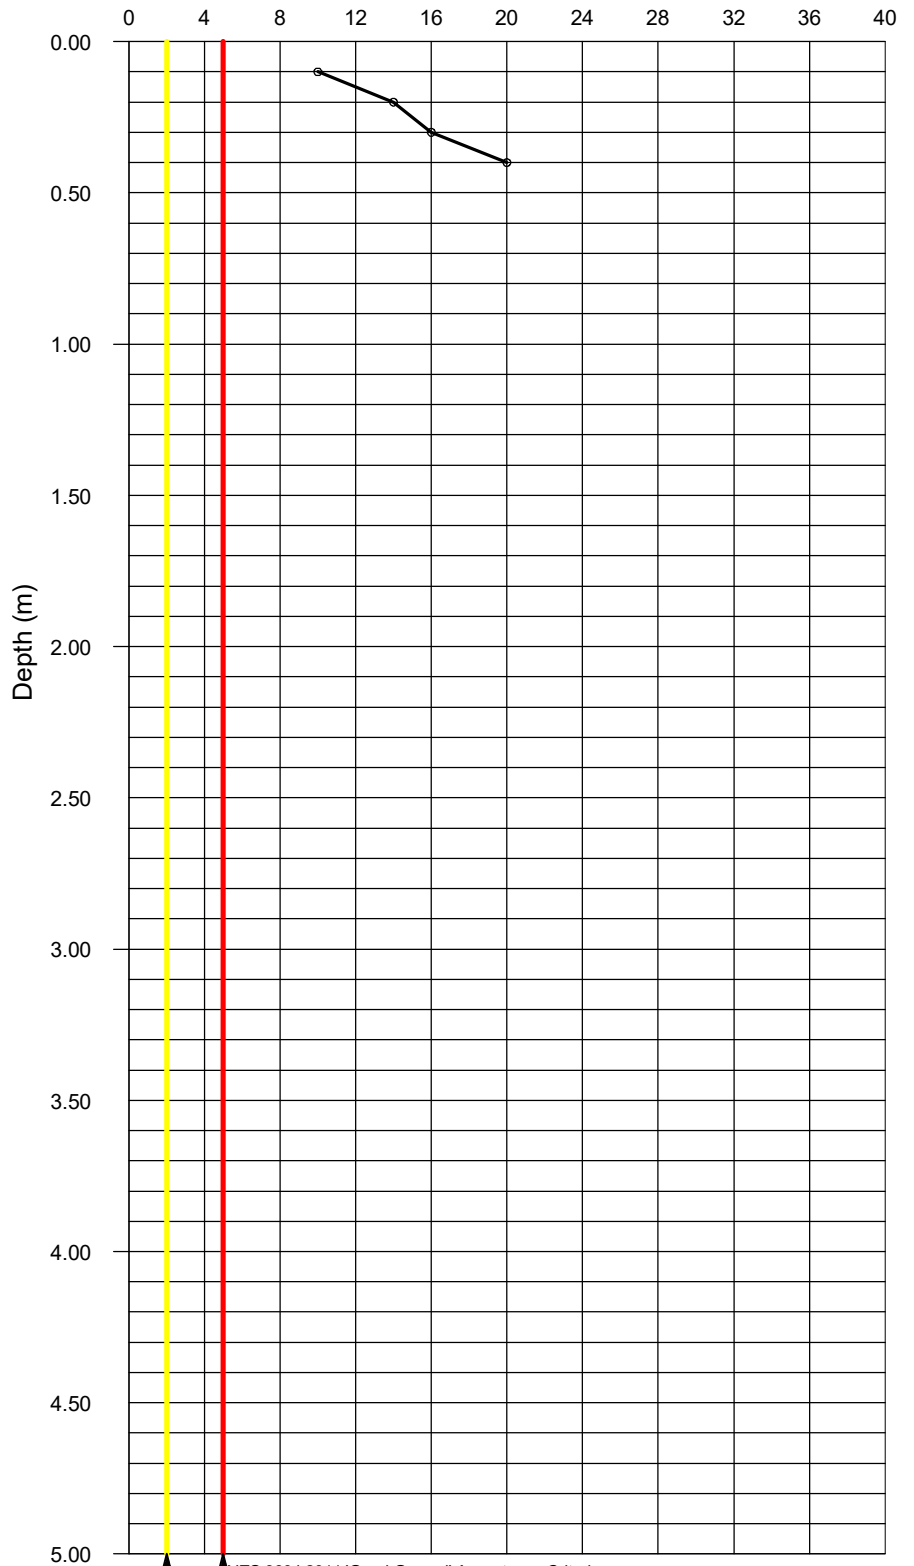
Number of blows per 100mm

20 blows for 100mm in the last increment.
Co-ordinates recorded in the field with a mobile device.
RL from data survey based on design contours (Christchurch drainage datum).
Effective refusal, 20+ blows per 100mm
