Prestons Park Subdivision
GEOTECHNICAL REPORT FOR LOT 997
CDL Land NZ Limited

10 January 2024
Revision: 1
Reference: 235361

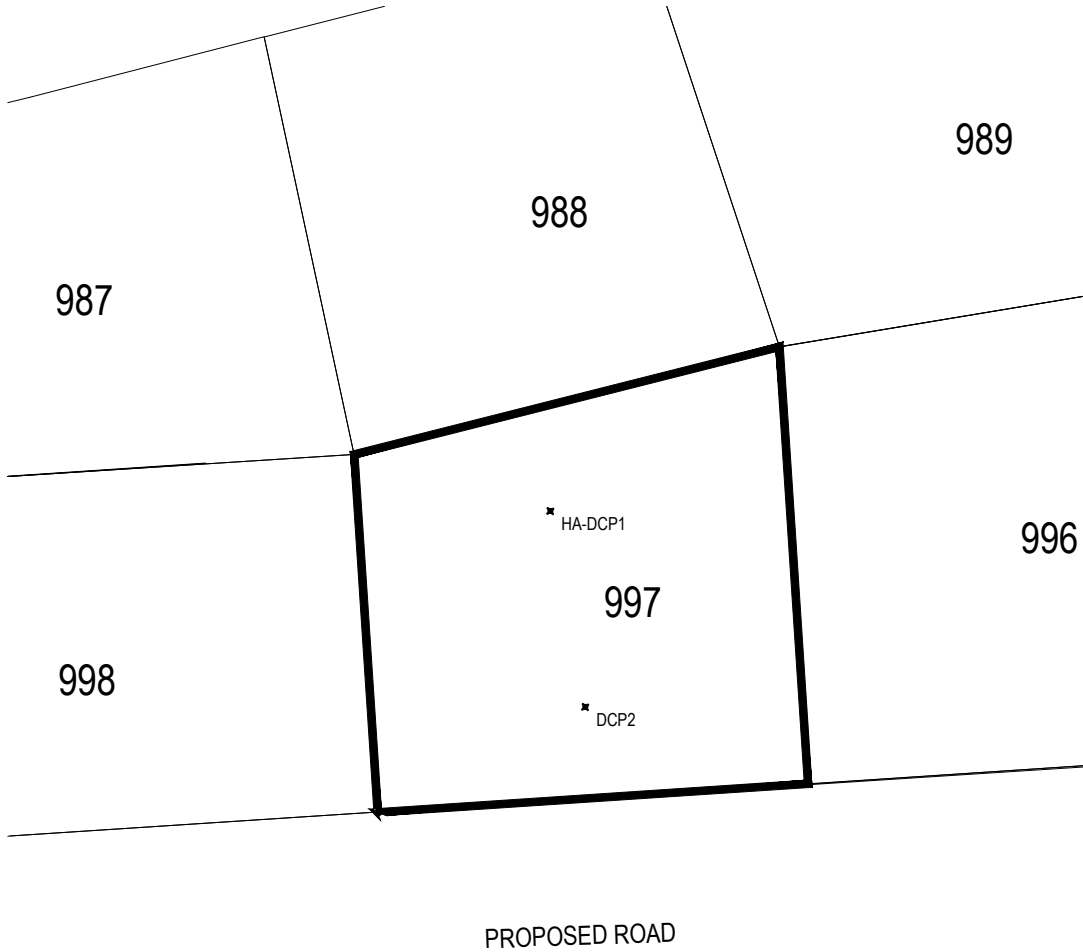
<small>www.aurecongroup.com</small>	REV	DATE	REVISION DETAILS	APPROVED	DRAWN	DESIGNED	PROJECT	INFORMATION	
	A	20/11/23	ISSUE FOR INFORMATION	T BROWNE	R DAWSON	C DOHERTY		PRESTONS PARK	PROJECT No. 235361
CLIENT PRESTONS PARK					CHECKED		TITLE	SCALE	SIZE
					J MUIRSON			1:400	A4
					APPROVED			DRAWING No.	REV
					T BROWNE	DATE		GO-PS-S5-IN-997	A
					T BROWNE		LOT 997 SITE LOCATION PLAN FIGURE 1

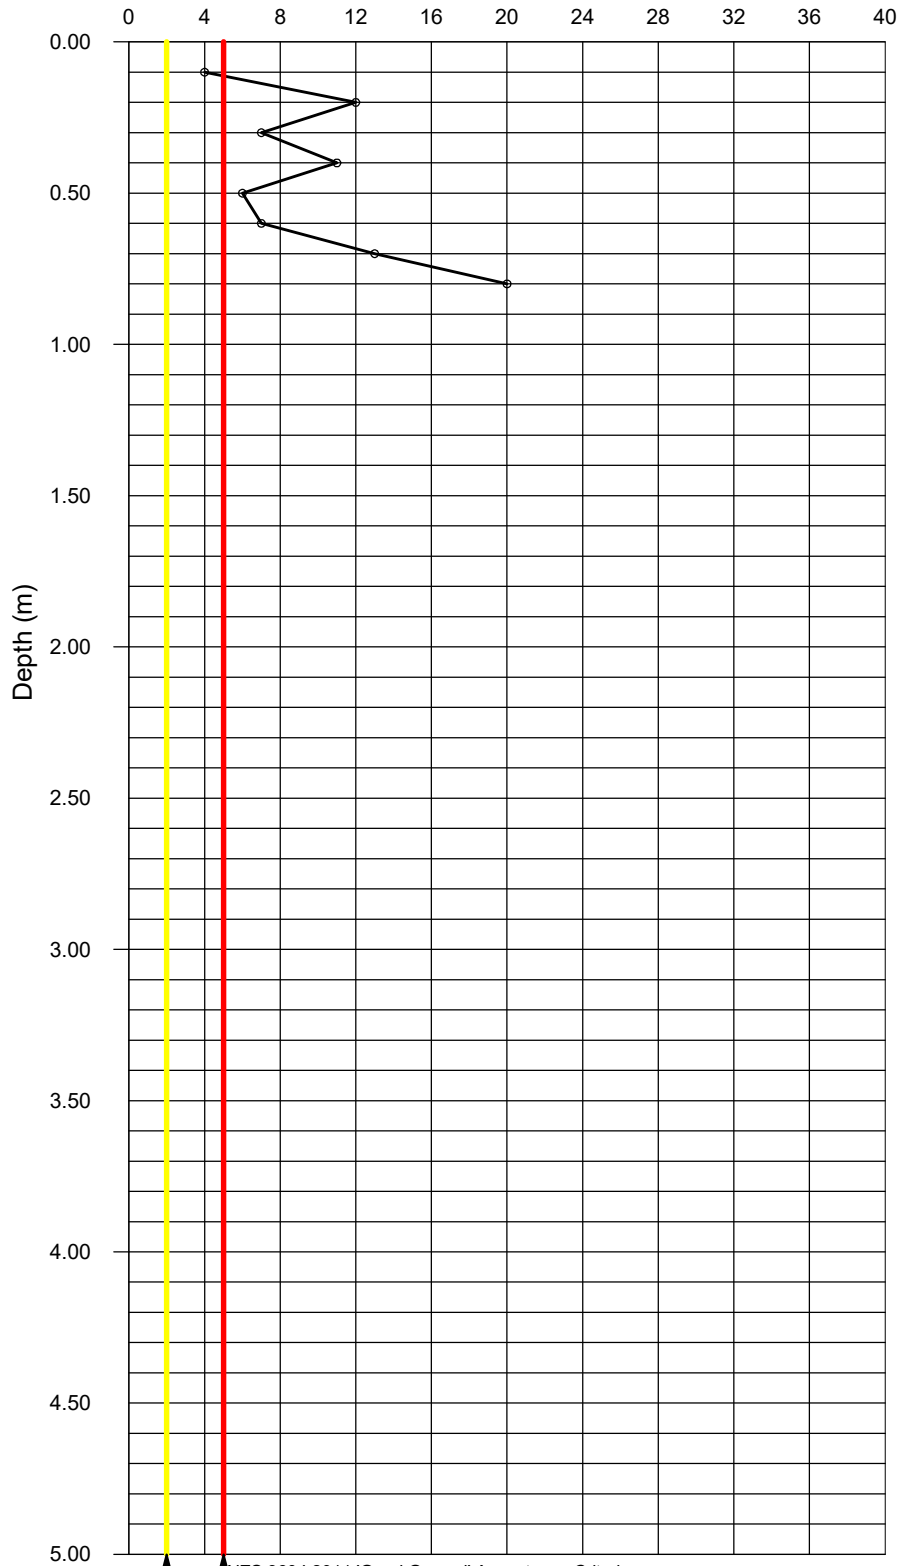
Depth (m)	Blows per 100 mm	Depth (m)	Blows per 100 mm
0.0	4	3.5	
0.1	12		
0.2	7		
0.3	11		
0.4	6	4.0	
0.5	7		
0.6	13		
0.7	20		
0.8		4.5	
0.9			
1.0			
1.1		5.0	
1.2			
1.3			
1.4			
1.5			
1.6			
1.7			
1.8			
1.9			
2.0			
2.1			
2.2			
2.3			
2.4			
2.5			
2.6			
2.7			
2.8			
2.9			
3.0			
3.1			
3.2			
3.3			
3.4			
3.5

Number of blows per 100mm

Remarks:

20 blows for 100mm in the last increment.
Co-ordinates recorded in the field with a mobile device.
RL from data survey based on design contours (+/- 10cm) (Christchurch Drainage Datum).
Effective refusal, 20+ blows per 100mm

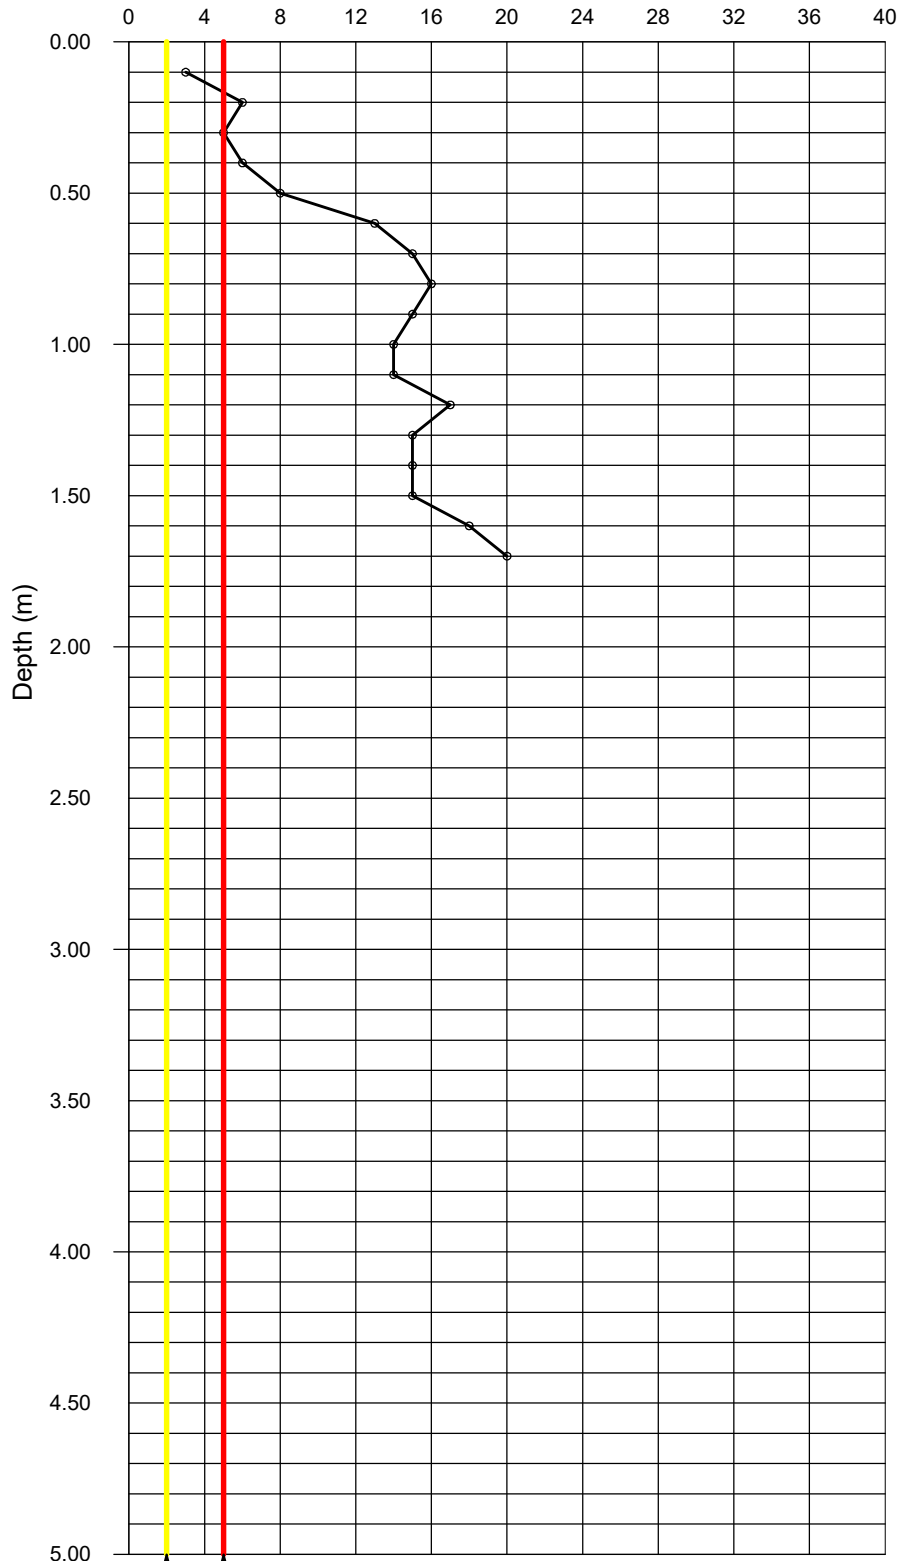
Depth (m)	Blows per 100 mm	Depth (m)	Blows per 100 mm
0.0	3	3.5	
	6		
	5		
	6		
0.5	8	4.0	
	13		
	15		
	16		
	15		
1.0	14	4.5	
	14		
	17		
	15		
	15		
1.5	15	5.0	
	18		
	20		
2.0			
2.5			
3.0			
3.5

Number of blows per 100mm

Remarks:

20 blows for 100mm in the last increment.
Co-ordinates recorded in the field with a mobile device.
RL from data survey based on design contours (+/- 10cm) (Christchurch Drainage Datum).
Effective refusal, 20+ blows per 100mm
