Prestons Park Subdivision
GEOTECHNICAL REPORT FOR LOT 1016
CDL Land NZ Limited

8 December 2023
Revision: 1
Reference: 235361

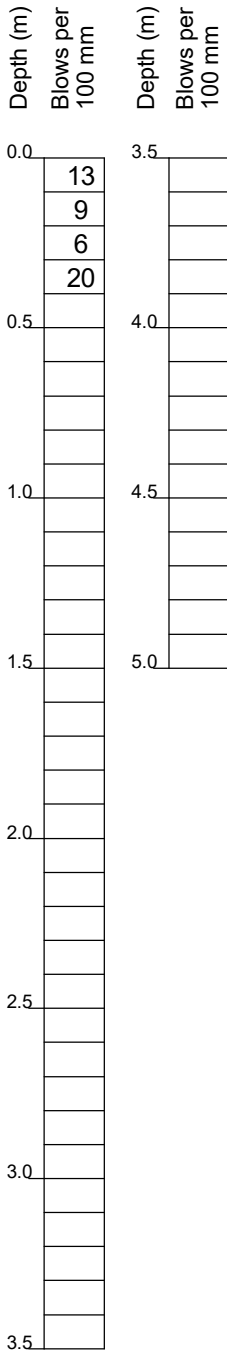
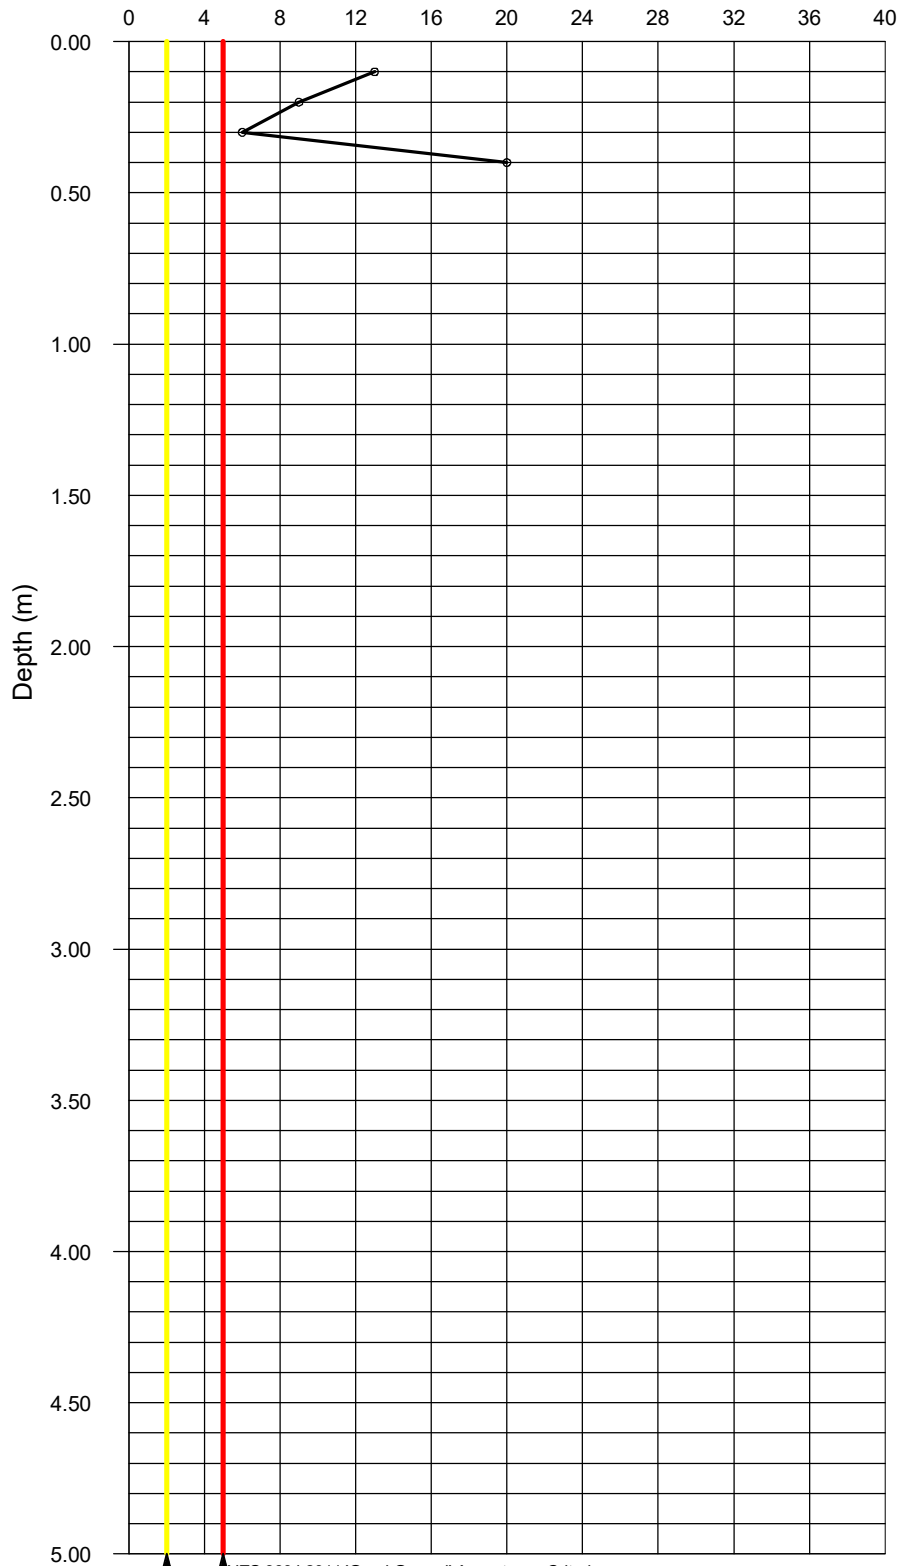
Number of blows per 100mm

Remarks:

20 blows for 100mm in the last increment.
Co-ordinates recorded in the field with a mobile device.
RL from data survey based on design contours (Christchurch drainage datum).
Effective refusal, 20+ blows per 100mm

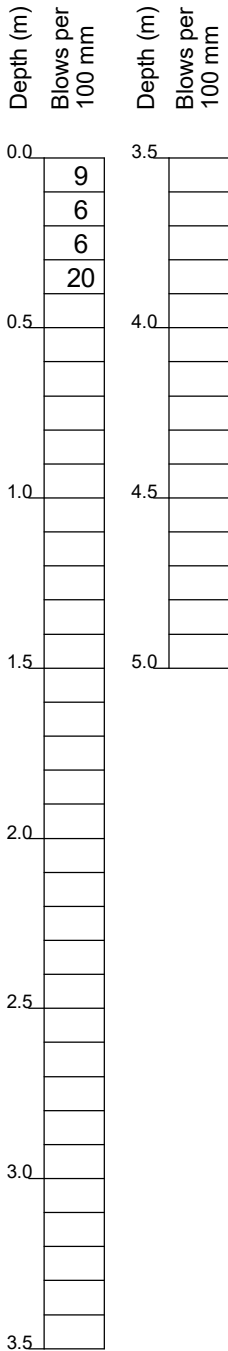
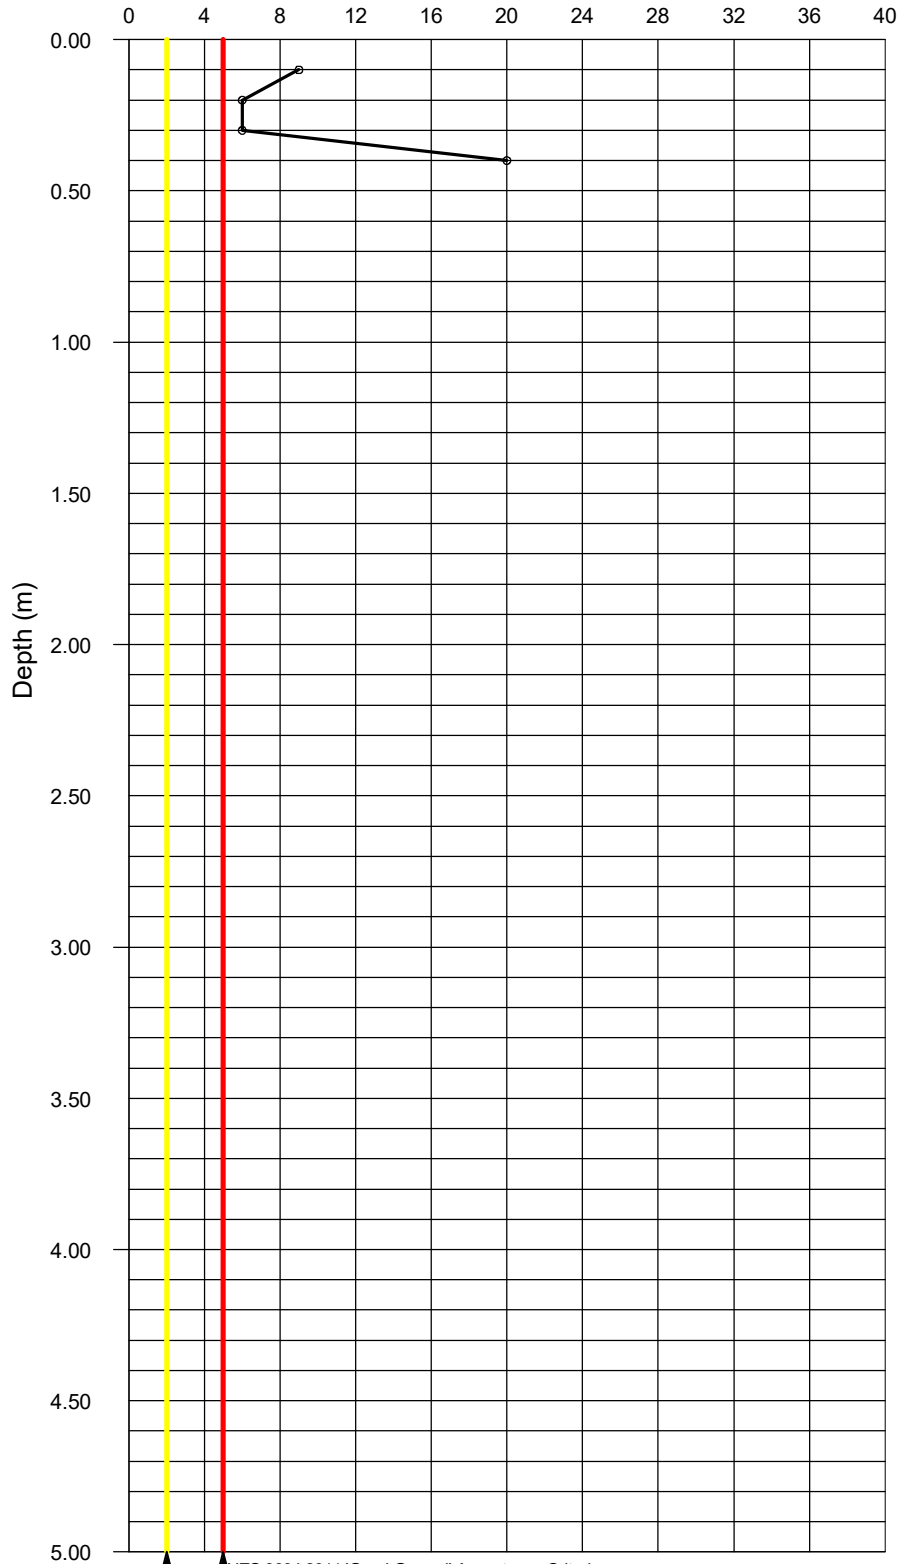
Number of blows per 100mm

Remarks:

20 blows for 100mm in the last increment.
Co-ordinates recorded in the field with a mobile device.
RL from data survey based on design contours (Christchurch drainage datum).
Effective refusal, 20+ blows per 100mm
