**Prestons Park Subdivision**  
**GEOTECHNICAL REPORT FOR LOT 1017**  
**CDL Land NZ Limited**

**8 December 2023**  
**Revision: 1**  
**Reference: 235361**

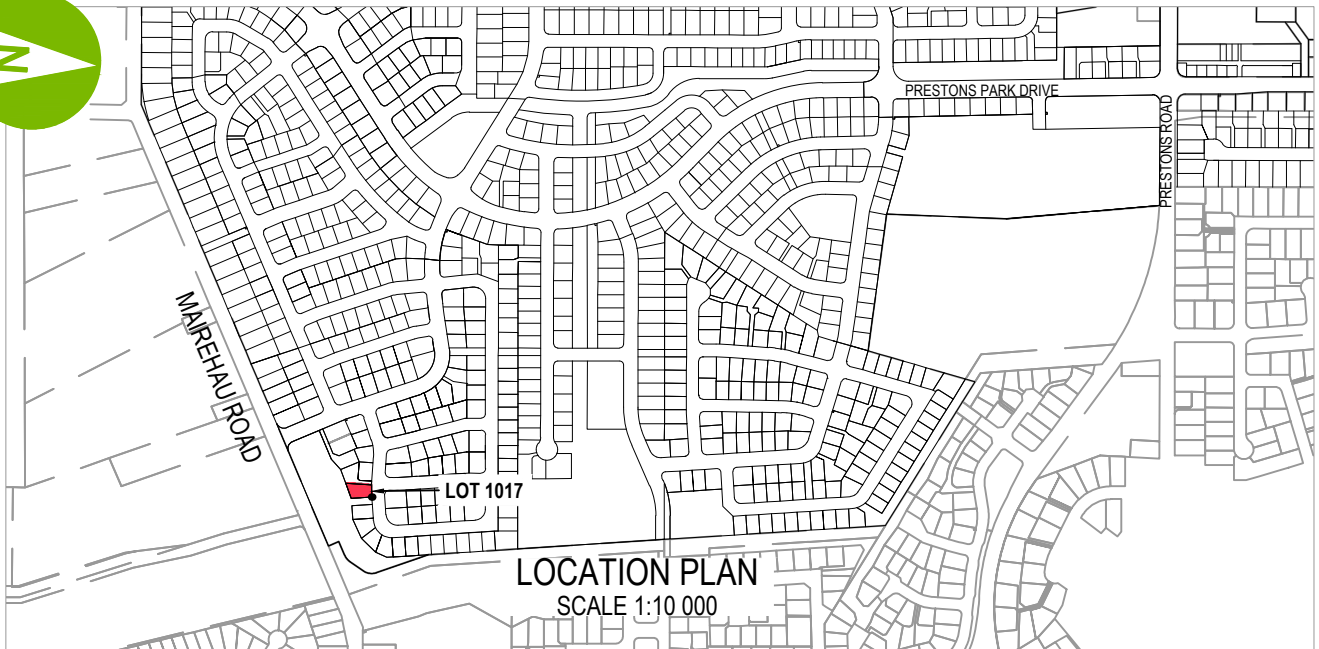
<small>www.aurecongroup.com</small>	<b>REV</b>	<b>DATE</b>	<b>REVISION DETAILS</b>	<b>APPROVED</b>	<b>DRAWN</b>	<b>DESIGNED</b>	<b>PROJECT</b>	<b>INFORMATION</b>	
	A	20/11/23	ISSUE FOR INFORMATION	T BROWNE	R DAWSON	C DOHERTY			
<b>CLIENT</b> <b>PRESTONS PARK</b>					<b>CHECKED</b>		<b>TITLE</b> LOT 1017 SITE LOCATION PLAN FIGURE 1	<b>SCALE</b>	<b>SIZE</b>
					J MUIRSON			1:400	A4
					<b>APPROVED</b>			<b>DRAWING No.</b>	<b>REV</b>
				T BROWNE		DATE	GO-PS-S5-IN-1017	A
