Prestons Park Subdivision
GEOTECHNICAL REPORT FOR LOT 933
CDL Land NZ Limited

8 October 2024
Revision: 0
Reference: 235361

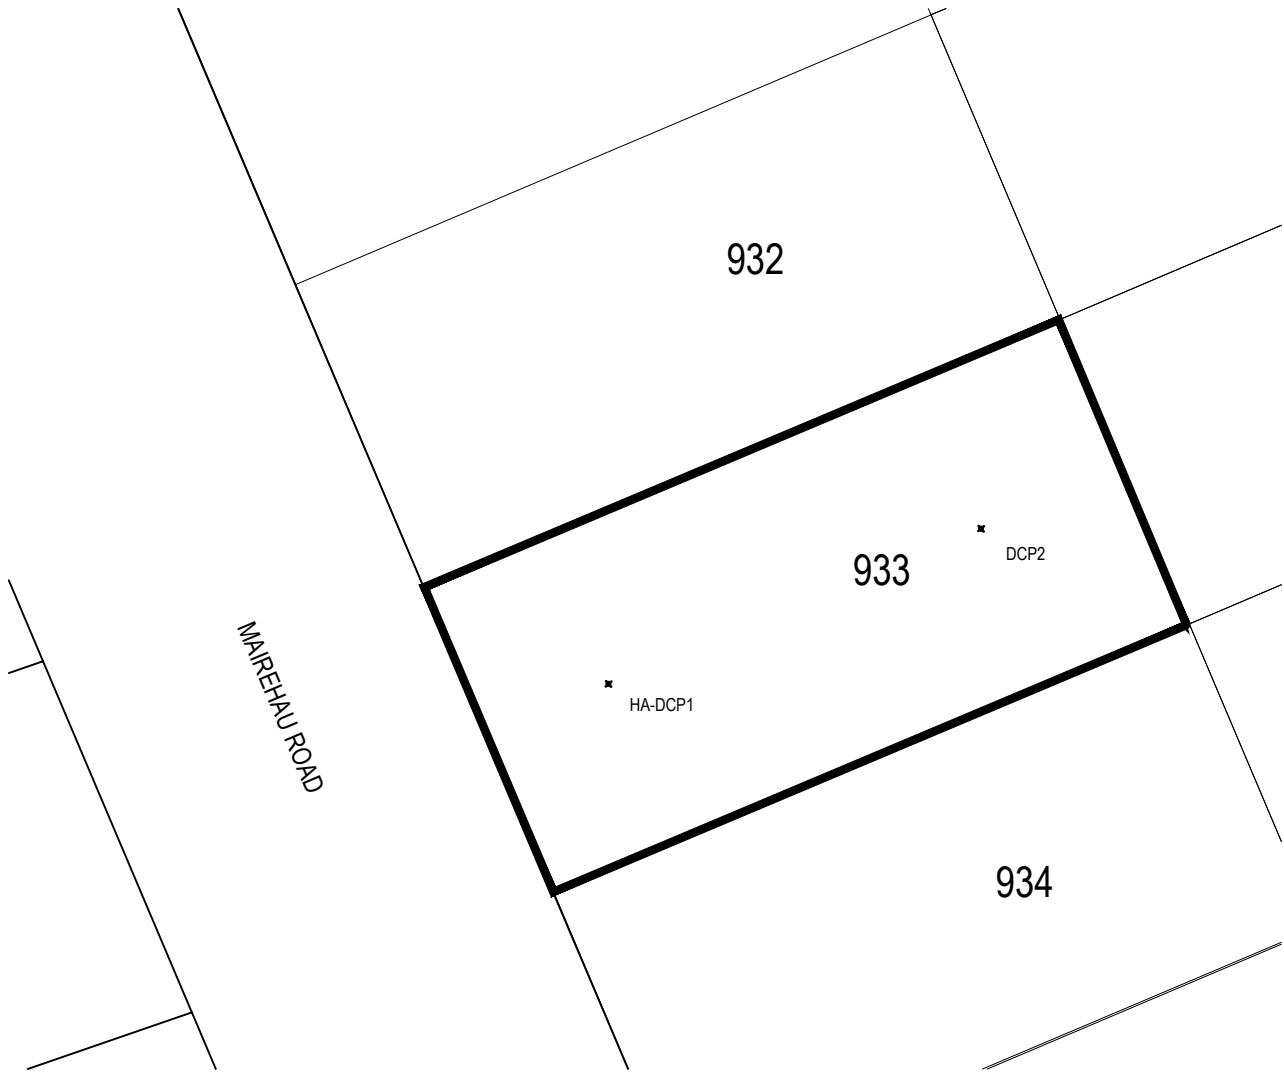
<small>www.aurecongroup.com</small>	REV	DATE	REVISION DETAILS	APPROVED	DRAWN	DESIGNED	PROJECT	INFORMATION	
	A	20/09/24	ISSUE FOR INFORMATION	J KUPEC	M KORAKO	C DOHERTY	PRESTONS PARK	PROJECT No.	235361
CLIENT PRESTONS PARK					CHECKED		TITLE	SCALE	SIZE
					J MUIRSON		LOT 933	1:400	A4
					APPROVED		SITE LOCATION PLAN	DRAWING No.	REV
					J KUPEC	DATE 20/09/24	FIGURE 1	GO-PS-S5-IN-933	A

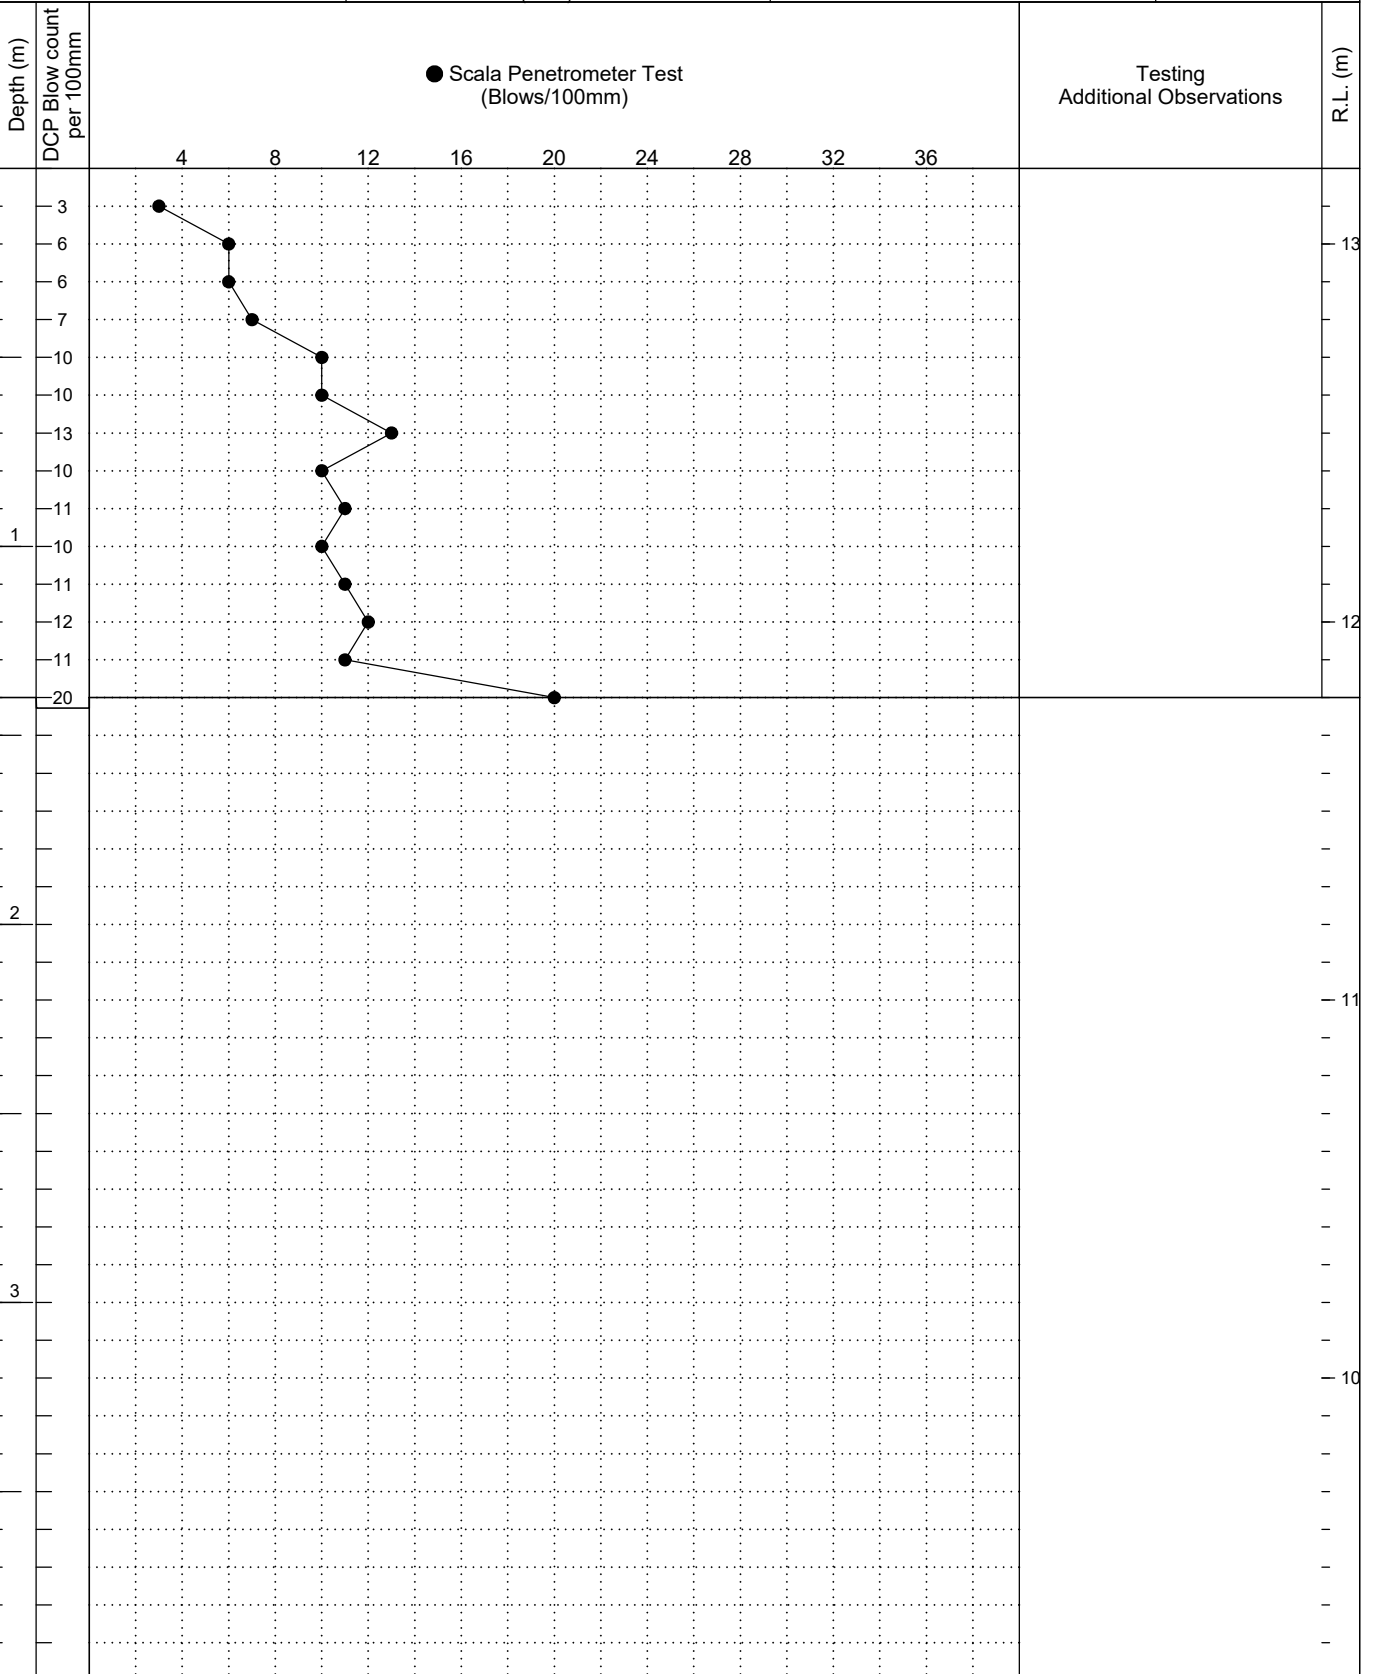
Date started: 12/09/2024
Date completed: 12/09/2024
Inclination: 90°
Orientation: N/A

REMARKS:
[1] Coordinates are approximate (+/- 5m), recorded in the field with a mobile device.
[2] RL is approximate (+/-0.5m) based on design contours.

Water Level Readings:
Date Time | Hole Depth | Water Level
No water level recorded

The hand auger borehole was terminated when soil samples became too dense to auger. The hand auger borehole indicates ground conditions comprise topsoil underlain by gravel.
