Prestons Park Subdivision
GEOTECHNICAL REPORT FOR LOT 934
CDL Land NZ Limited

8 October 2024
Revision: 0
Reference: 235361

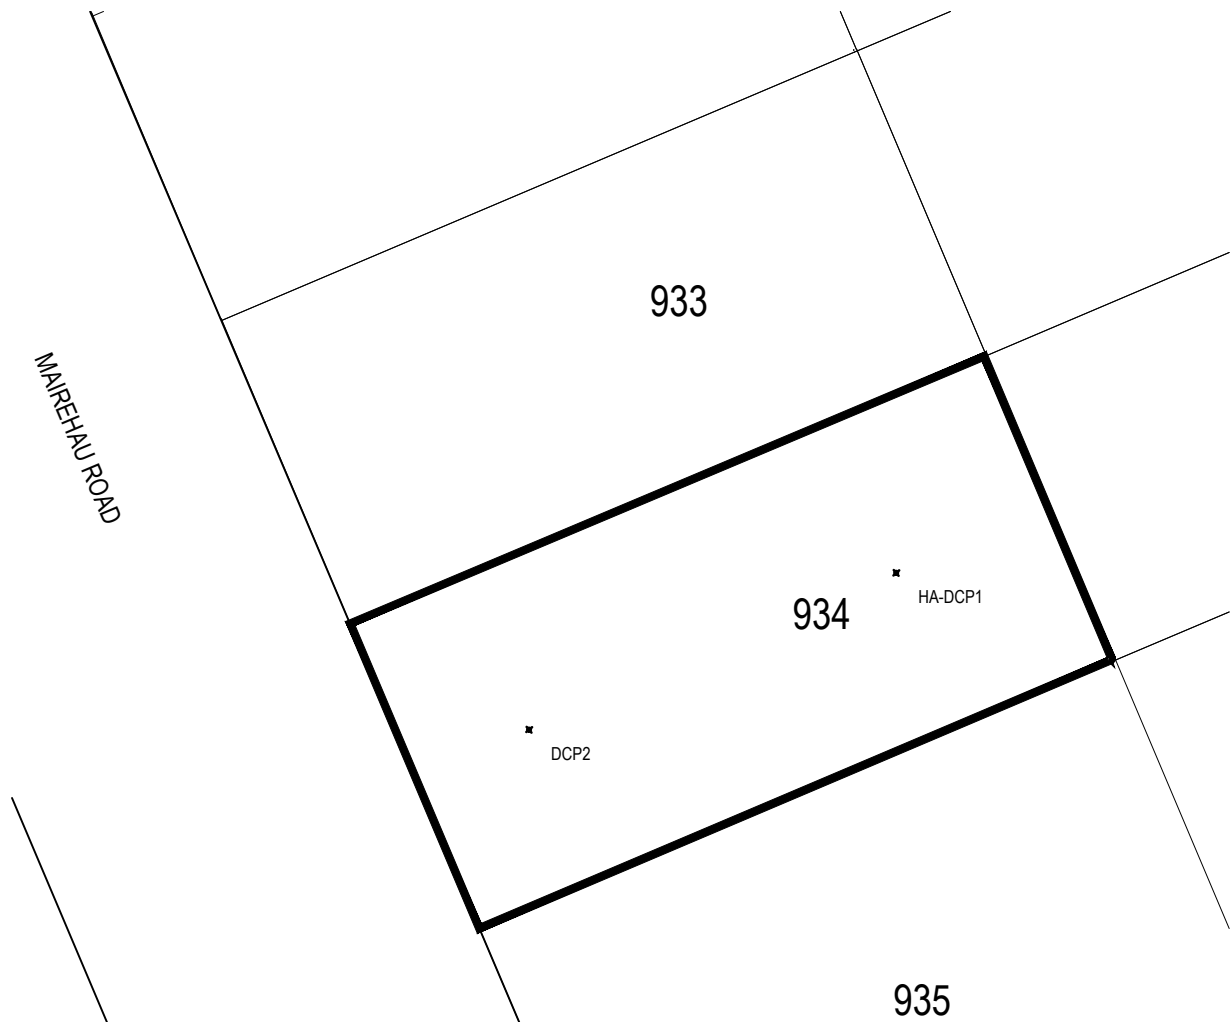
<small>www.aurecongroup.com</small>	REV	DATE	REVISION DETAILS	APPROVED	DRAWN	DESIGNED	PROJECT	INFORMATION	
	A	20/09/24	ISSUE FOR INFORMATION	J KUPEC	M KORAKO	C DOHERTY		PRESTONS PARK	PROJECT No.
CLIENT PRESTONS PARK					CHECKED		TITLE LOT 934 SITE LOCATION PLAN FIGURE 1	SCALE	SIZE
					J MUIRSON			1:400	A4
					APPROVED			DRAWING No.	REV
					J KUPEC	DATE		20/09/24	GO-PS-S5-IN-934

This building consent report is for Lot 934 which is located in Stage 2 of the Prestons Park Subdivision development (refer Figure 1 in Appendix A). The lot is bordered by residential lots to the north, west and east and Mairehau Road to the south.

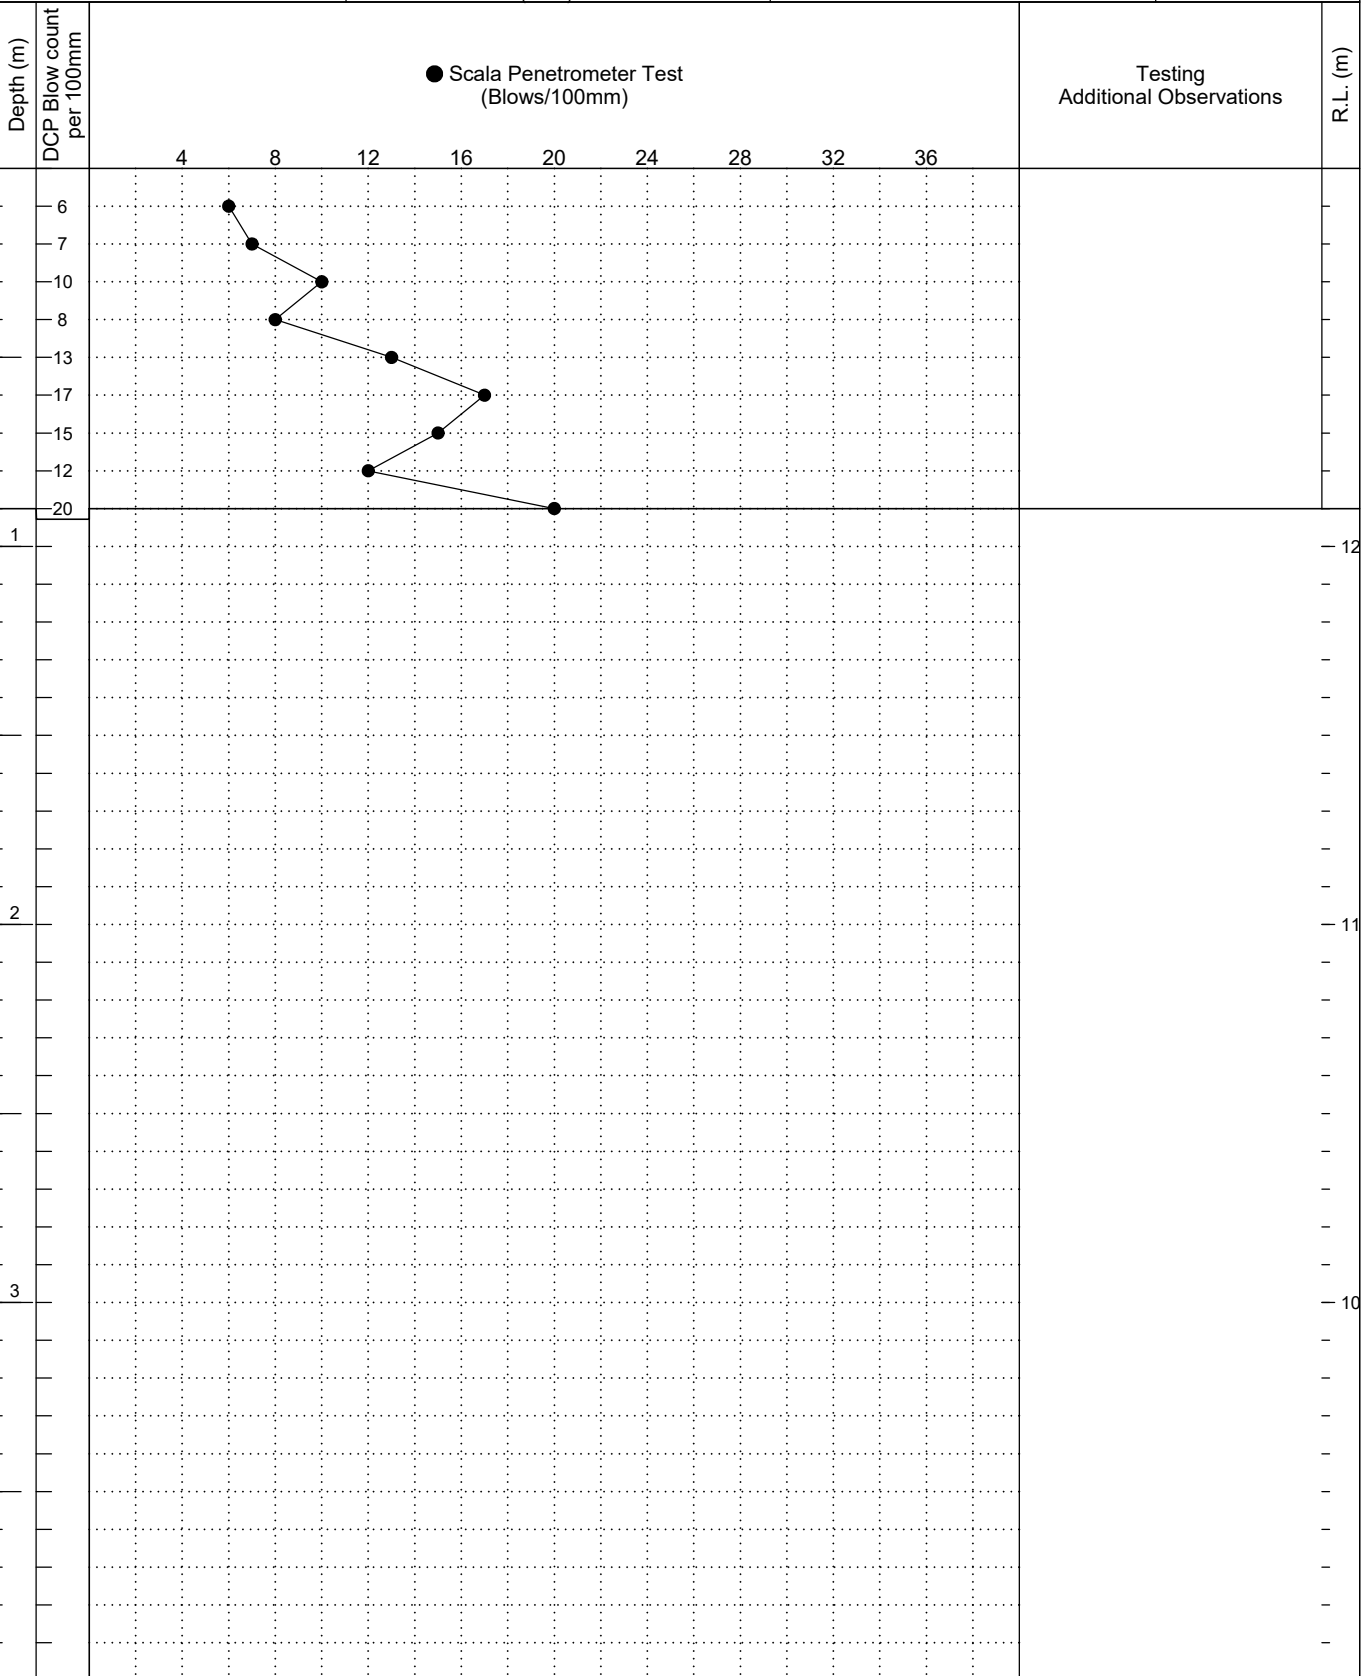
Date started: 1/10/2024
Date completed: 1/10/2024
Inclination: 90°
Orientation: N/A

REMARKS:
[1] Coordinates are approximate (+/- 5m), recorded in the field with a mobile device.
[2] RL is approximate (+/-0.5m) based on design contours.

The hand auger borehole was terminated when the base of the hole collapsed, and further samples could not be obtained. The hand auger borehole indicates ground conditions comprise topsoil underlain by sand.

An indicative groundwater level was noted where the hole collapsed due to saturated soil at 1.8m. Nearby investigations indicate that groundwater is typically encountered at approximately 1m to 2m depth. We note that the groundwater level could vary depending on the time of year.
