Prestons Park Subdivision
GEOTECHNICAL REPORT FOR LOT 314
CDL Land NZ Limited

26 July 2024
Revision: 0
Reference: 235361

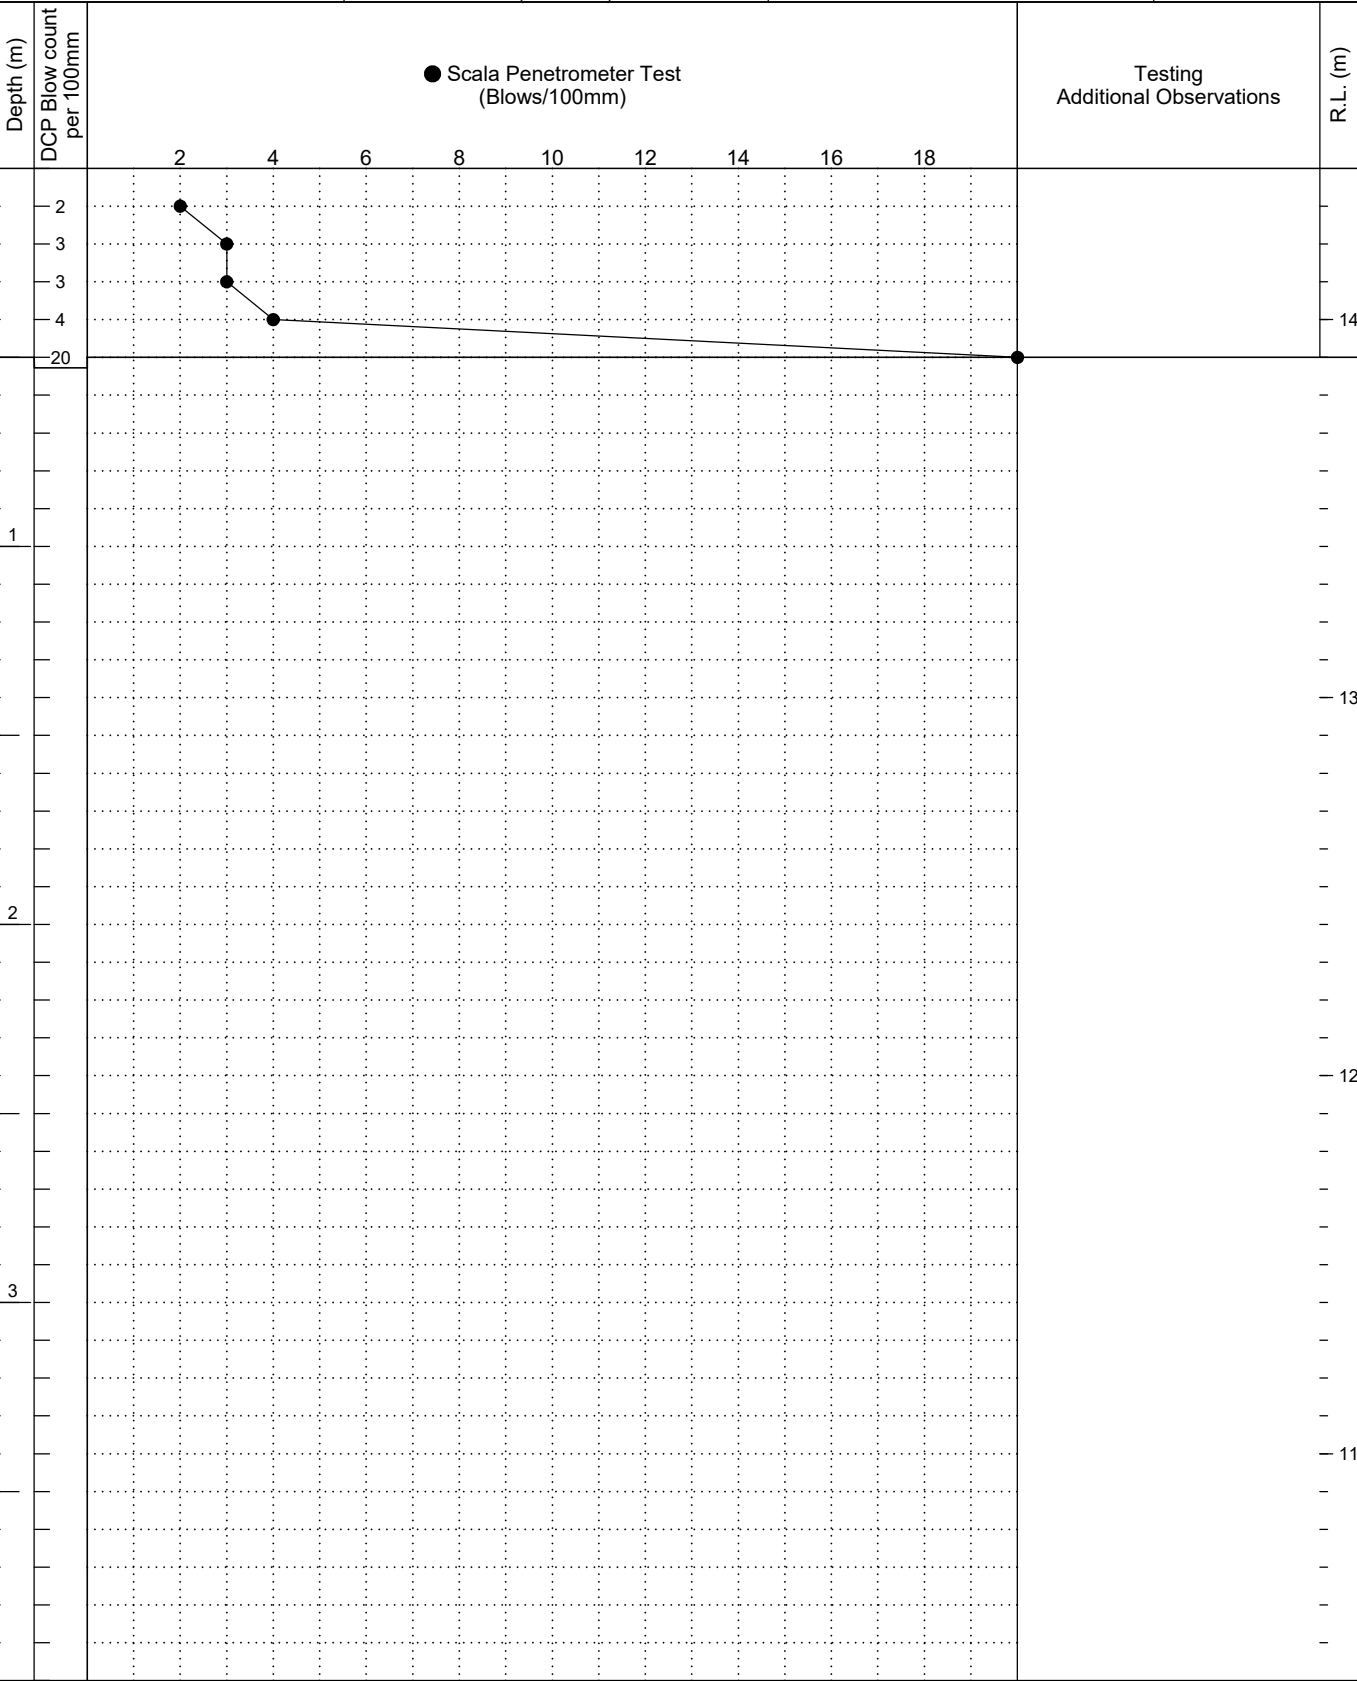
Sheet 1 of 1

DRILLING INFORMATION Method: Scala Penetrometer Equipment: Scala Penetrometer Contractor: N/A	CO-ORDINATES: NZTM Easting: 1573248m Northing: 5185193m Ground level: 14.4m (LVD 1937)	Date started: 9/07/2024 Date completed: 9/07/2024 Inclination: 90° Orientation: N/A	Logged by: JN Input by: AP Checked by: RL Verified by: KF
---	---	--	--

REMARKS: [1] Coordinates are approximate (+/- 5m), recorded in the field with a mobile device. [2] RL is approximate (+/-0.5m) based on design contours.	Water Level Readings: Date Time Hole Depth Water Level Groundwater level not encountered
---	---
