Prestons Park Subdivision
GEOTECHNICAL REPORT FOR LOT 317
CDL Land NZ Limited

26 July 2024
Revision: 0
Reference: 235361

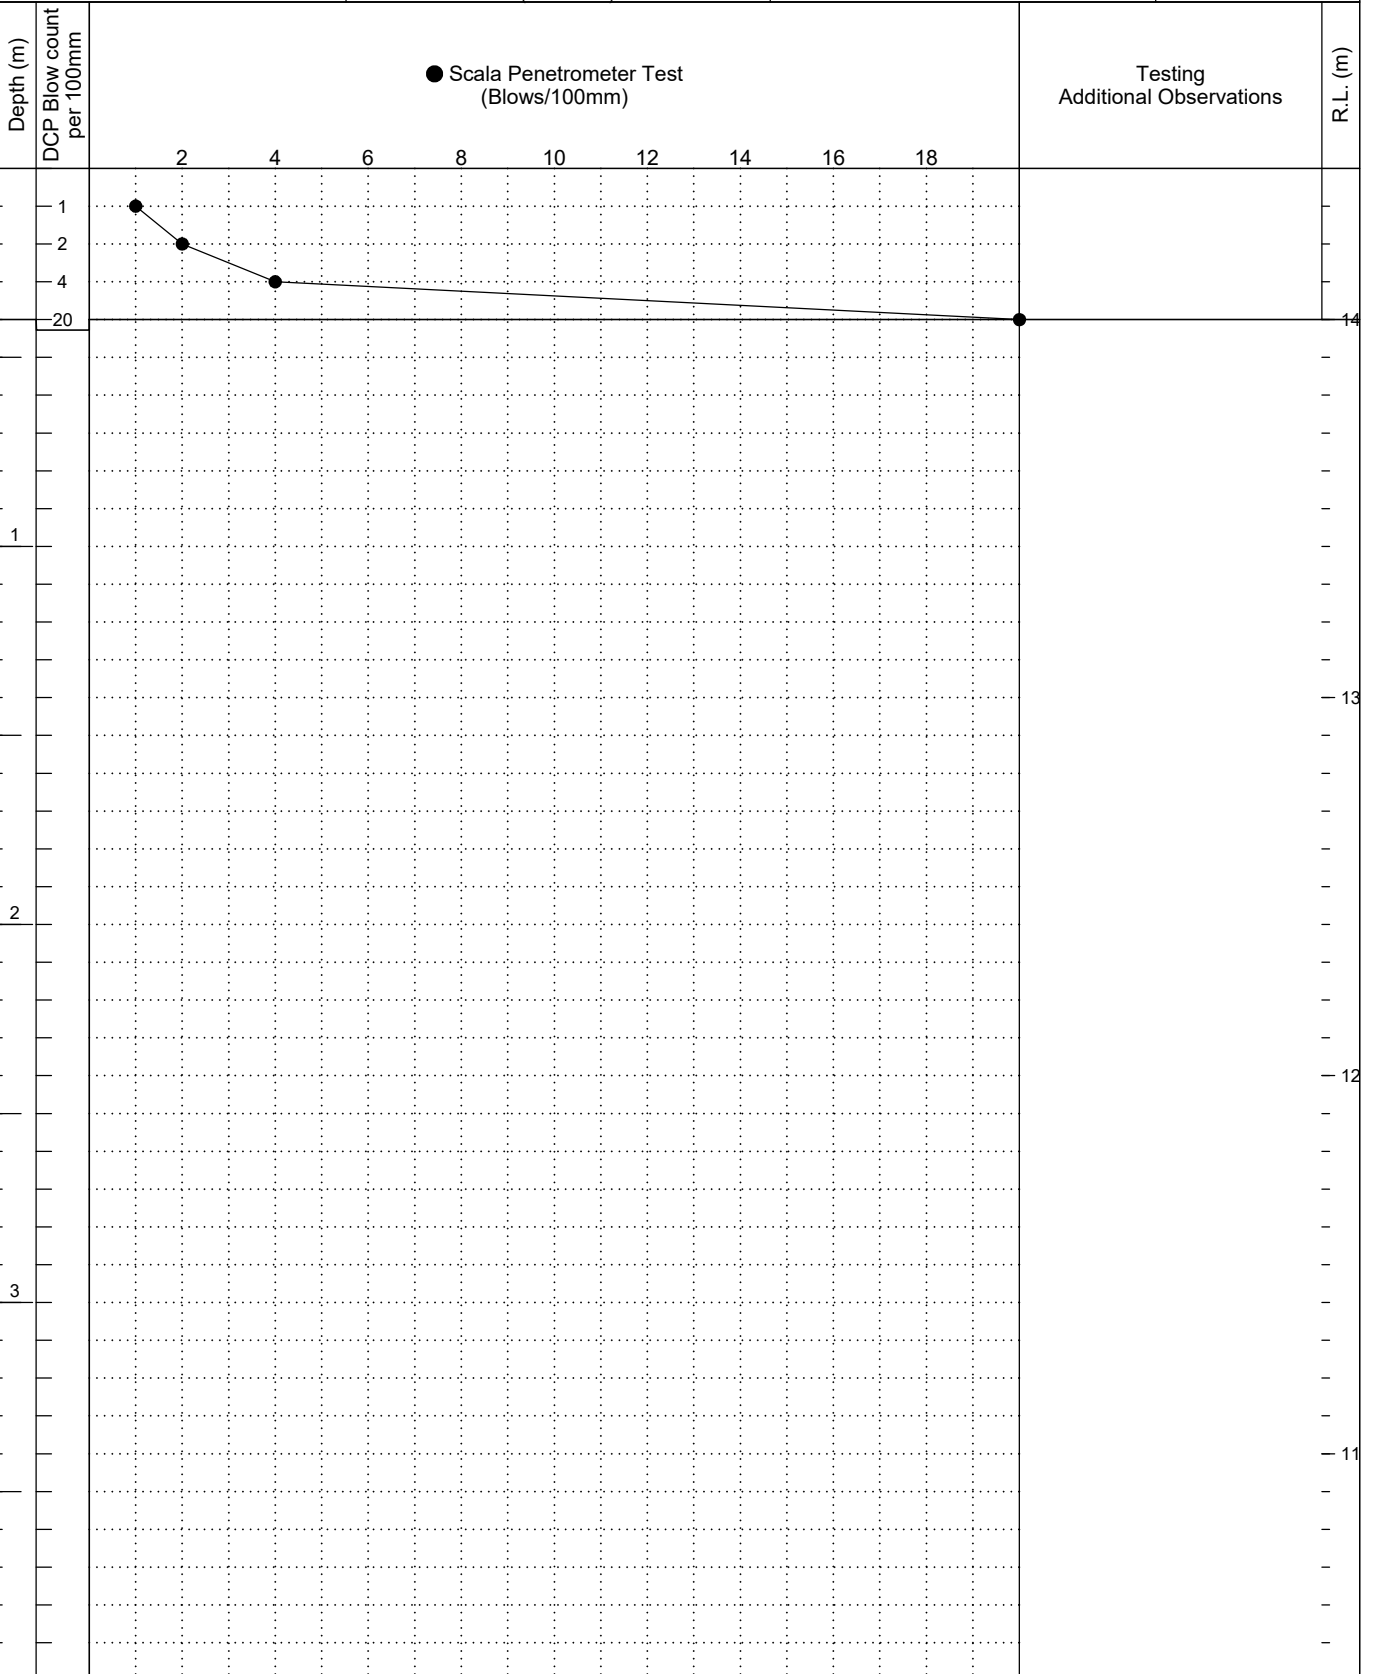
Date started: 9/07/2024
Date completed: 9/07/2024
Inclination: 90°
Orientation: N/A

REMARKS:
[1] Coordinates are approximate (+/- 5m), recorded in the field with a mobile device.
[2] RL is approximate (+/-0.5m) based on design contours.

Water Level Readings:
Date Time | Hole Depth | Water Level
Groundwater level not encountered

The hand auger borehole was terminated when soil samples became too dense to auger. The hand auger borehole indicates ground conditions comprise topsoil underlain by gravel.
