Prestons Park Subdivision
GEOTECHNICAL REPORT FOR LOT 779
CDL Land NZ Limited

5 August 2024 Revision: 0

Reference: 235361

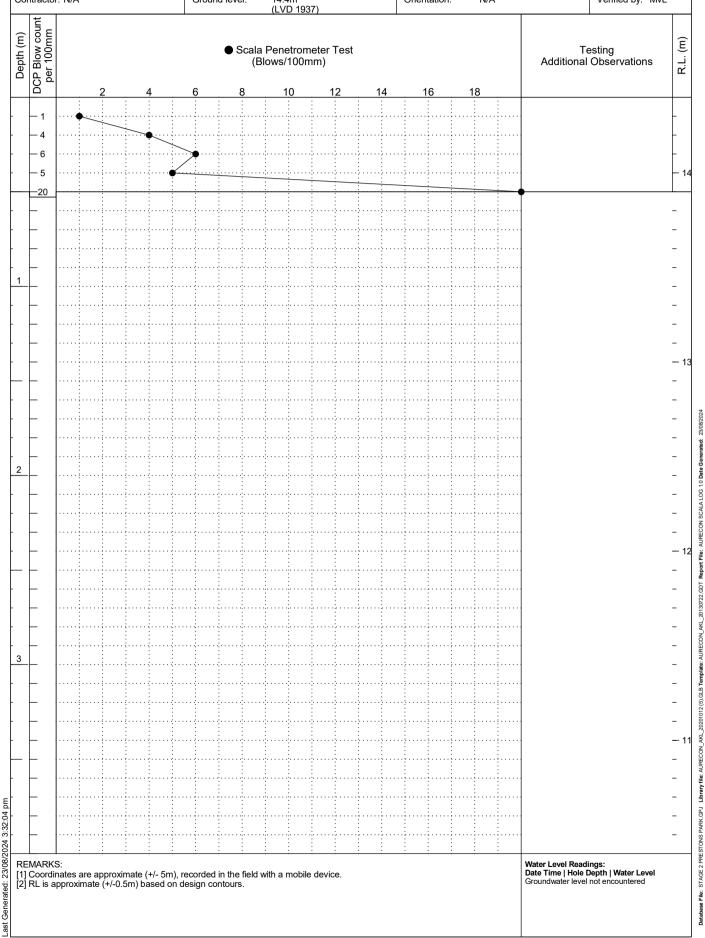
24/07/2024 Date started: Date completed: 24/07/2024 90° N/A Inclination: Orientation:

Logged by: AP Input by: AP Checked by: RL Verified by: MvL

The hand auger borehole was terminated when soil samples became too dense to auger. The hand auger borehole indicates ground conditions comprise topsoil underlain by gravel.
