Prestons Park Subdivision
GEOTECHNICAL REPORT FOR LOT 780
CDL Land NZ Limited

5 August 2024
Revision: 0
Reference: 235361

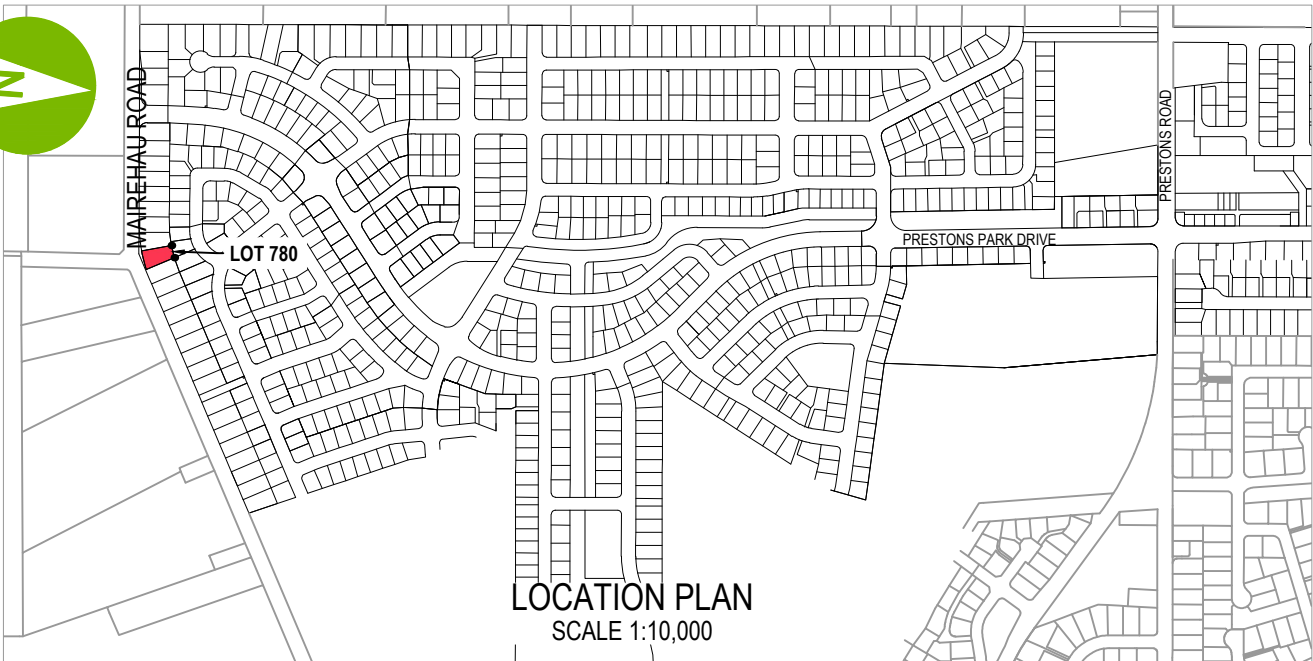
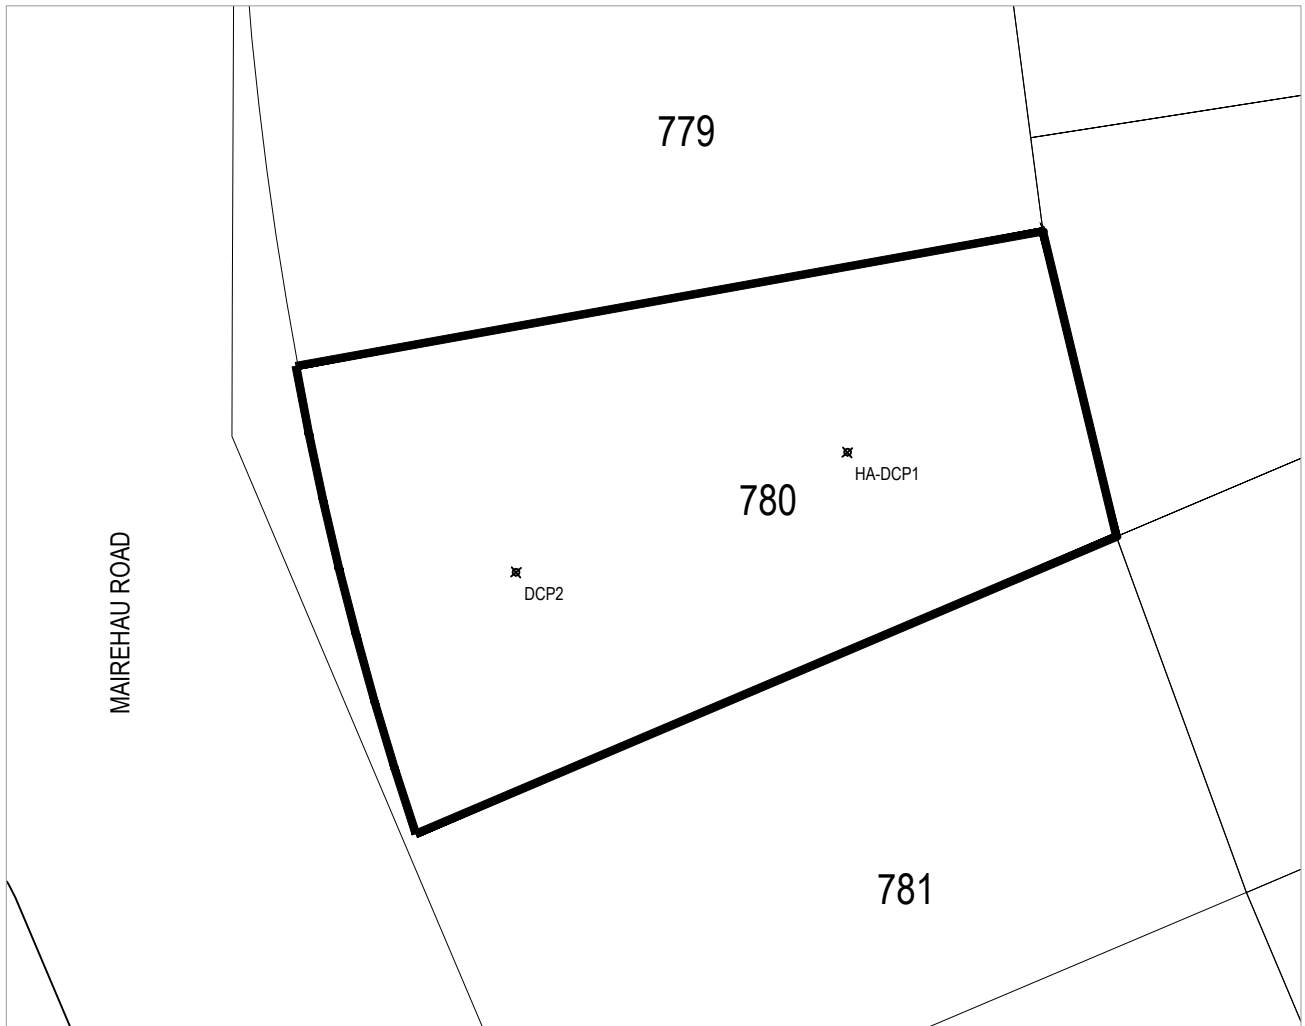
<small>www.aurecongroup.com</small>	REV	DATE	REVISION DETAILS	APPROVED	DRAWN	DESIGNED	PROJECT	PRELIMINARY	
	A	29/07/2024	ISSUE FOR INFORMATION	J KUPEC	J TODD	C DOHERTY	PRESTONS PARK	NOT FOR CONSTRUCTION	
CLIENT PRESTONS PARK					CHECKED			PROJECT No.	
					A PAYNE			235361	
					APPROVED		TITLE	SCALE	SIZE
					J KUPEC	DATE	LOT 780	1:400	A4
				J KUPEC		FIGURE 1	DRAWING No.	REV	
							GO-PS-S2-IN-780	A

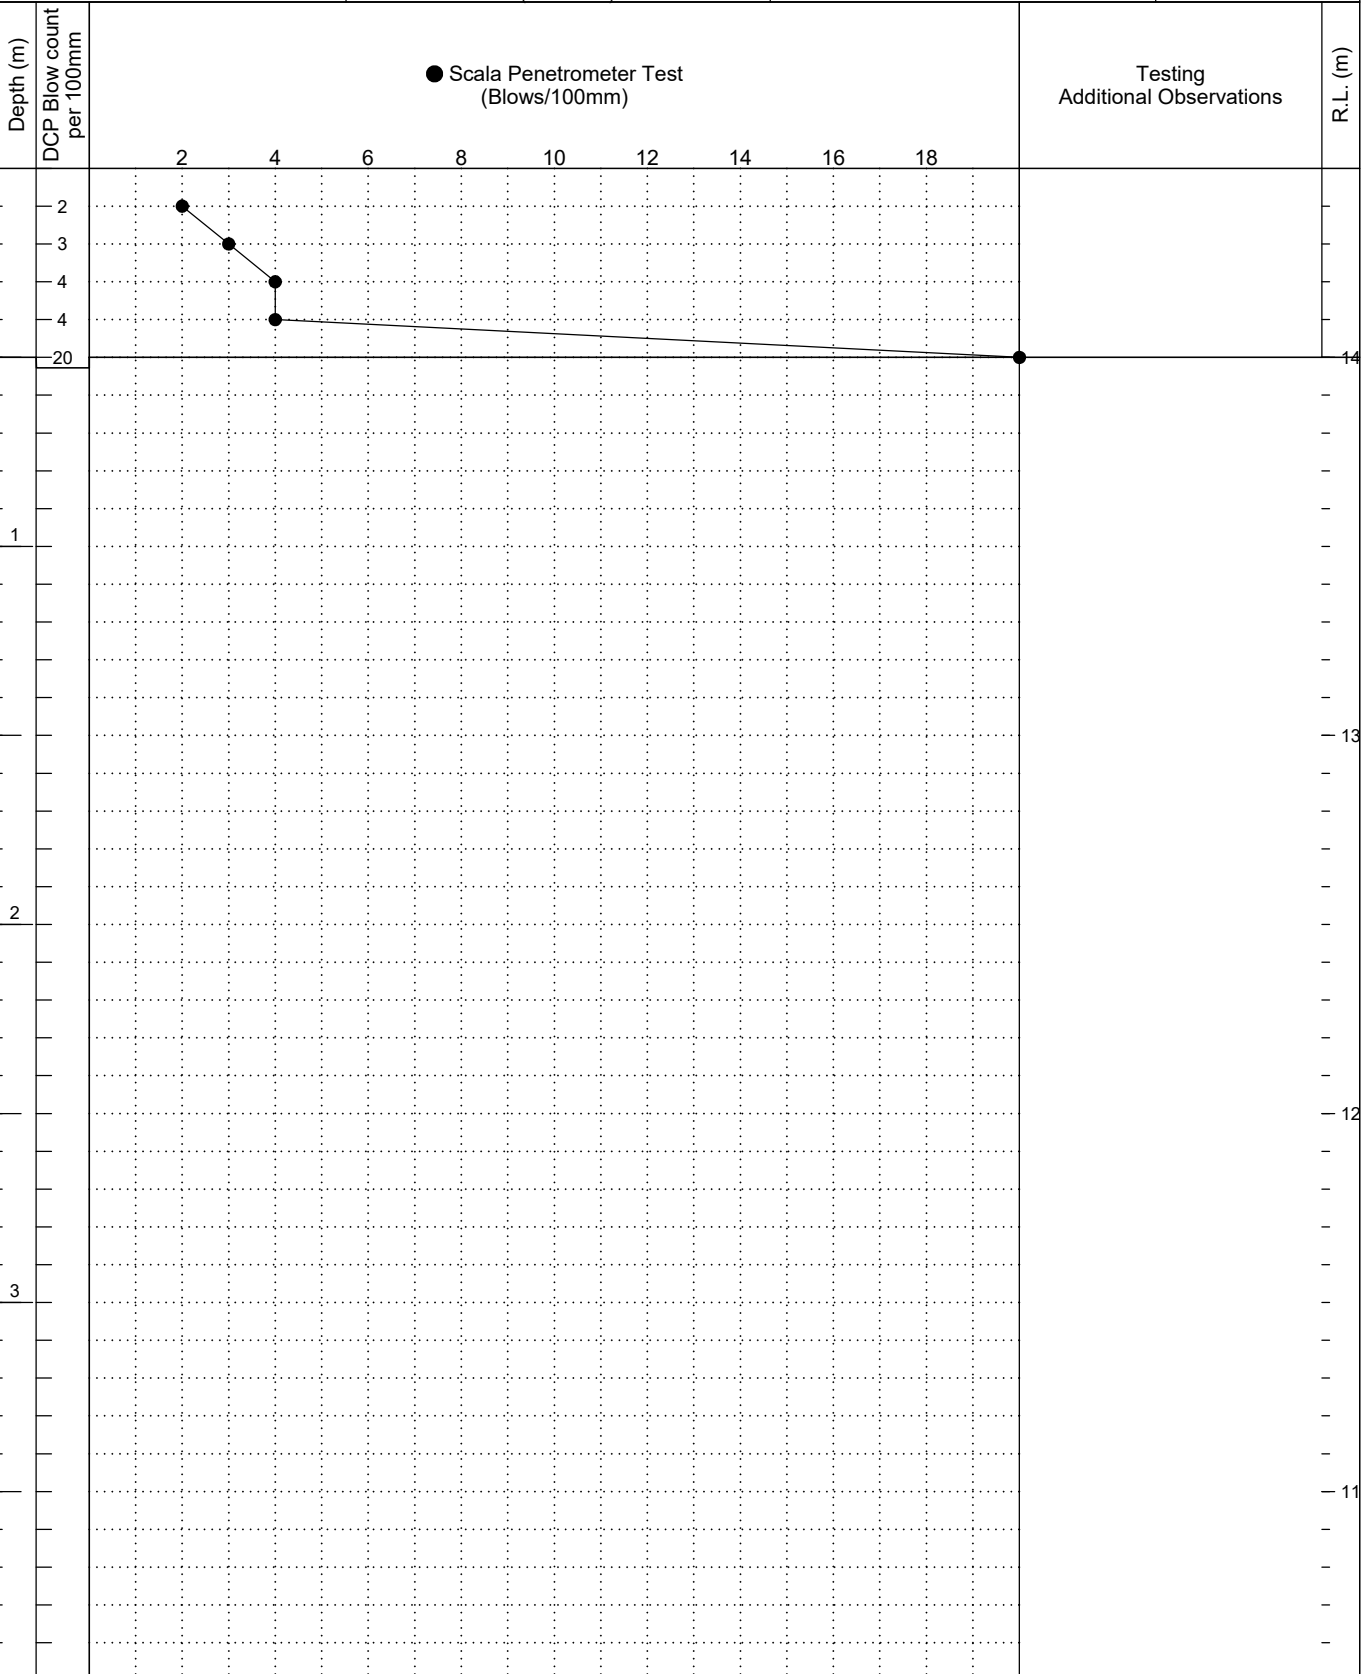
Date started: 24/07/2024
Date completed: 24/07/2024
Inclination: 90°
Orientation: N/A

REMARKS:
[1] Coordinates are approximate (+/- 5m), recorded in the field with a mobile device.
[2] RL is approximate (+/-0.5m) based on design contours.

Water Level Readings:
Date Time | Hole Depth | Water Level
Groundwater level not encountered

The hand auger borehole was terminated when soil samples became too dense to auger. The hand auger borehole indicates ground conditions comprise topsoil underlain by gravel.
