Prestons Park Subdivision
GEOTECHNICAL REPORT FOR LOT 781
CDL Land NZ Limited

5 August 2024
Revision: 0
Reference: 235361

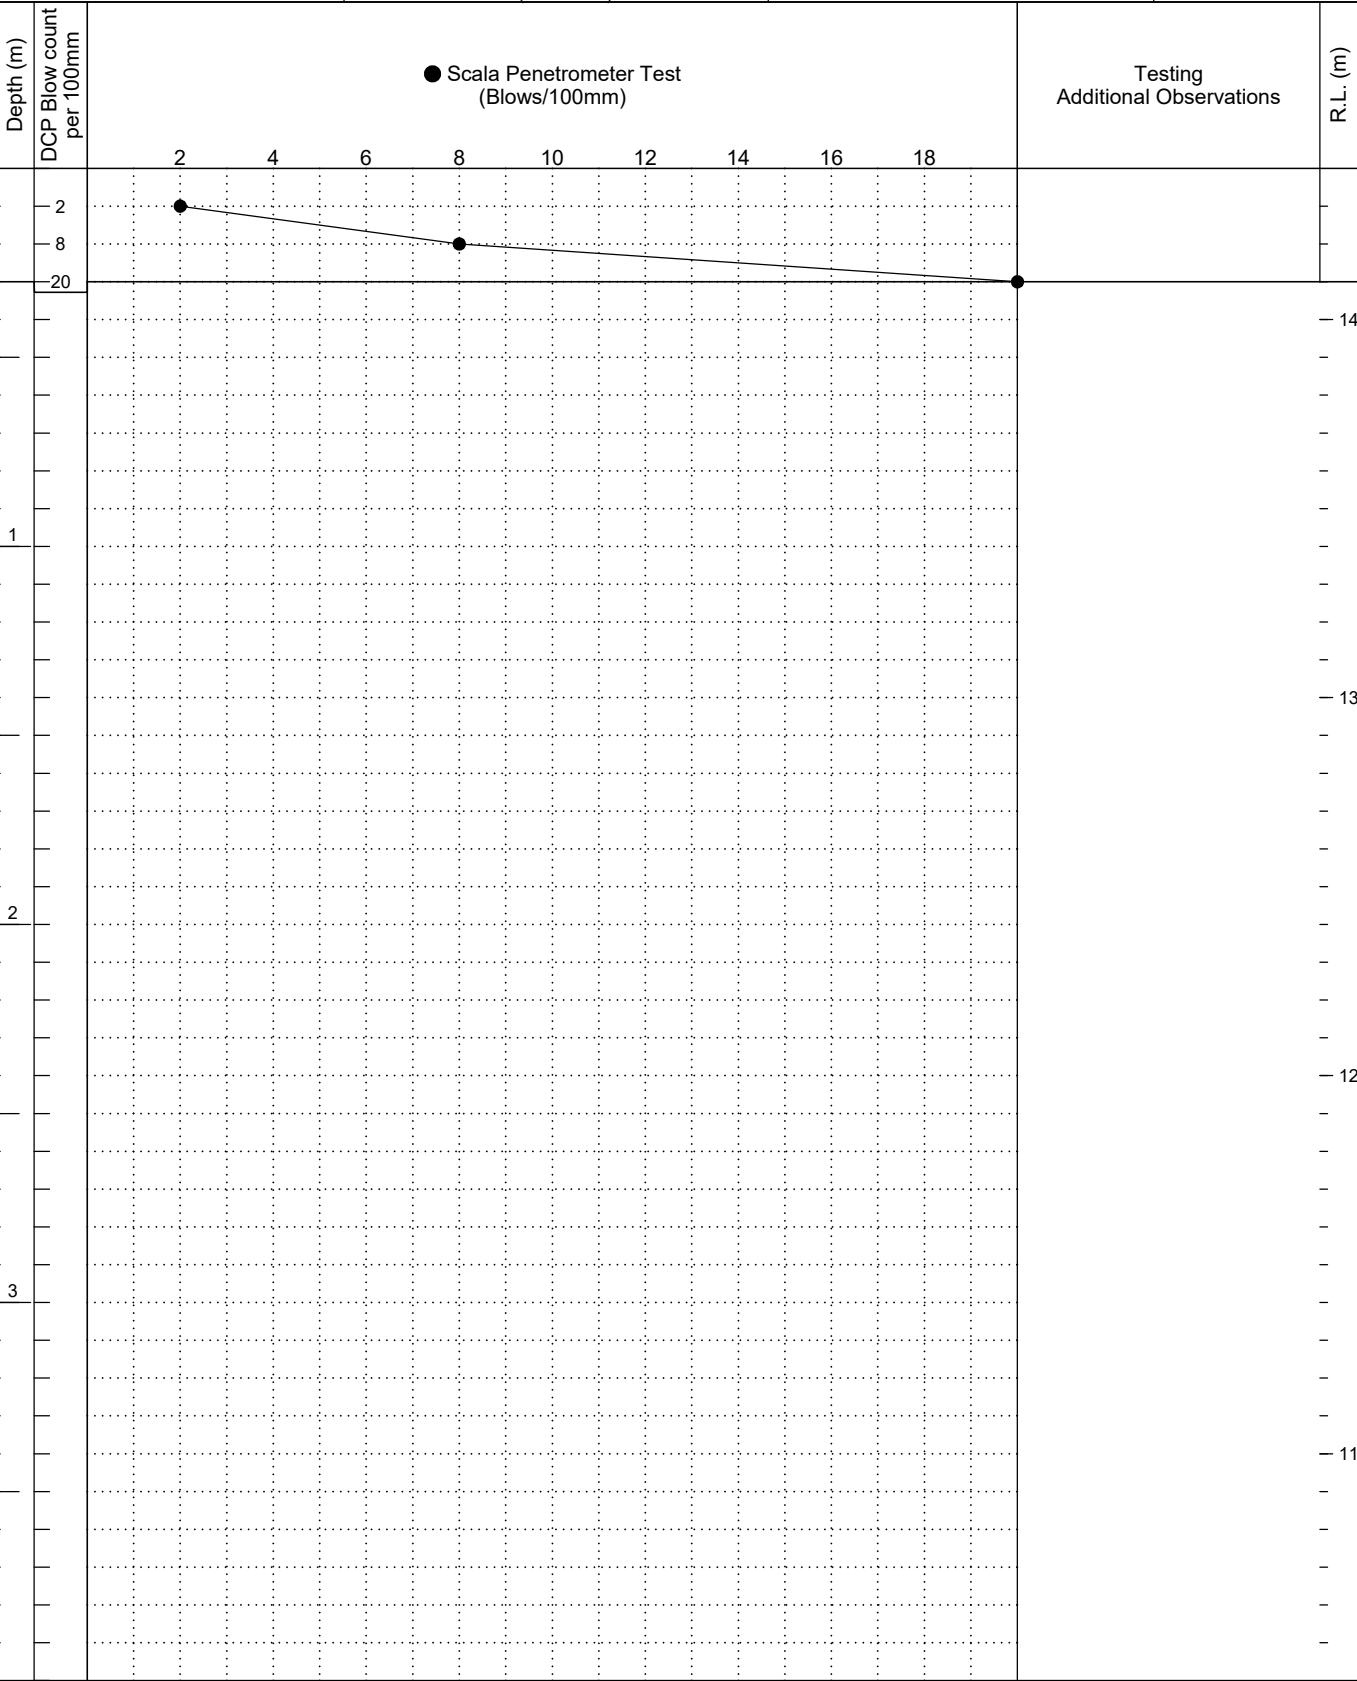
REMARKS:
[1] Coordinates are approximate (+/- 5m), recorded in the field with a mobile device.
[2] RL is approximate (+/-0.5m) based on design contours.

Water Level Readings:
Date Time | Hole Depth | Water Level
Groundwater level not encountered

The hand auger borehole was terminated when soil samples became too dense to auger. The hand auger borehole indicates ground conditions comprise topsoil underlain by gravel.
