Prestons Park Subdivision
GEOTECHNICAL REPORT FOR LOT 783
CDL Land NZ Limited

5 August 2024
Revision: 0
Reference: 235361

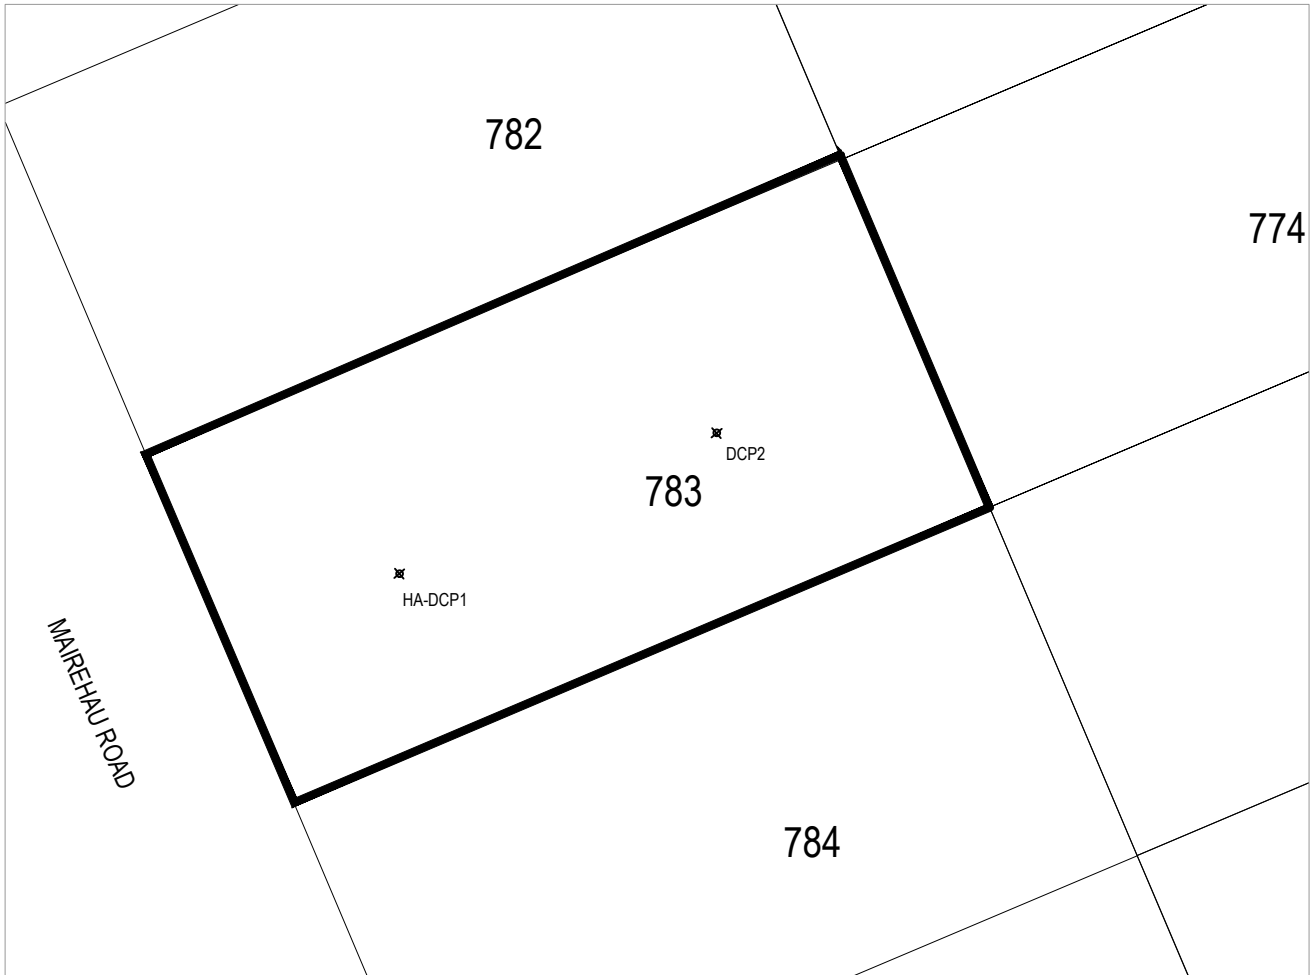
CLIENT
PRESTONS PARK

REV	DATE	REVISION DETAILS
A	29/07/2024	ISSUE FOR INFORMATION

The depth of topsoil has been determined from the single hand auger and two DCPs undertaken on site. We note that the topsoil depths may vary by +/- 100mm between the testing locations and hence it is recommended that at least a 100mm tolerance should be allowed for building foundation excavations.
