Prestons Park Subdivision
GEOTECHNICAL REPORT FOR LOT 381
CDL Land NZ Limited

25 September 2024
Revision: 0
Reference: 235361

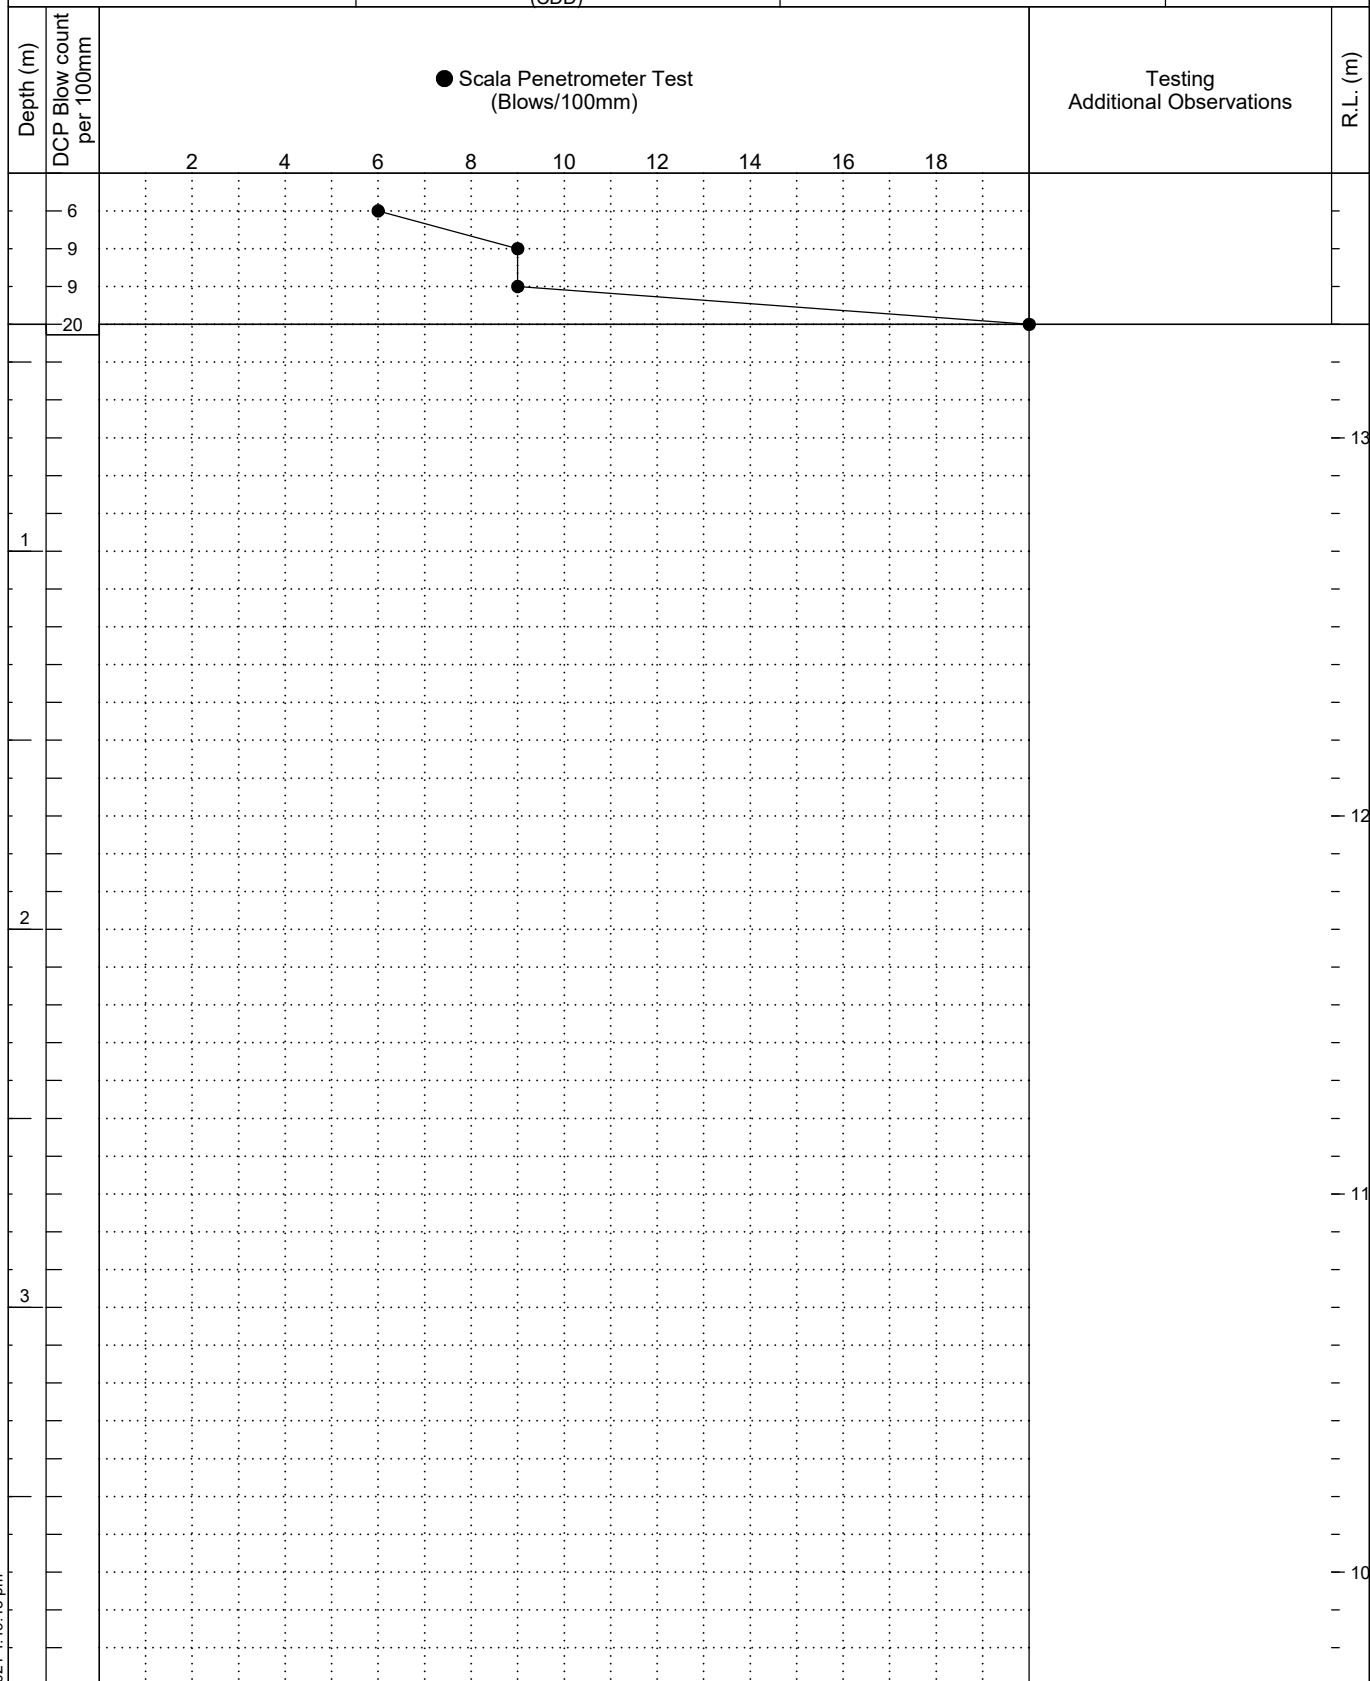
DRILLING INFORMATION	CO-ORDINATES: NZTM	Date started: 12/09/2024	Logged by: AP
Method: Scala Penetrometer	Easting: 1573622m	Date completed: 12/09/2024	Input by: AP
Equipment: Scala Penetrometer	Northing: 5185307m	Inclination: 90°	Checked by: RL
Contractor: N/A	Ground level: 13.7m (CDD)	Orientation: N/A	Verified by: MvL

REMARKS:

[1] Coordinates are approximate ($\pm 5\text{m}$), recorded in the field with a mobile device.
[2] RL is approximate ($\pm 0.5\text{m}$) based on design contours.

The depth of topsoil has been determined from the single hand auger and two DCPs undertaken on site. We note that the topsoil depths may vary by +/- 100mm between the testing locations and hence it is recommended that at least a 100mm tolerance should be allowed for building foundation excavations.
