Prestons Park Subdivision
GEOTECHNICAL REPORT FOR LOT 382
CDL Land NZ Limited

25 September 2024
Revision: 0
Reference: 235361

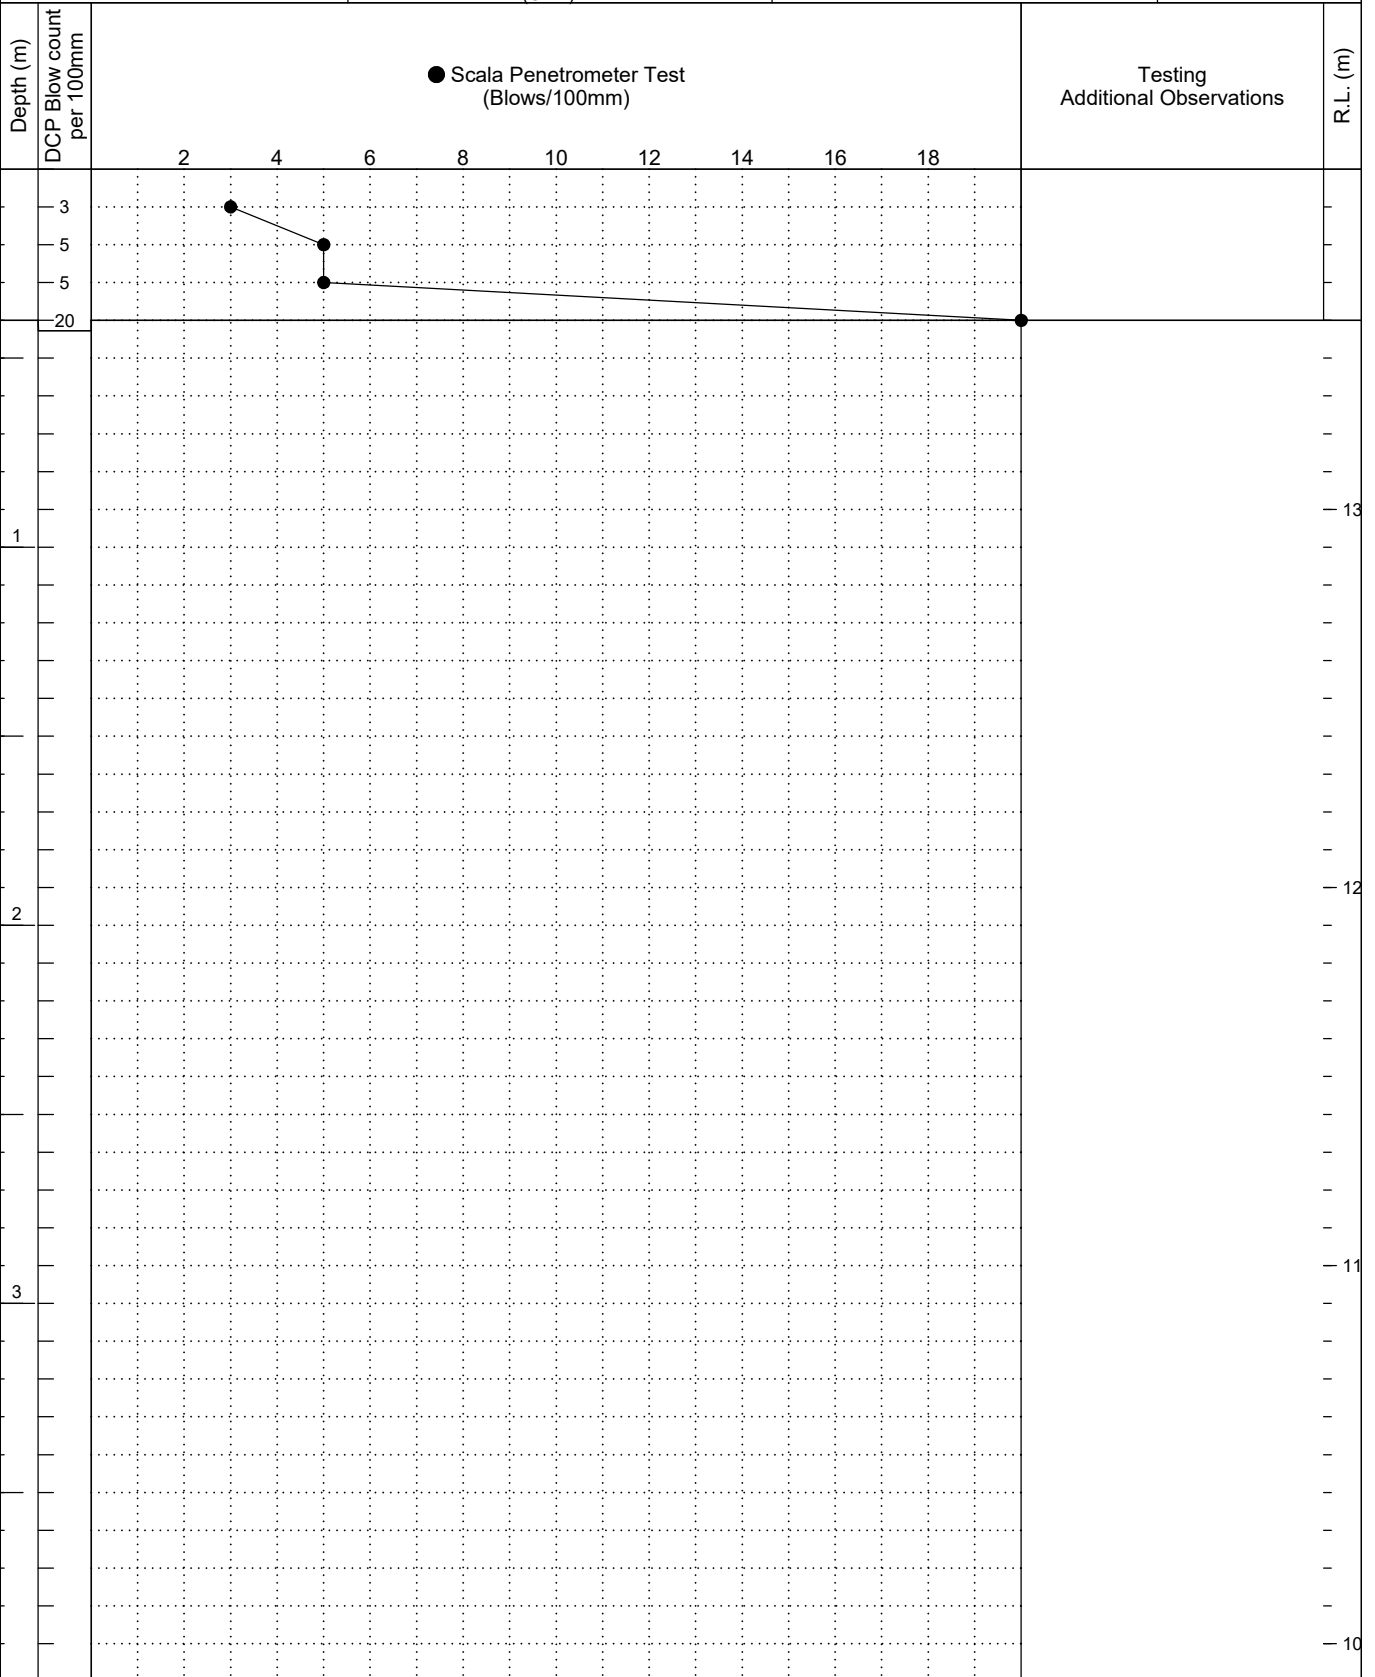
Date started: 12/09/2024
Date completed: 12/09/2024
Inclination: 90°
Orientation: N/A

REMARKS:
[1] Coordinates are approximate (+/- 5m), recorded in the field with a mobile device.
[2] RL is approximate (+/-0.5m) based on design contours.

Water Level Readings:
Date Time | Hole Depth | Water Level
Groundwater level not encountered

The hand auger borehole was terminated when soil samples became too dense to auger. The hand auger borehole indicates ground conditions comprise topsoil underlain by gravel.
