Prestons Park Subdivision
GEOTECHNICAL REPORT FOR LOT 384
CDL Land NZ Limited

25 September 2024
Revision: 0
Reference: 235361

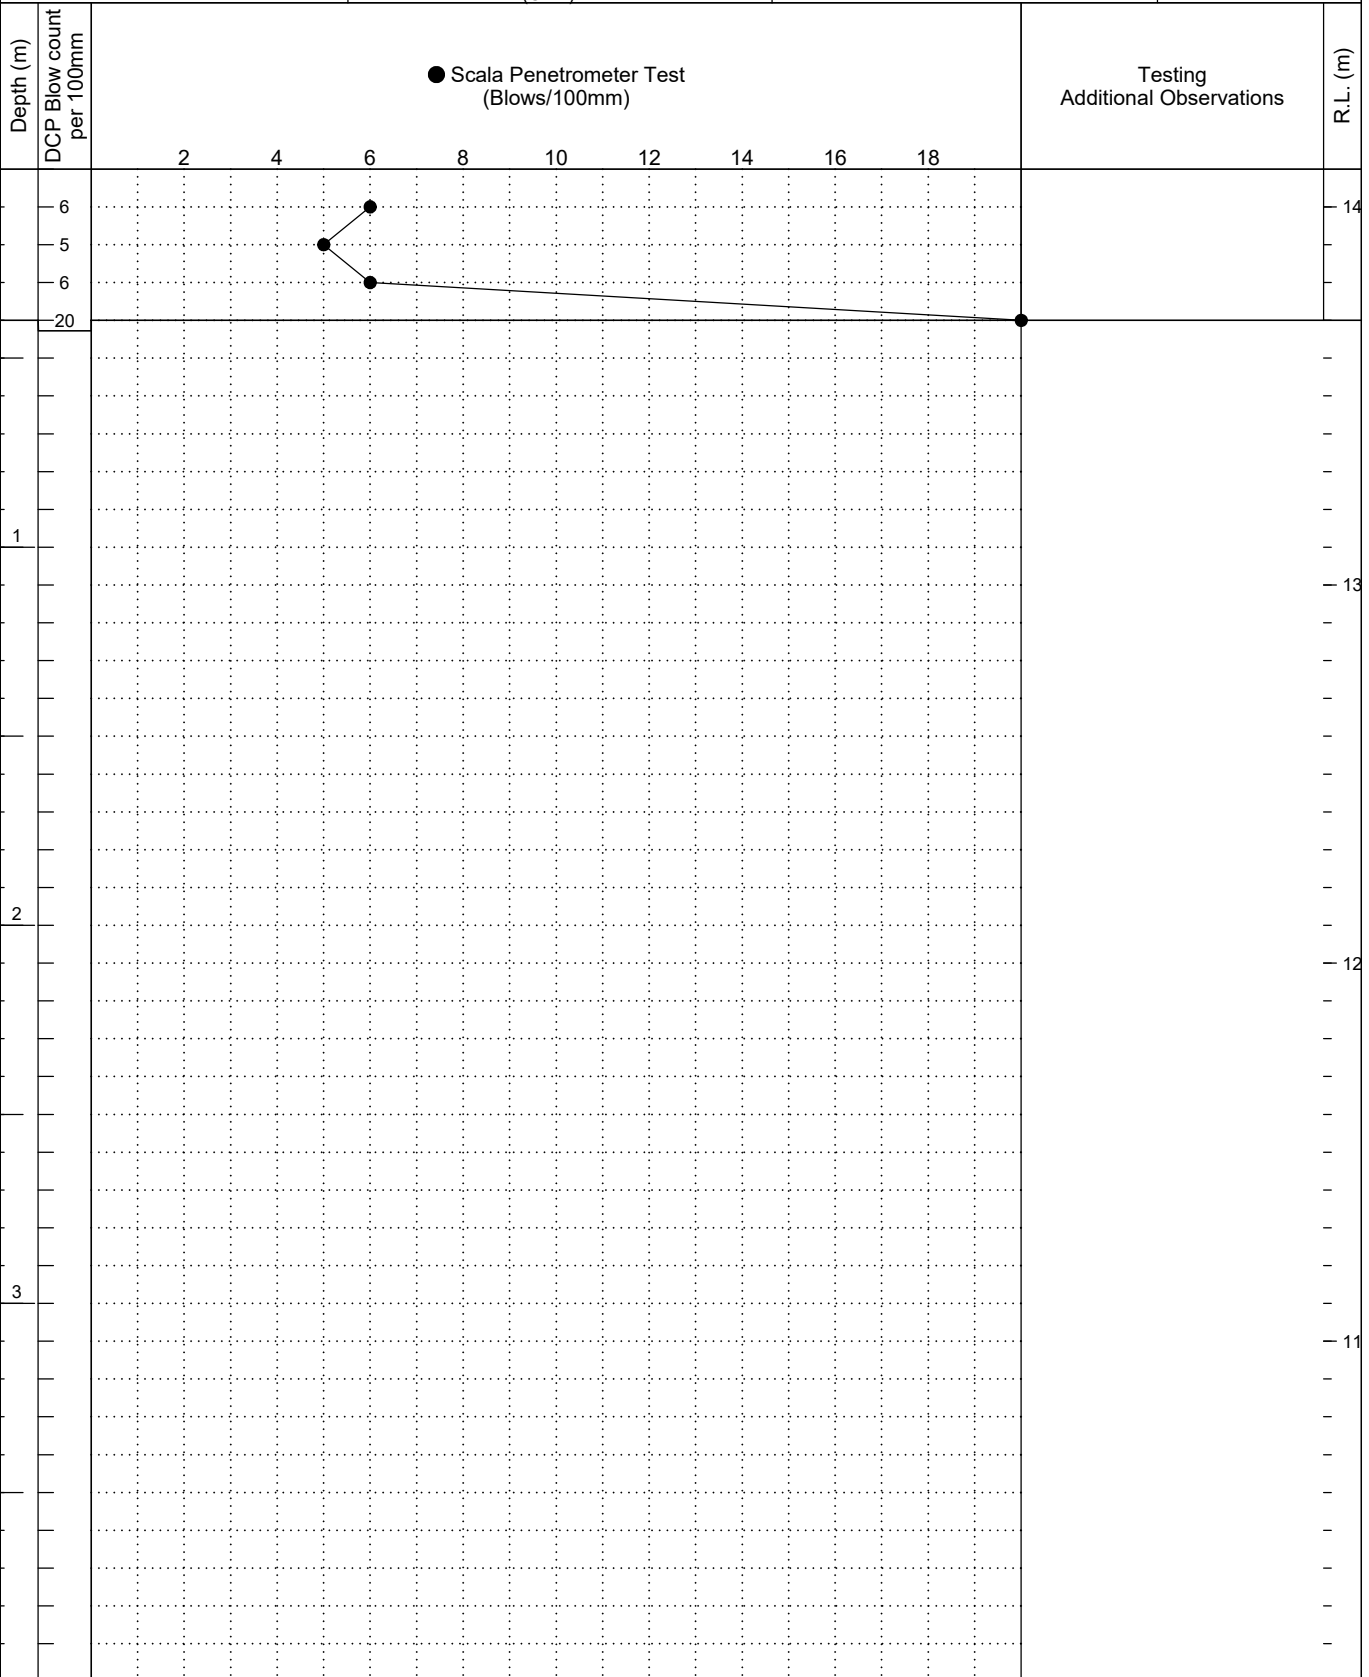
Date started: 12/09/2024
Date completed: 12/09/2024
Inclination: 90°
Orientation: N/A

REMARKS:
[1] Coordinates are approximate (+/- 5m), recorded in the field with a mobile device.
[2] RL is approximate (+/-0.5m) based on design contours.

Water Level Readings:
Date Time | Hole Depth | Water Level
Groundwater level not encountered

The hand auger borehole was terminated when soil samples became too dense to auger. The hand auger borehole indicates ground conditions comprise topsoil underlain by gravel.
