Prestons Park Subdivision
GEOTECHNICAL REPORT FOR LOT 386
CDL Land NZ Limited

26 August 2024
Revision: 0
Reference: 235361

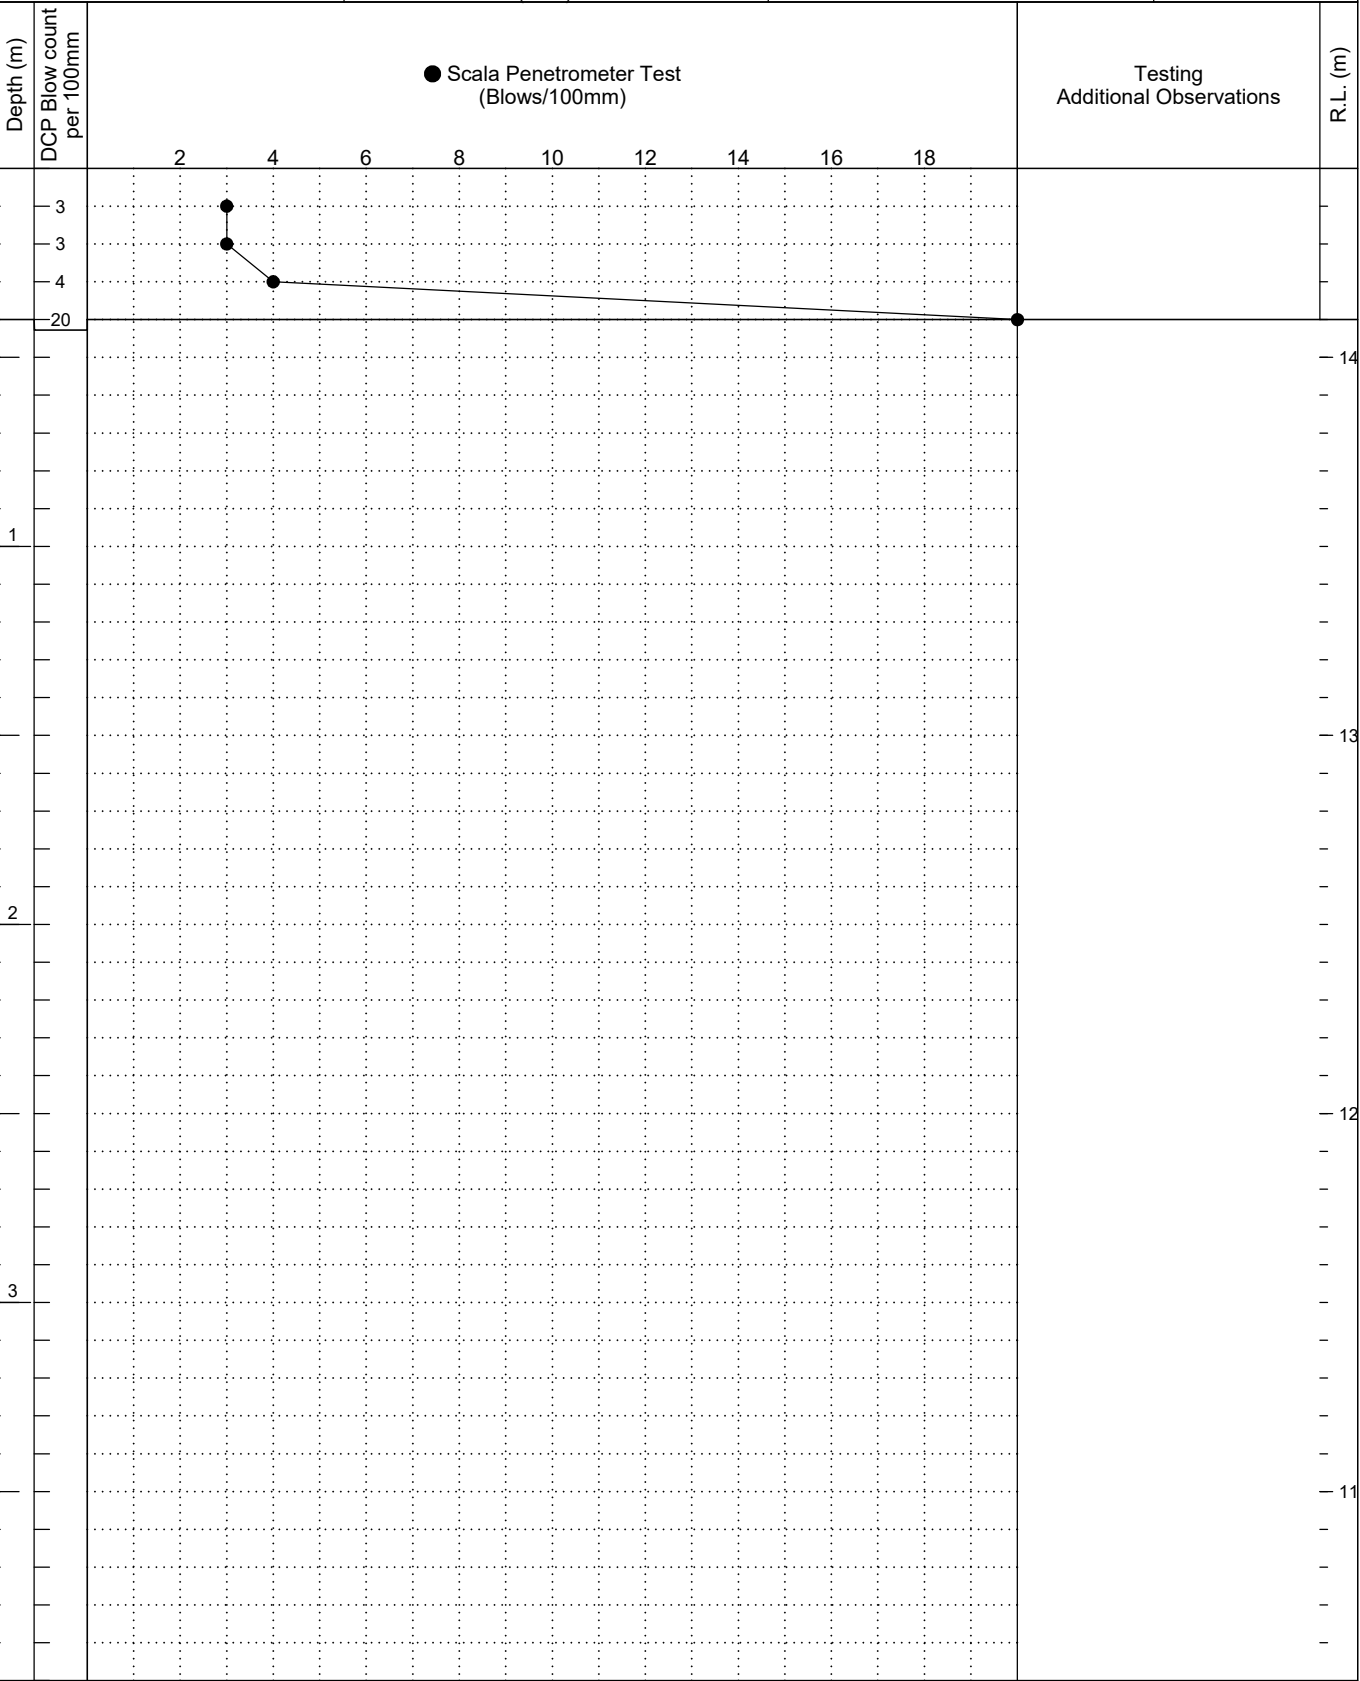
The hand auger borehole was terminated when soil samples became too dense to auger. The hand auger borehole indicates ground conditions comprise topsoil underlain by gravel.

REMARKS:
[1] Coordinates are approximate (+/- 5m), recorded in the field with a mobile device.
[2] RL is approximate (+/-0.5m) based on design contours.

Water Level Readings:
Date Time | Hole Depth | Water Level
Groundwater level not encountered
