Prestons Park Subdivision
GEOTECHNICAL REPORT FOR LOT 387
CDL Land NZ Limited

26 August 2024
Revision: 0
Reference: 235361

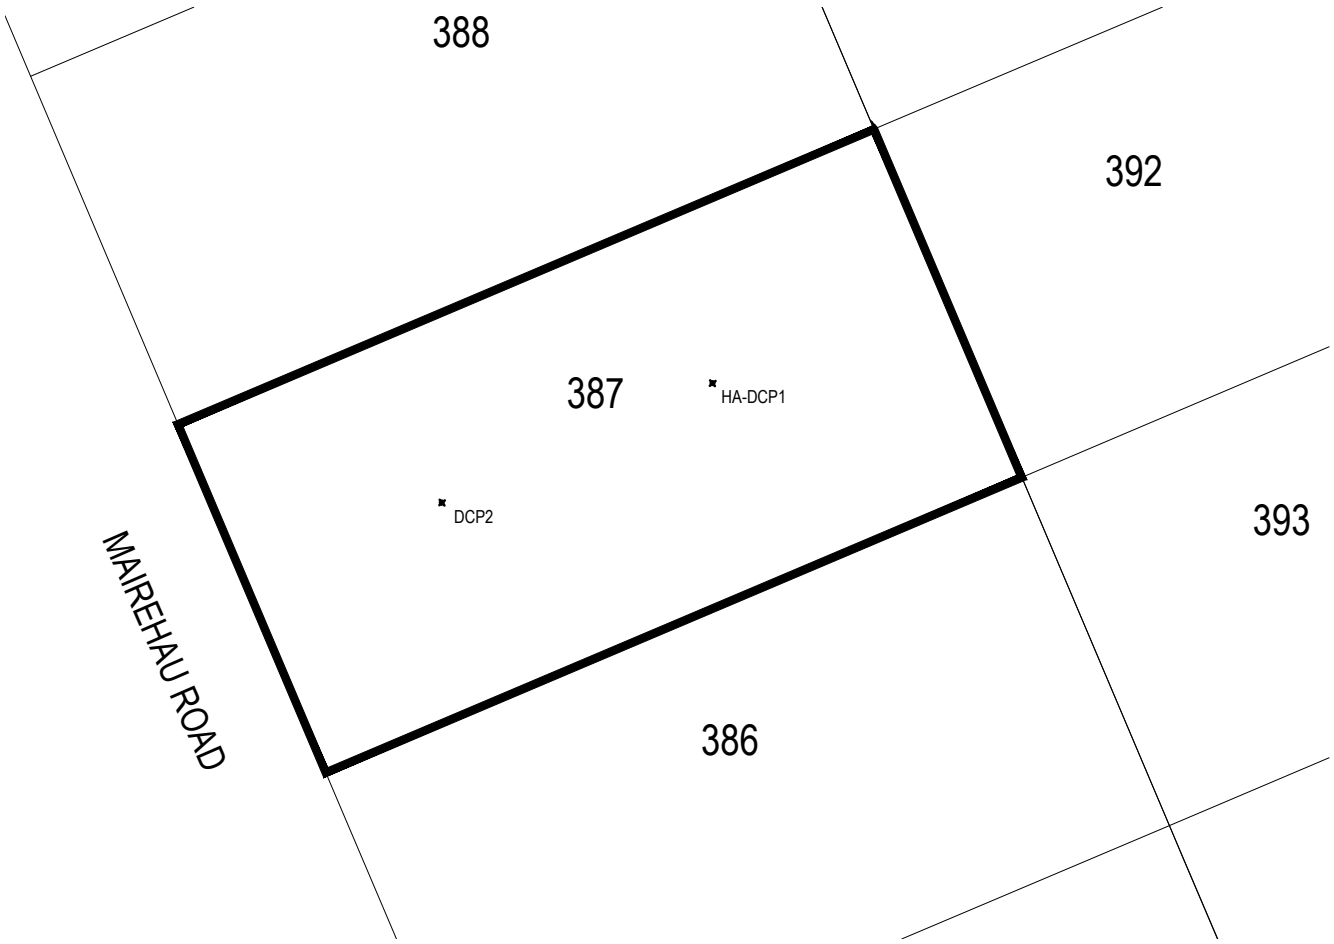
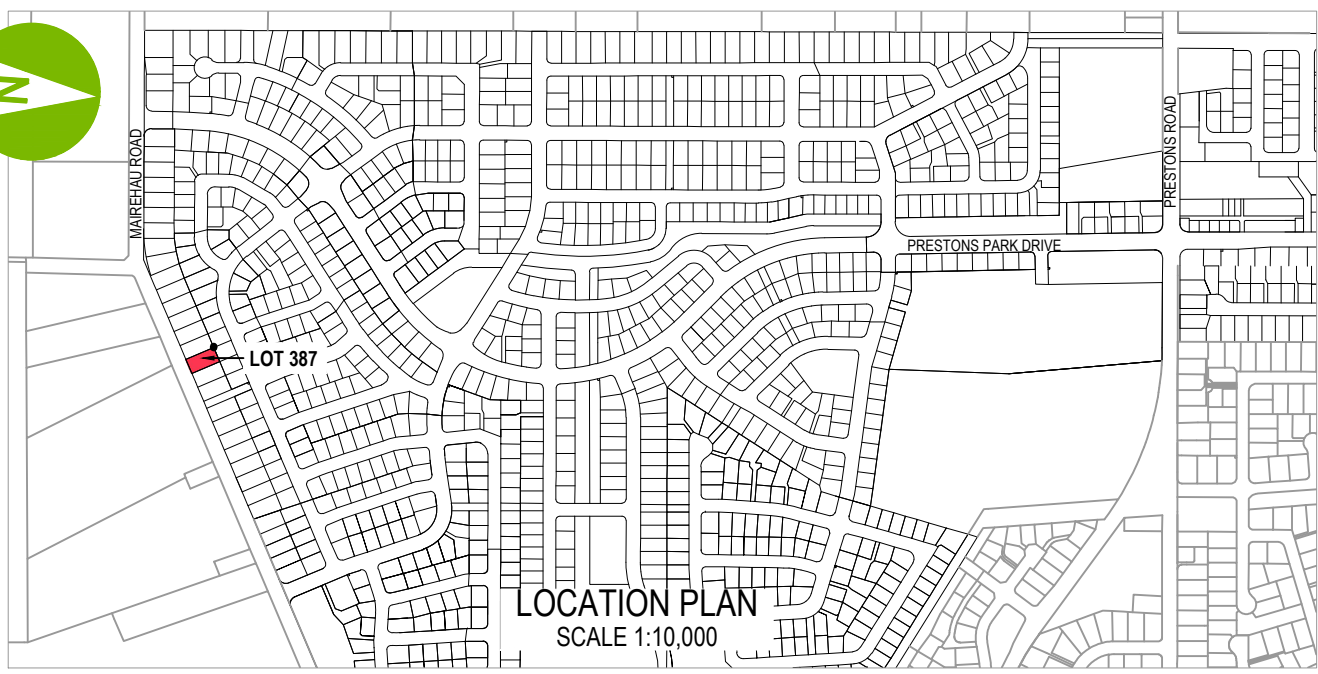
<small>www.aurecongroup.com</small>	REV	DATE	REVISION DETAILS	APPROVED	DRAWN	DESIGNED	PROJECT	INFORMATION	
	A	28/08/24	ISSUE FOR INFORMATION	J KUPEC	R DAWSON		PRESTONS PARK	PROJECT No. 235361	
CLIENT PRESTONS PARK					CHECKED		TITLE	SCALE	SIZE
					J MUIRSON		LOT 387	1:400	A4
					APPROVED		SITE LOCATION PLAN	DRAWING No.	REV
					J KUPEC	DATE 28/08/24	FIGURE 1	GO-PS-S2-IN-387	A

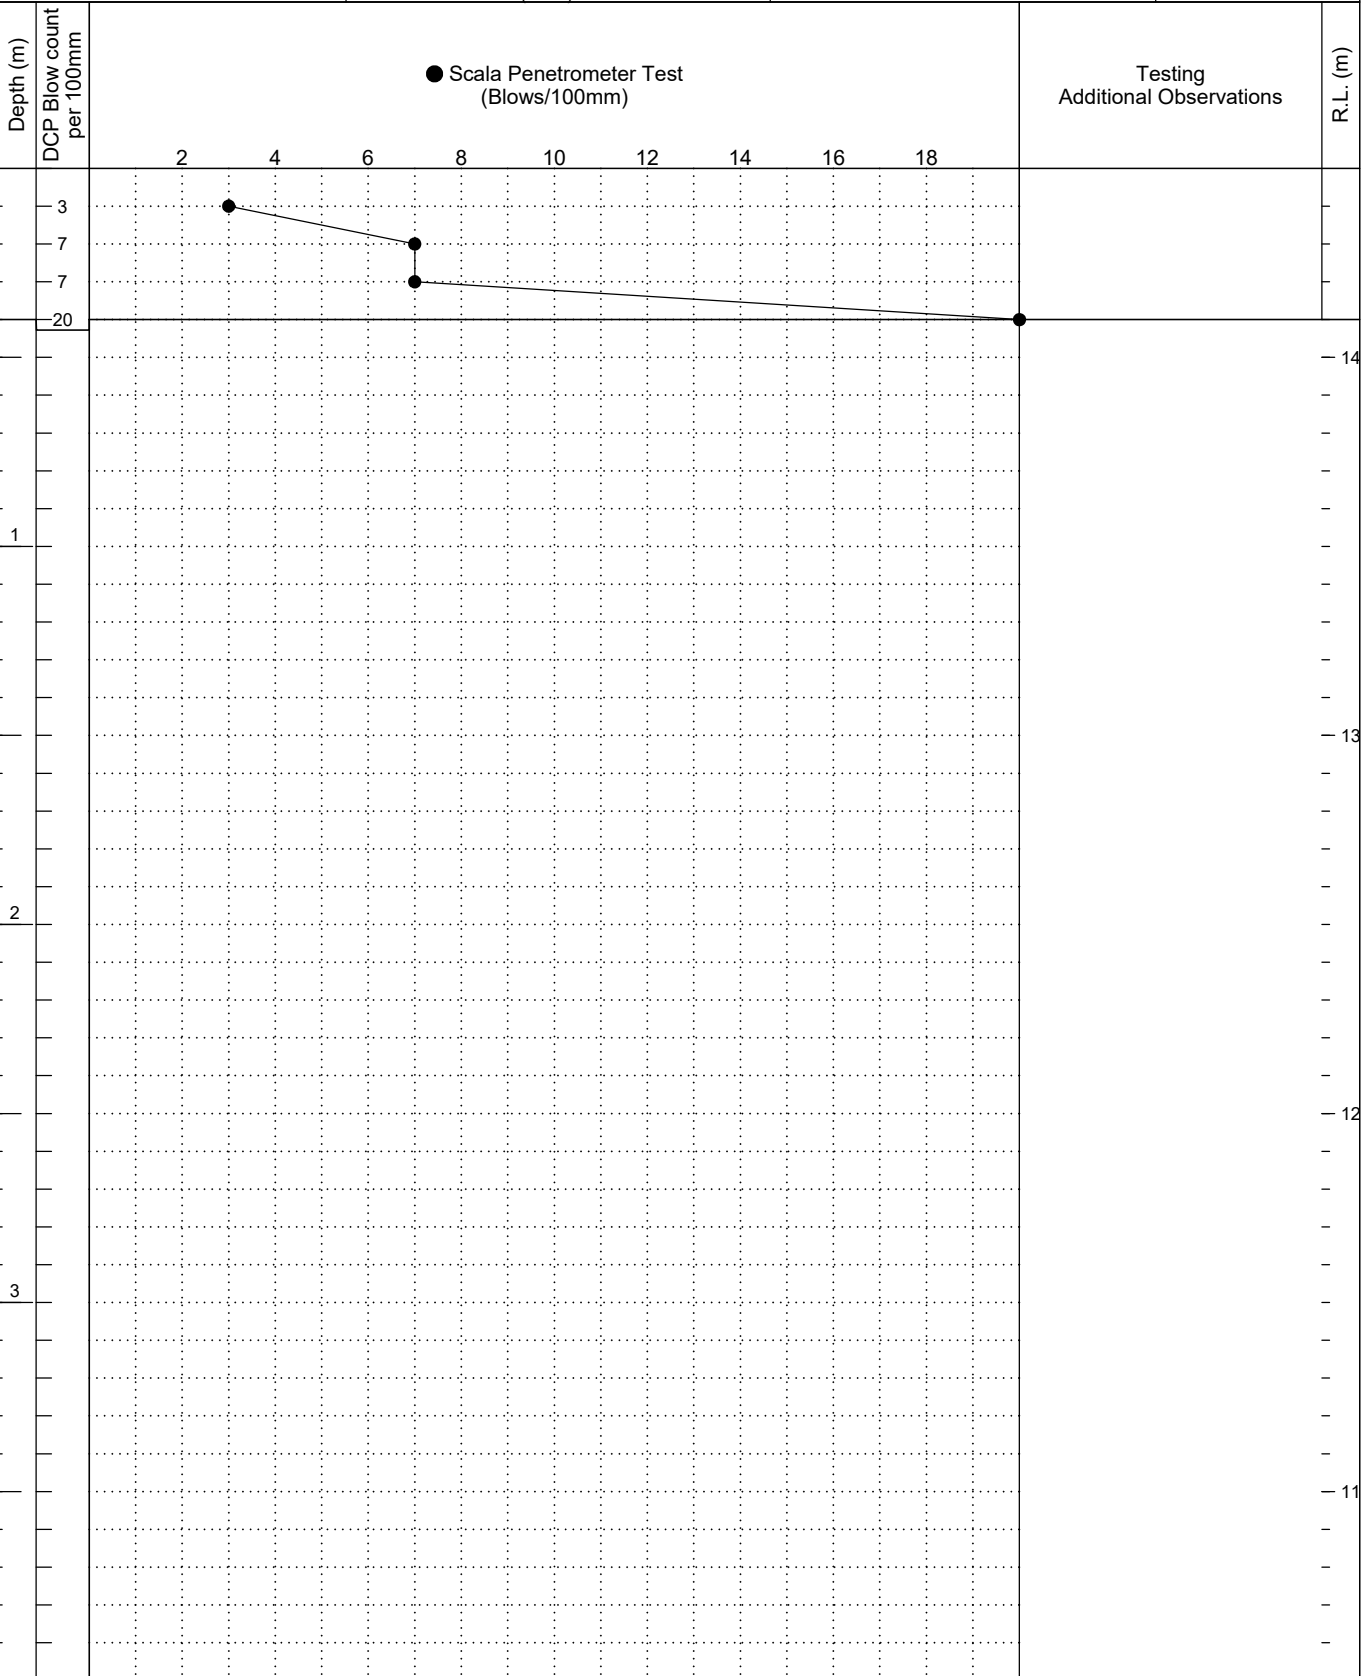
Date started: 22/08/2024
Date completed: 22/08/2024
Inclination: 90°
Orientation: N/A

REMARKS:
[1] Coordinates are approximate (+/- 5m), recorded in the field with a mobile device.
[2] RL is approximate (+/-0.5m) based on design contours.

Water Level Readings:
Date Time | Hole Depth | Water Level
Groundwater level not encountered

The hand auger borehole was terminated when soil samples became too dense to auger. The hand auger borehole indicates ground conditions comprise topsoil underlain by gravel.
