**Prestons Park Subdivision**  
**GEOTECHNICAL REPORT FOR LOT 1093**  
**CDL Land NZ Limited**

**16 September 2021**  
**Revision: 1**  
**Reference: 235361**

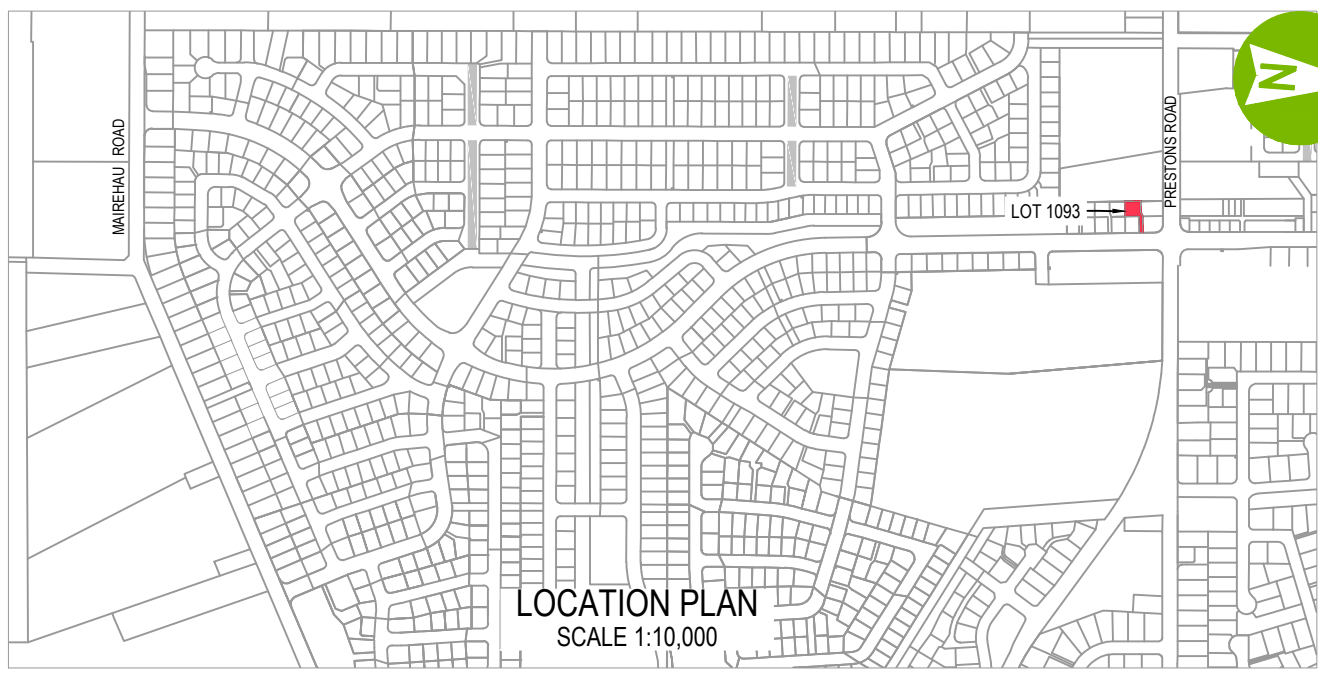
REV	DATE	REVISION DETAILS	APPROVED	DRAWN	DESIGNED	PROJECT	INFORMATION	
	A	25/02/21	ISSUE FOR INFORMATION	T BROWNE	R DAWSON	K FOOTE	PRESTONS	PROJECT No. 235361	
					CHECKED			SCALE	SIZE
					J MUIRSON			1:400	A4
CLIENT				APPROVED			TITLE	DRAWING No.	REV
				T BROWNE	DATE		LOT 1093	GO-PS-DC-IN-1093	A
				T BROWNE	25/02/2021		SITE LOCATION PLAN		
							FIGURE 1
