Prestons Park Subdivision

Stages H1 G1 and G2 Geotechnical Completion Report

CDL Land New Zealand Ltd

Reference: 235361 Revision: 0 2023-04-28

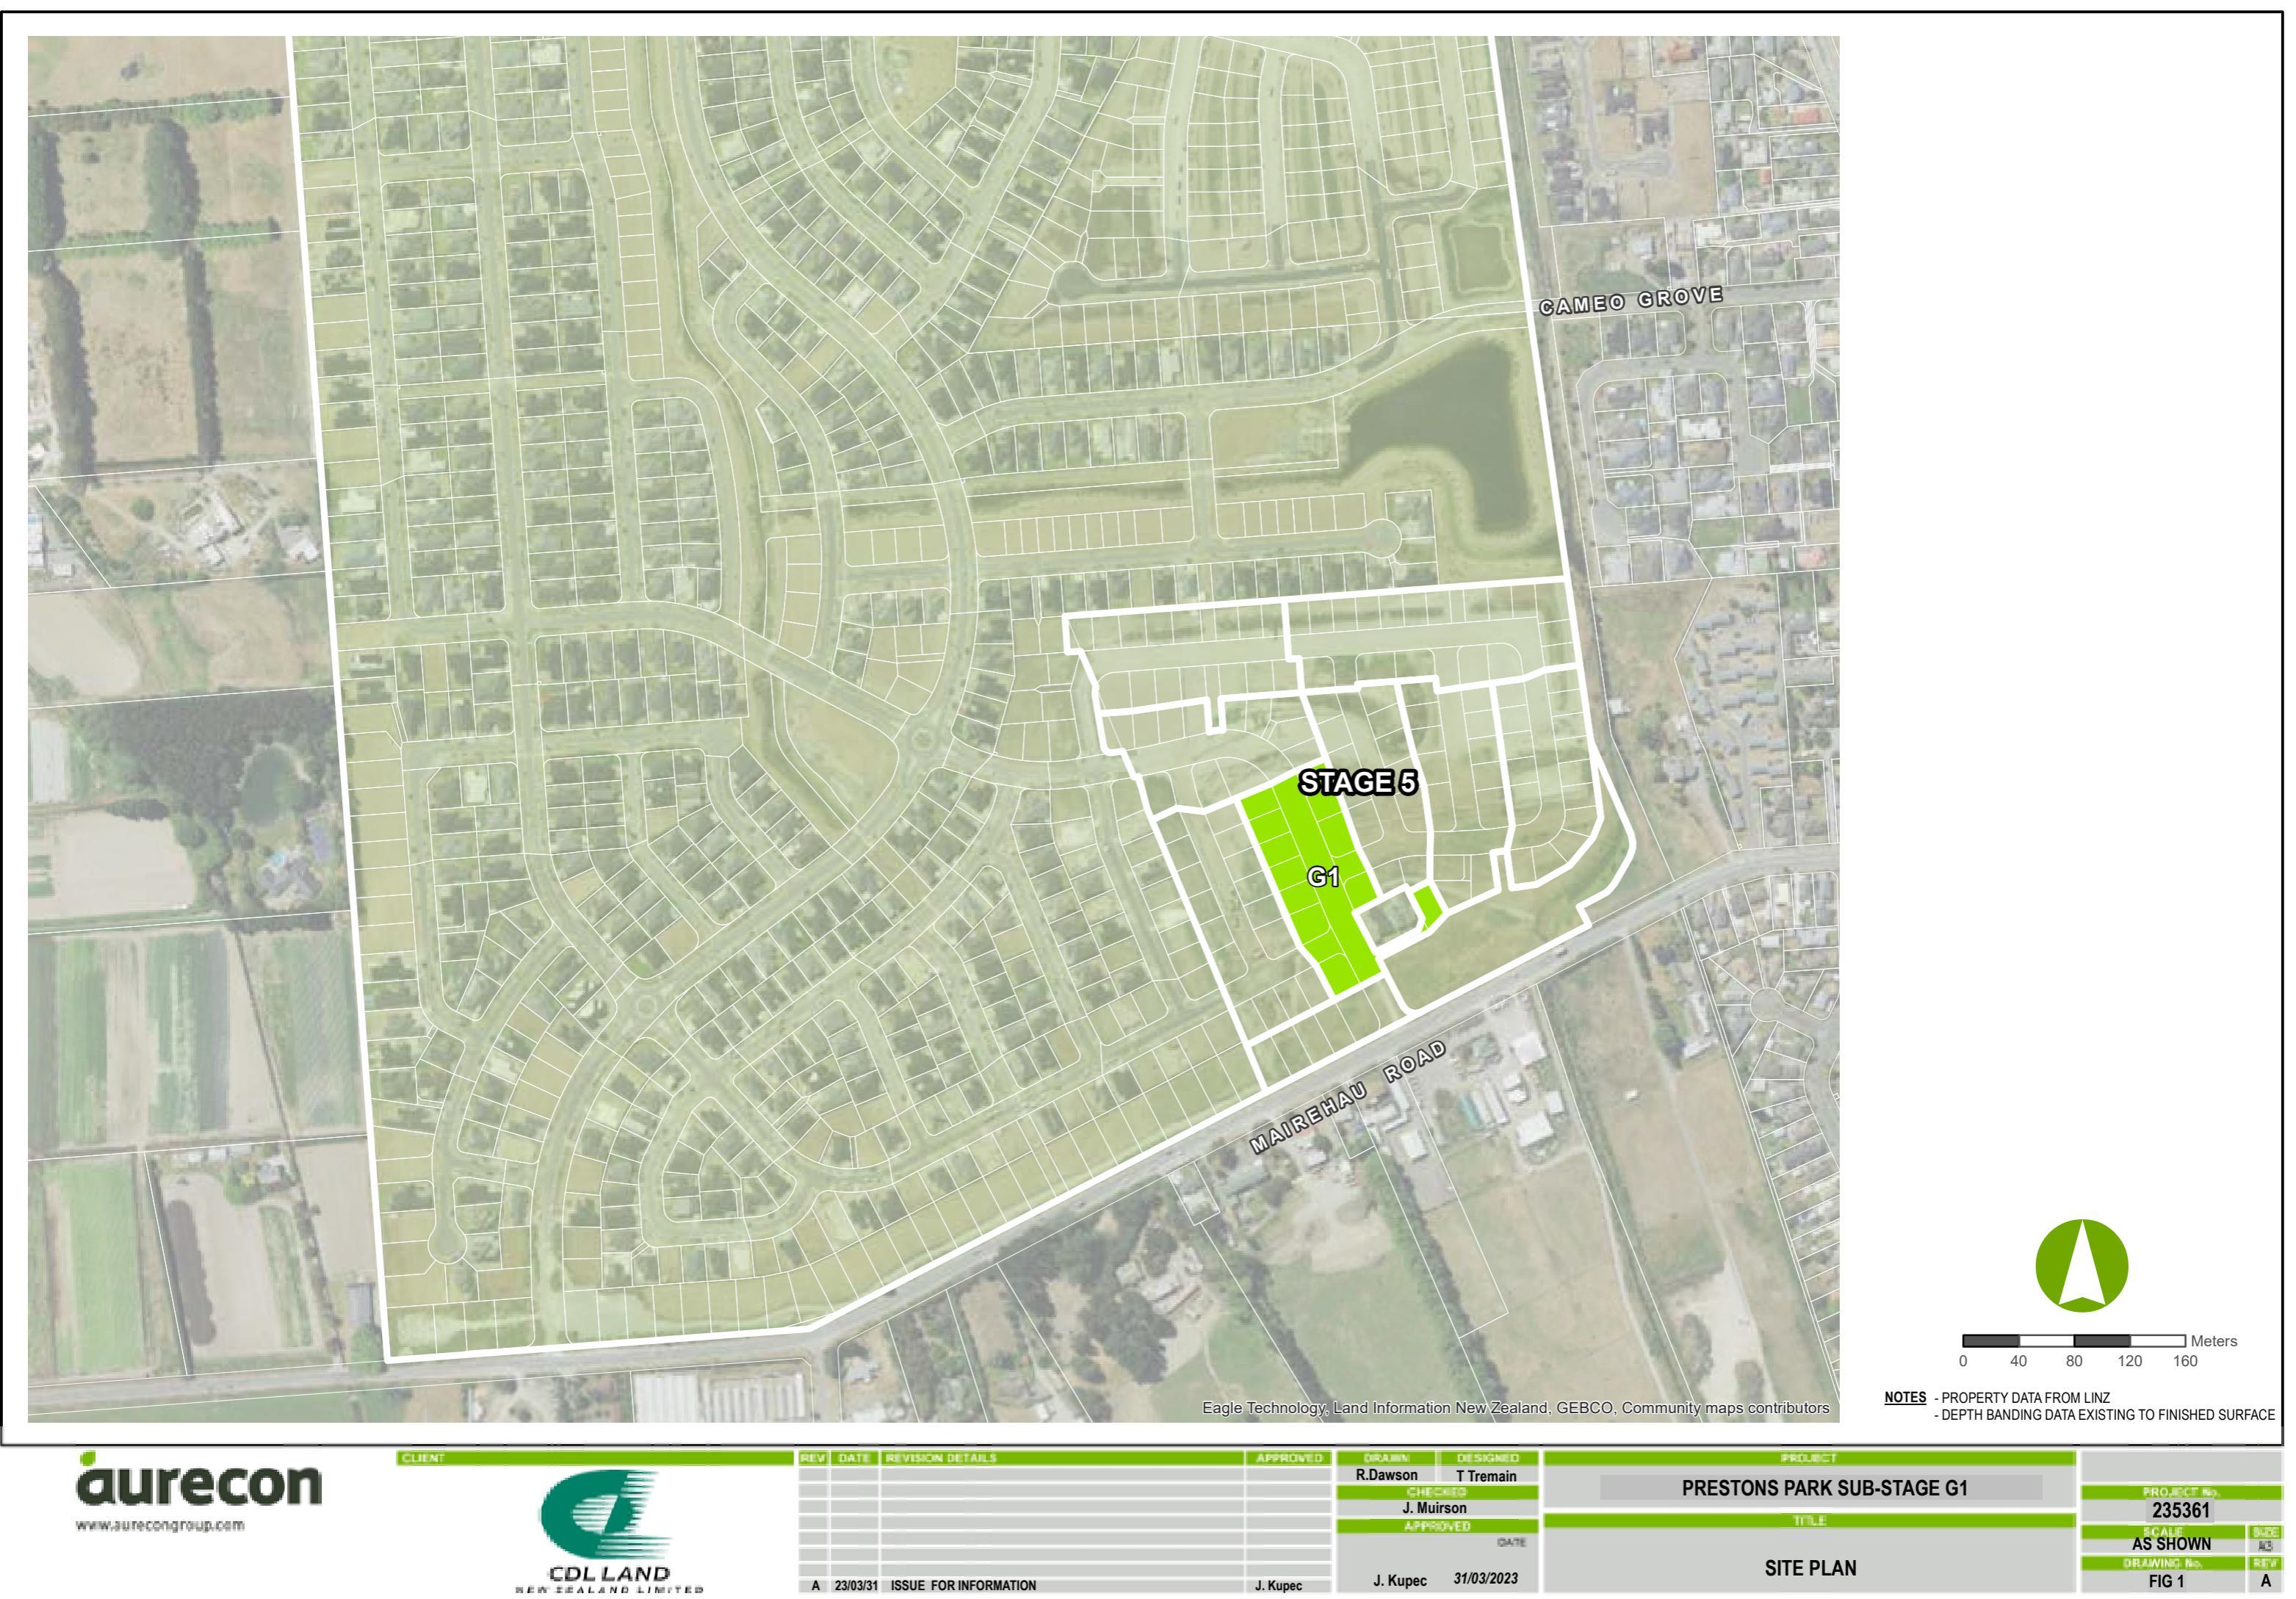
This report has been prepared for CDL Land New Zealand Limited and issued to Christchurch City Council (CCC). It describes the earthworks involved within Stages H1, G1 and G2 of the Prestons Park Subdivision (see Figure 1 in Appendix A1, A2 & A3 respectively).

The focus of this geotechnical completion report is on Stages H1, G1 & G2 of the Prestons Park Subdivision. Stages H1, G1 & G2 incorporates a block in the southeast part of the Prestons Park Subdivision (see Figure 1 in Appendix A1, A2 & A3 respectively).

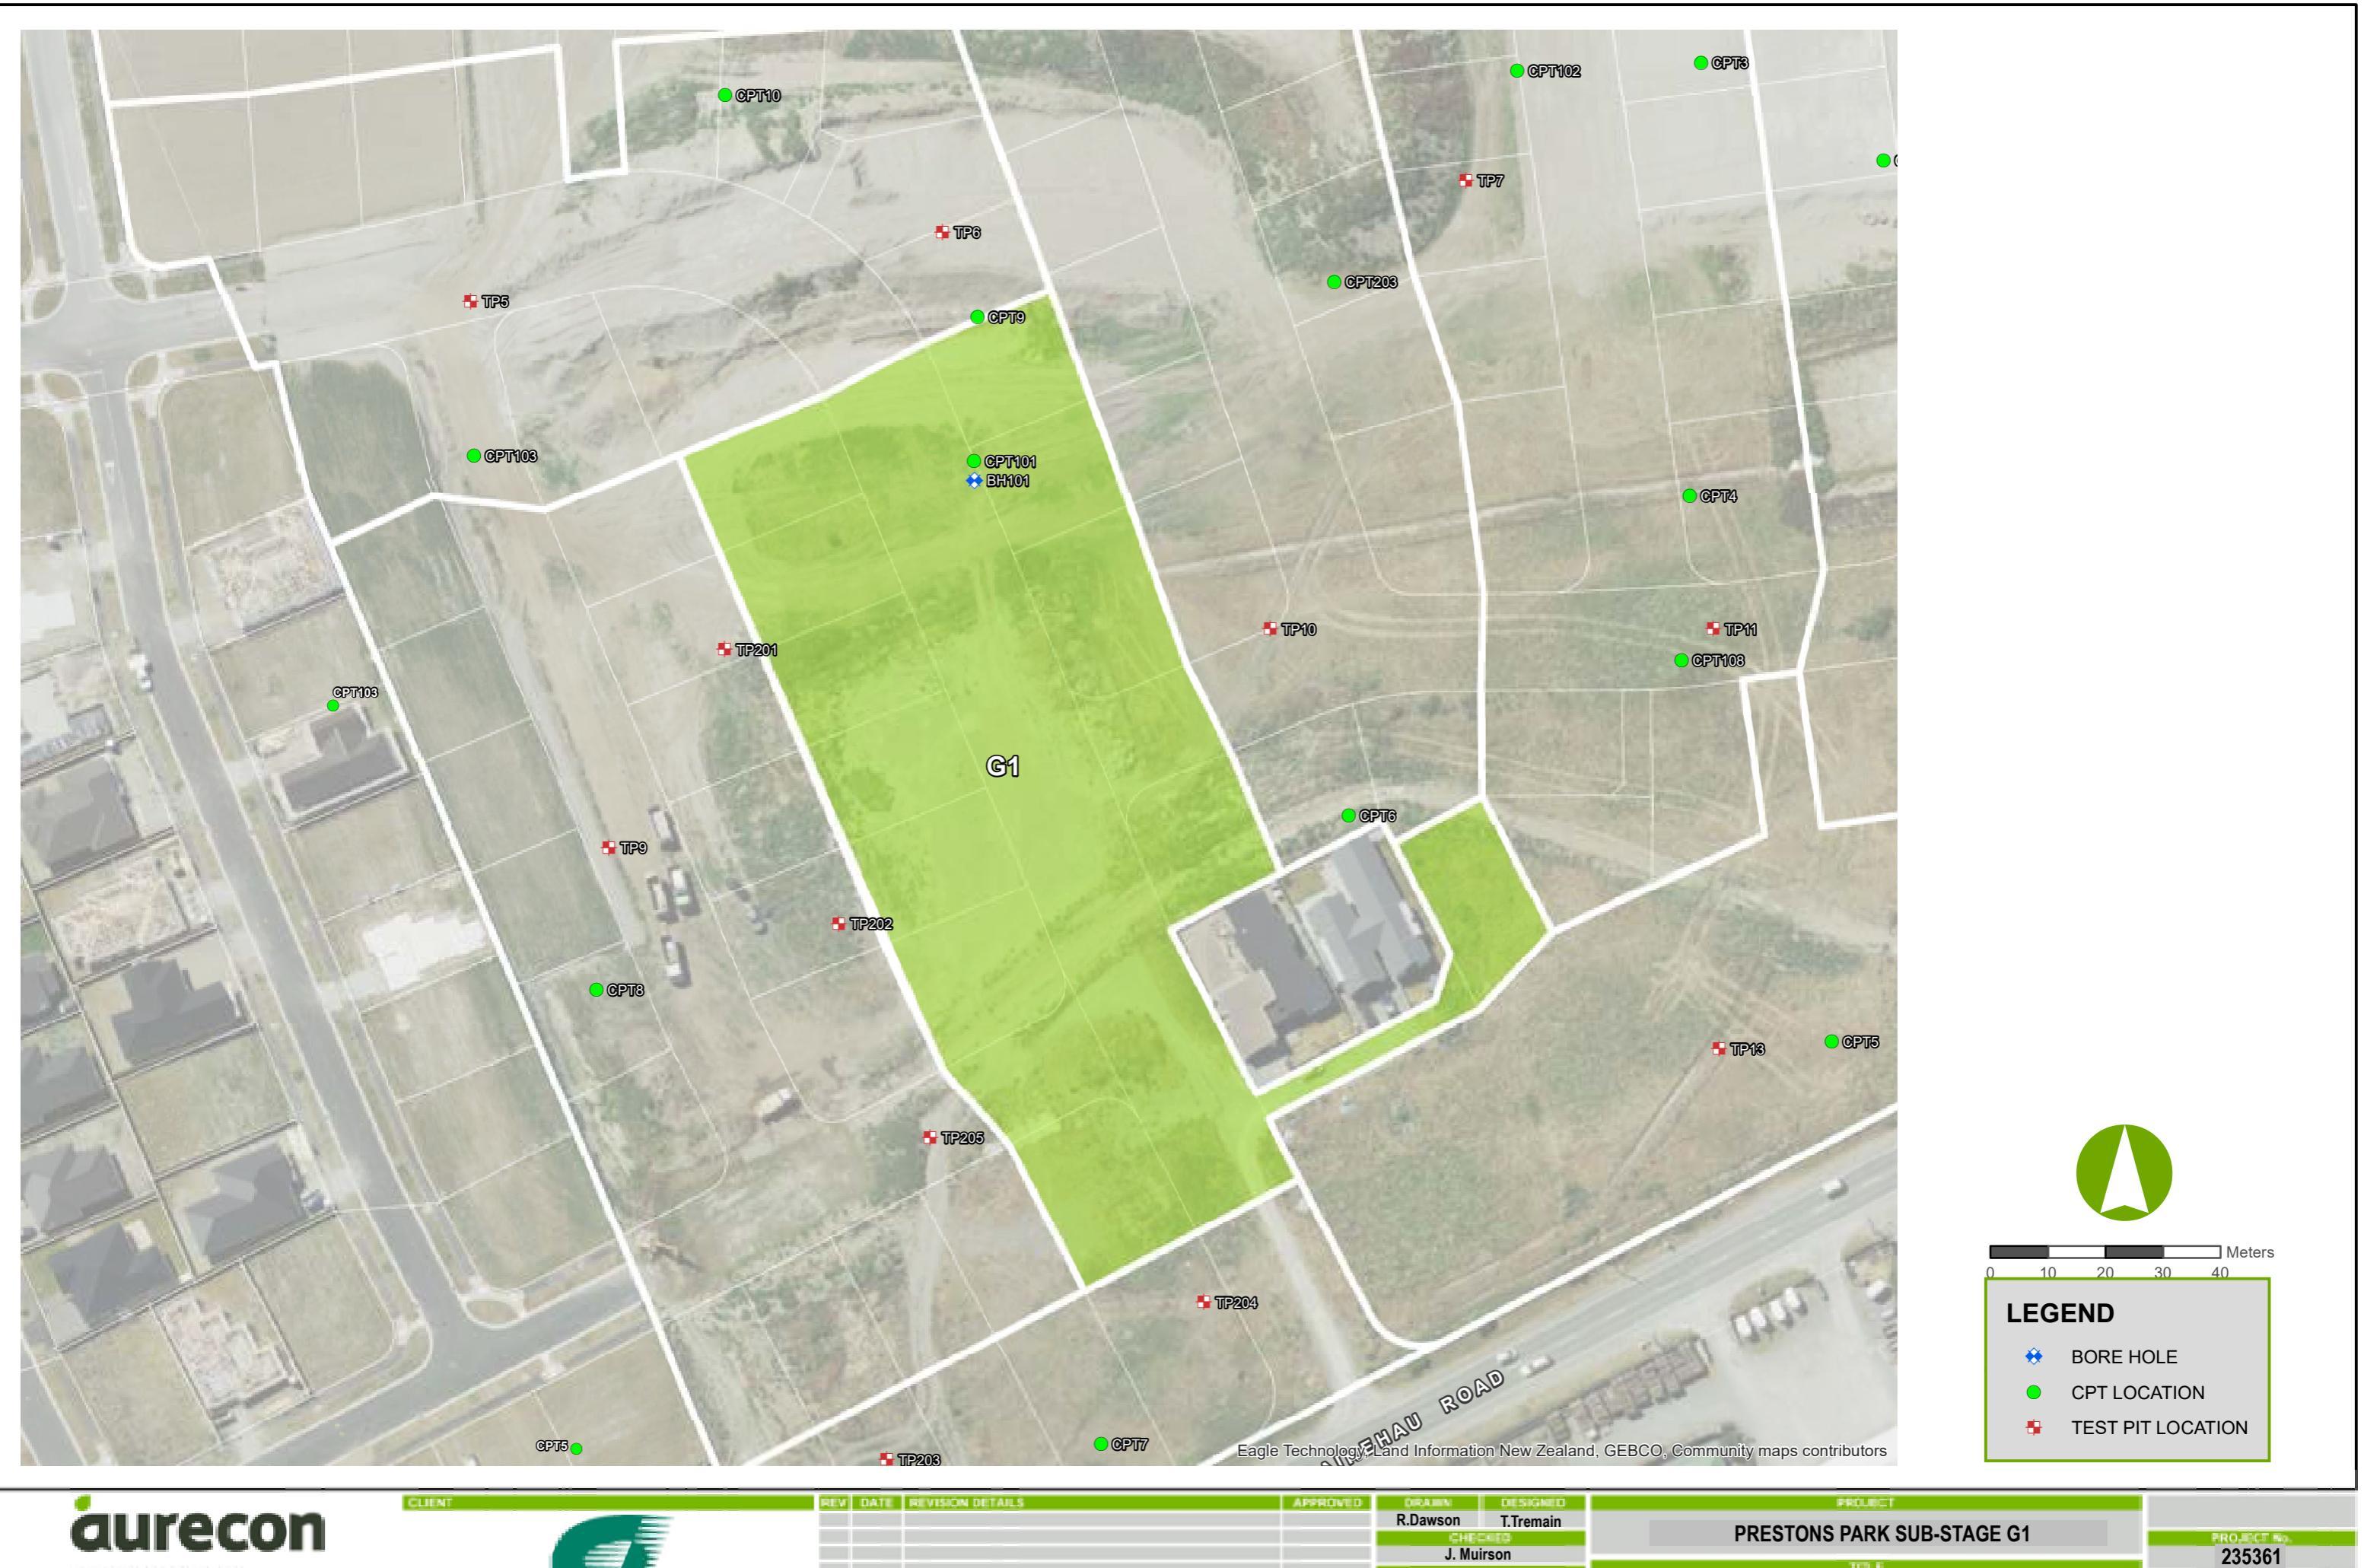
FIG 2

The investigation tests carried out within Stages H1, G1 & G2 of the Prestons Park area are presented in Figure 2 in Appendix A1, A2 & A3 respectively.

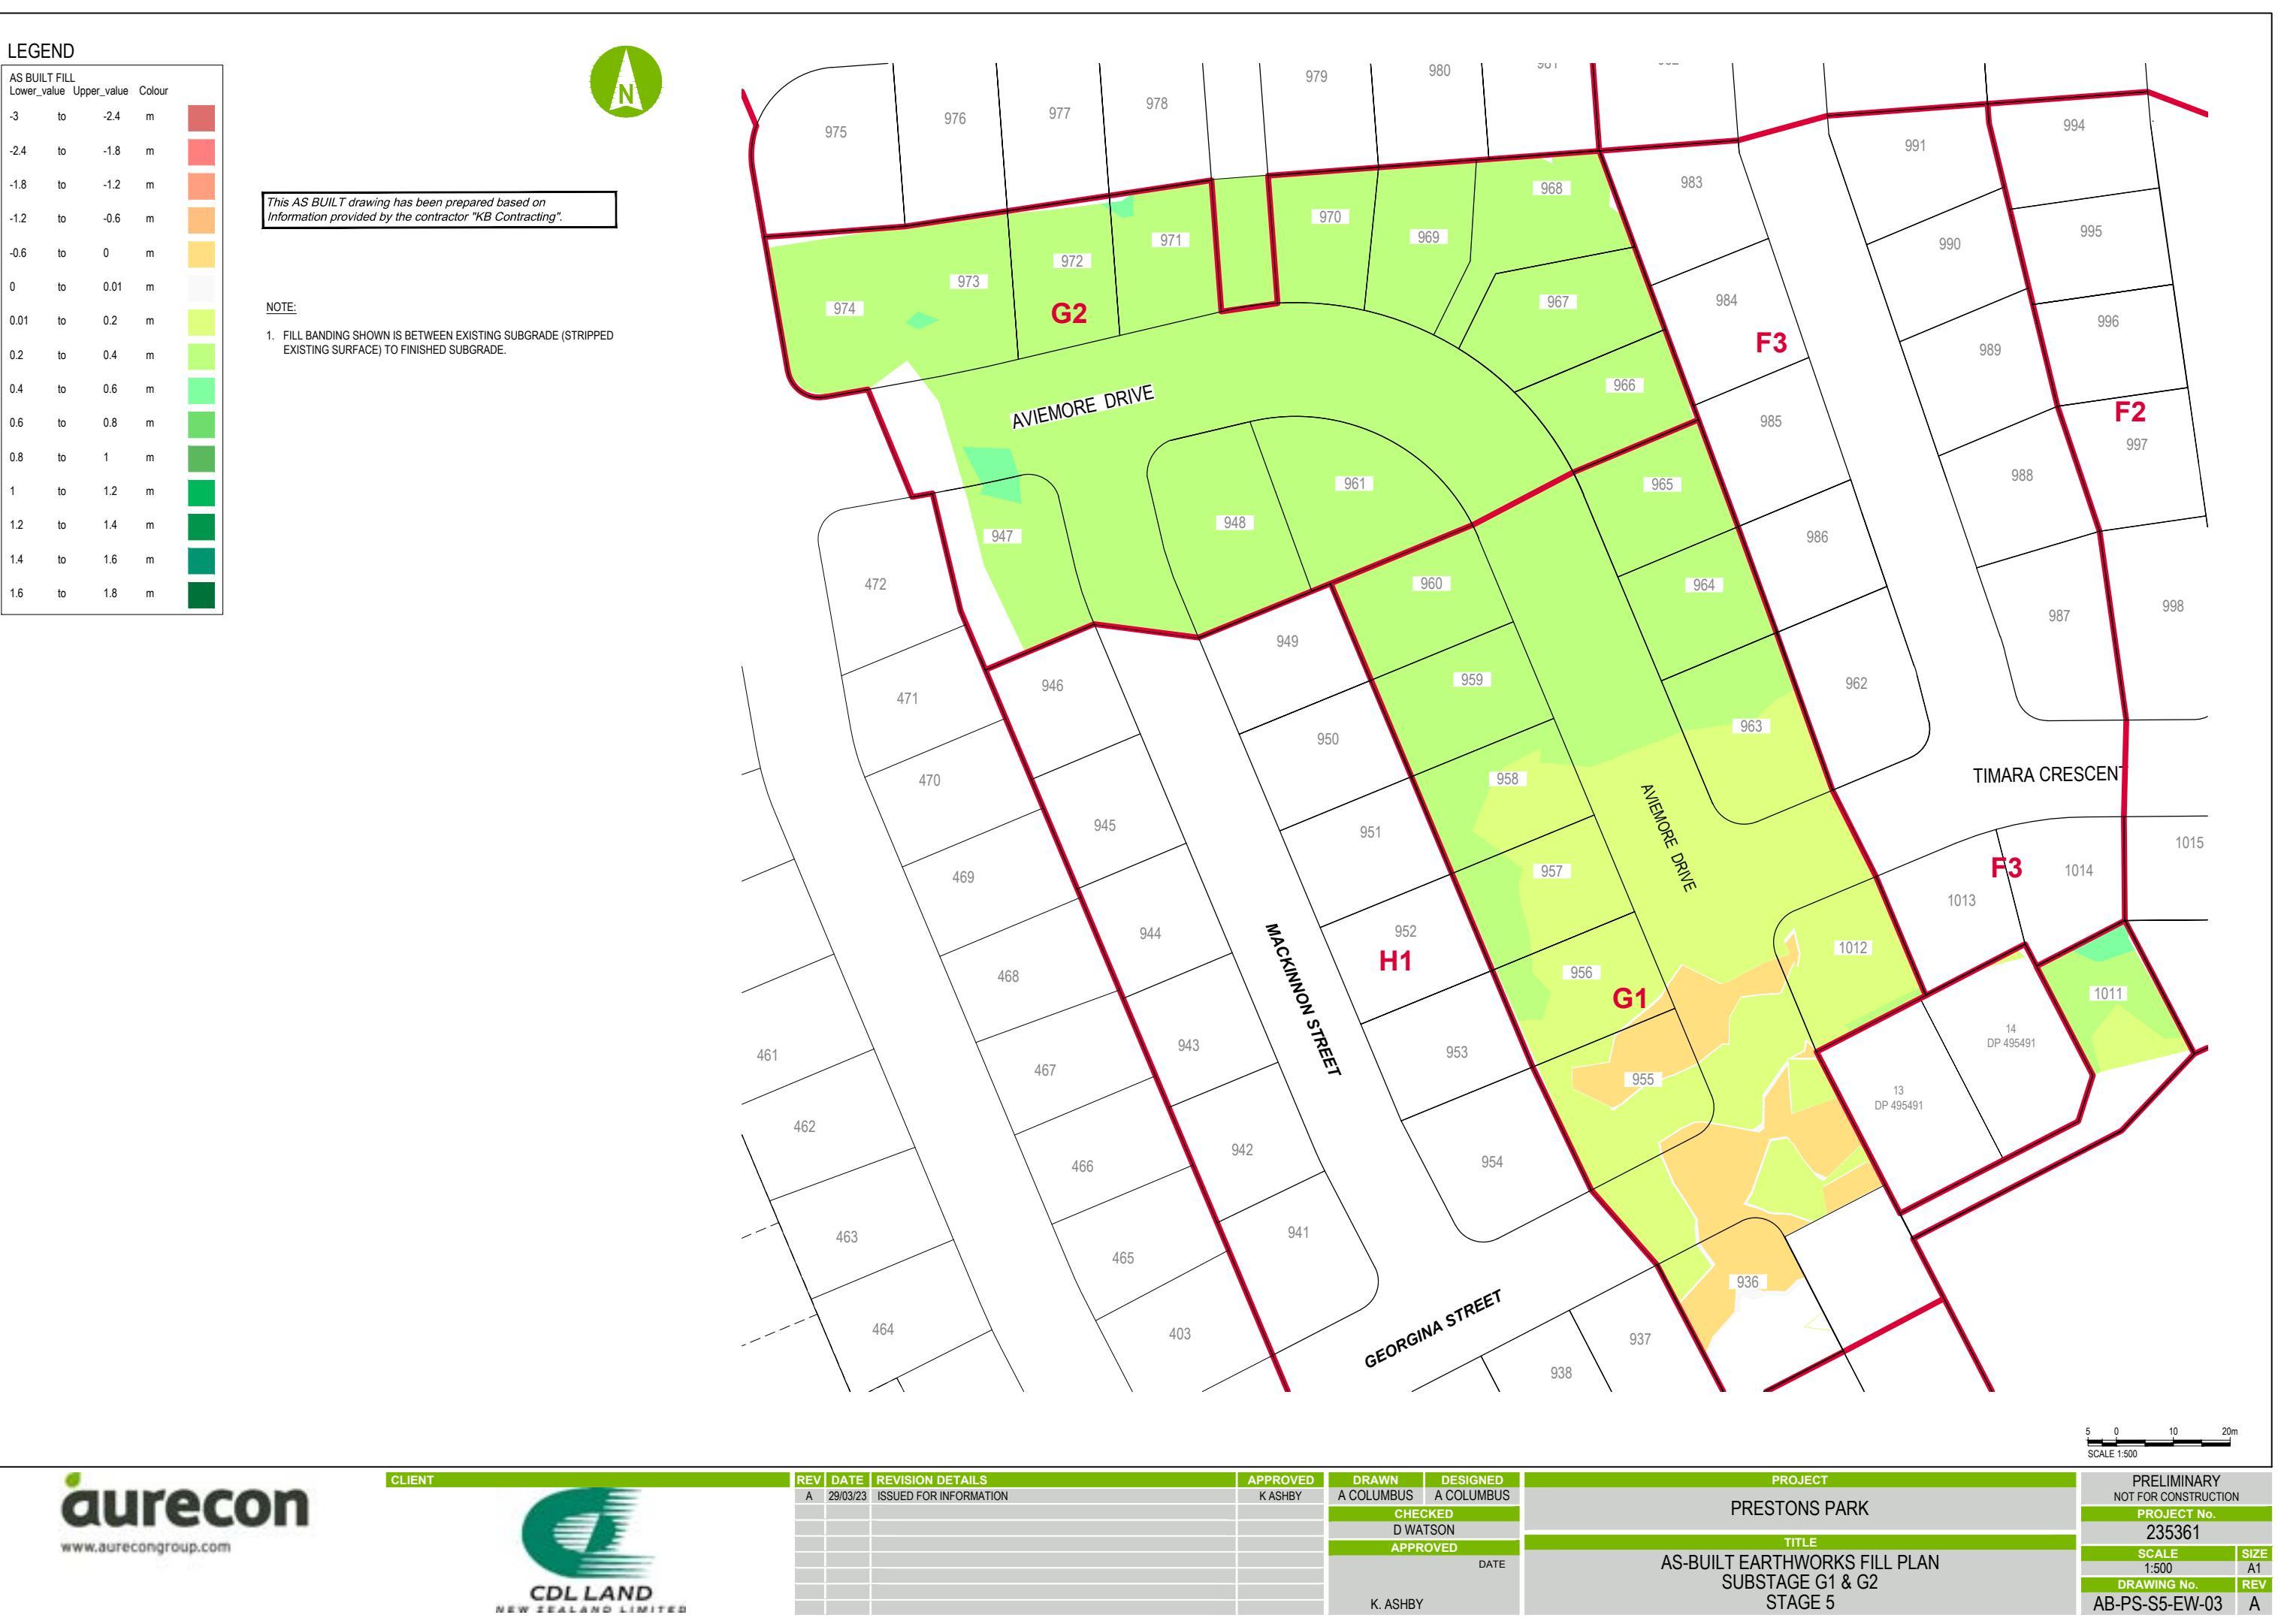
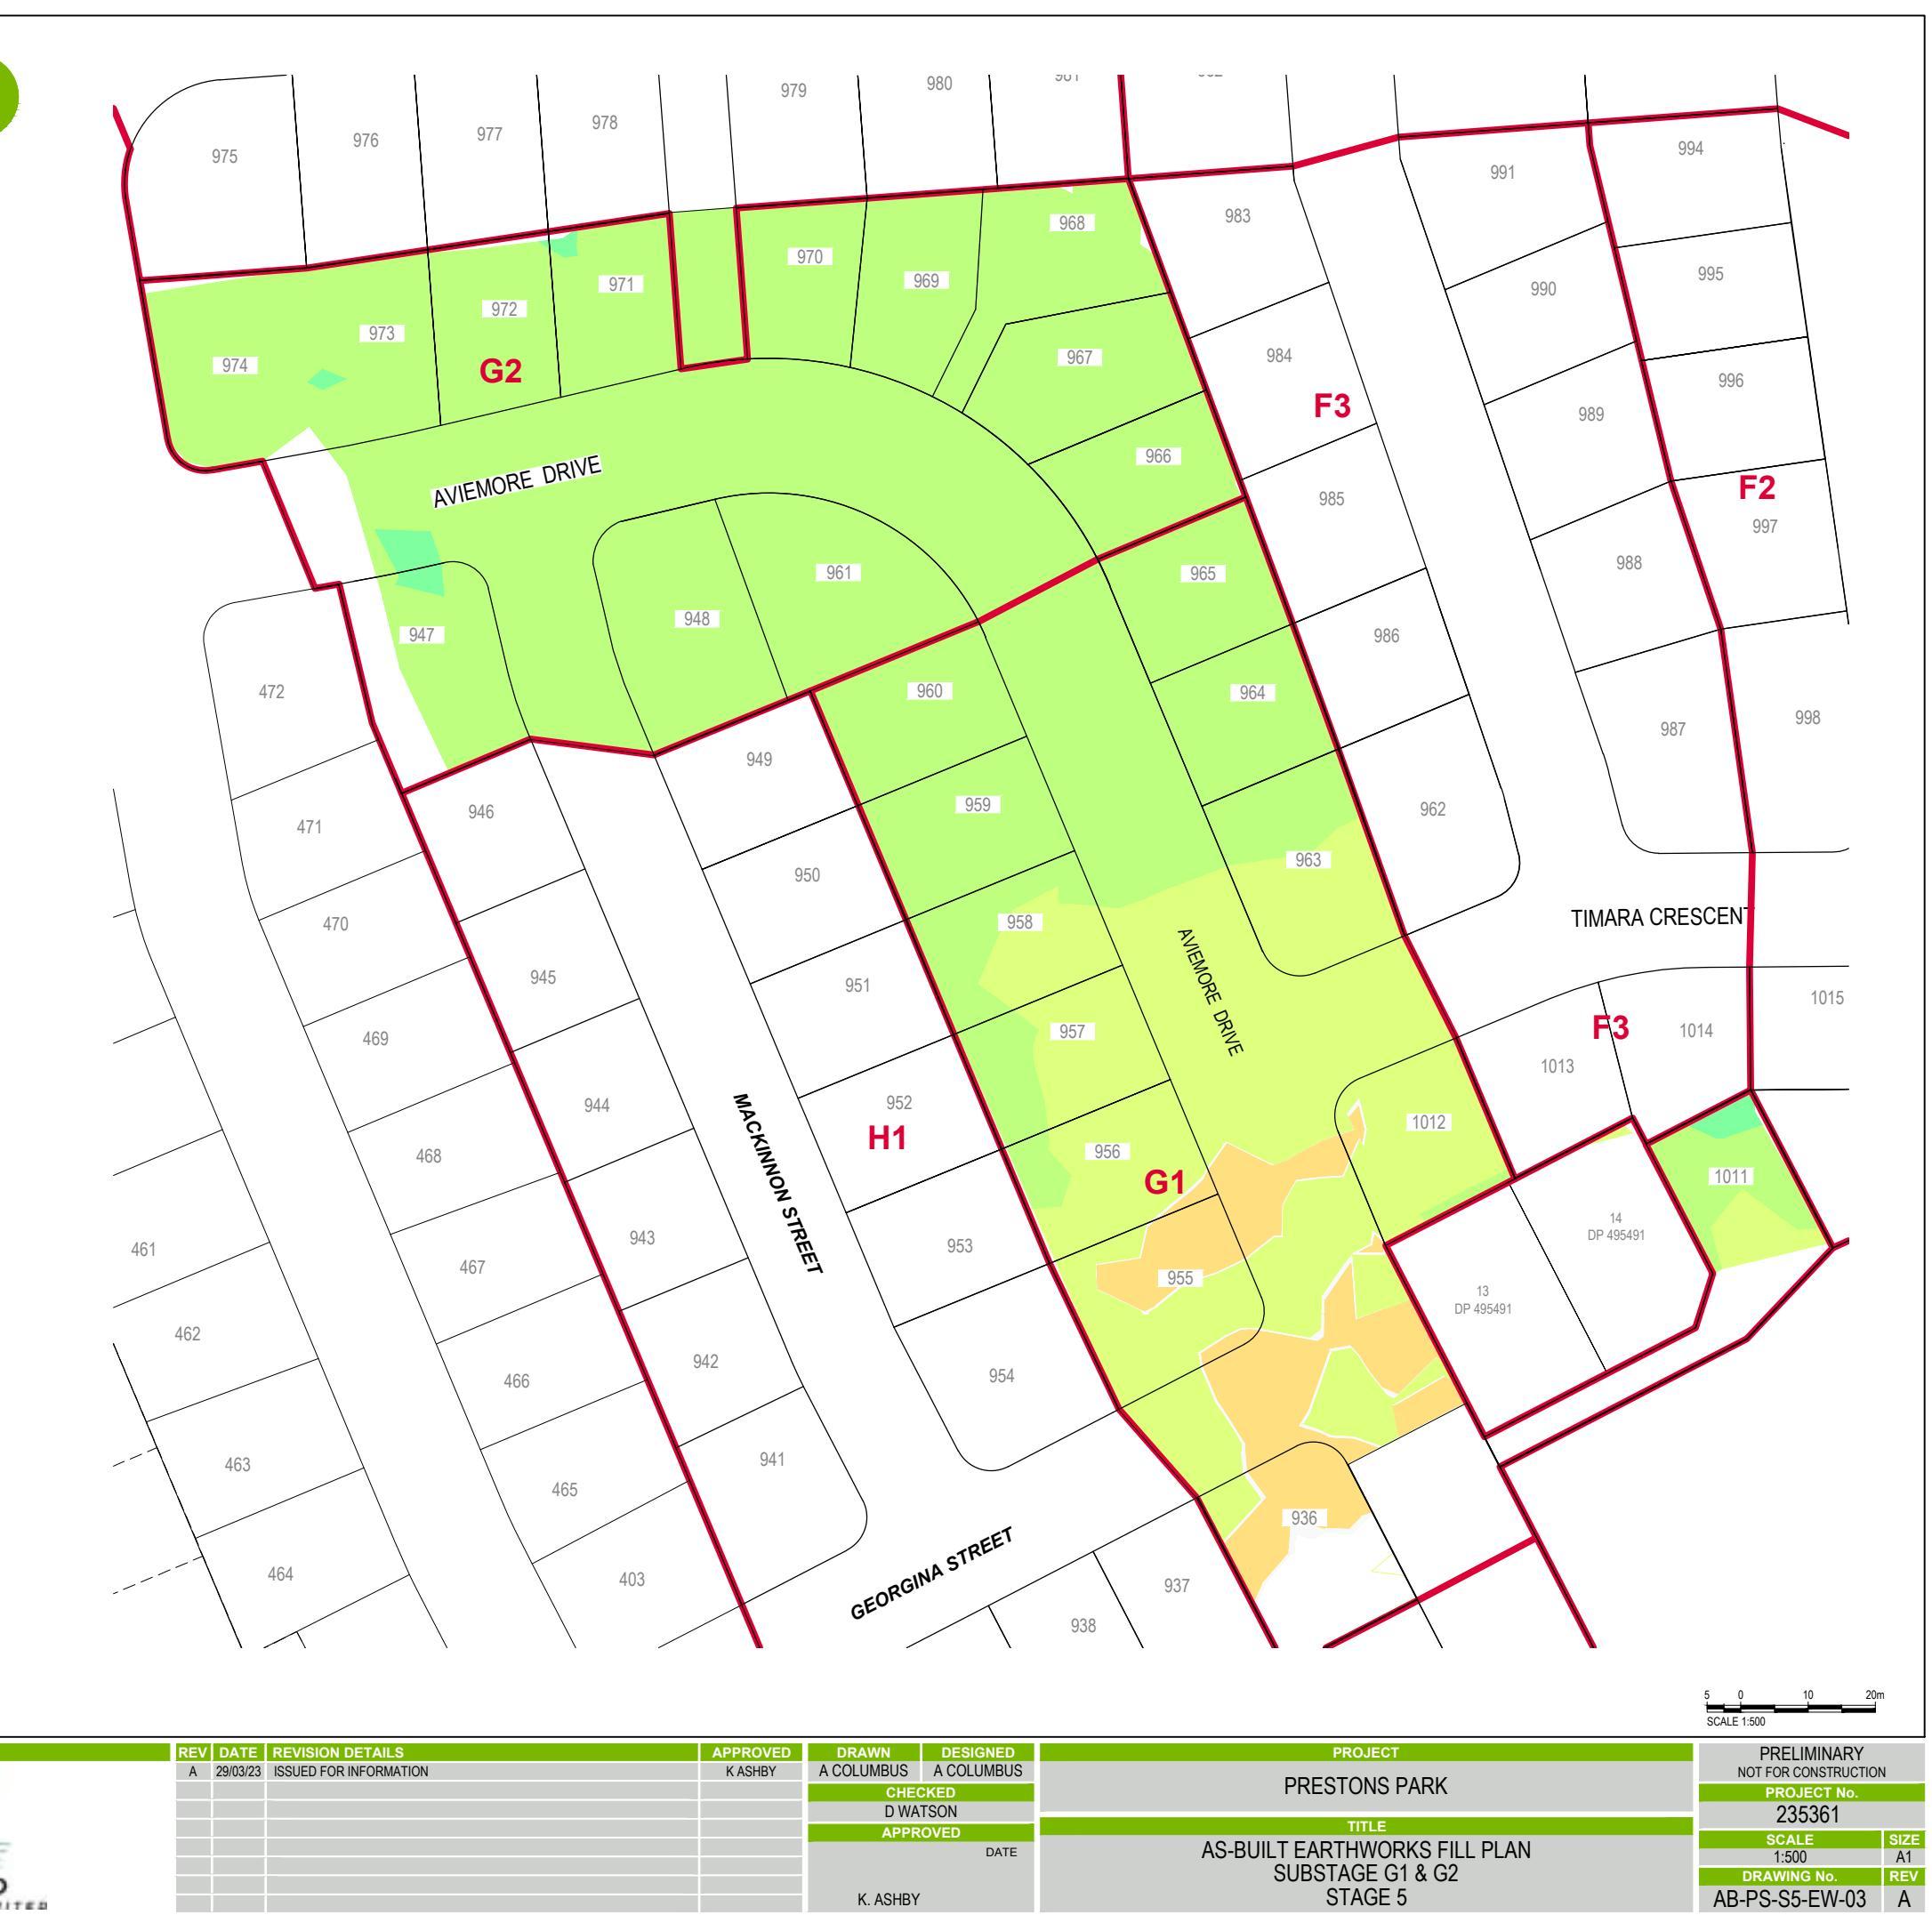
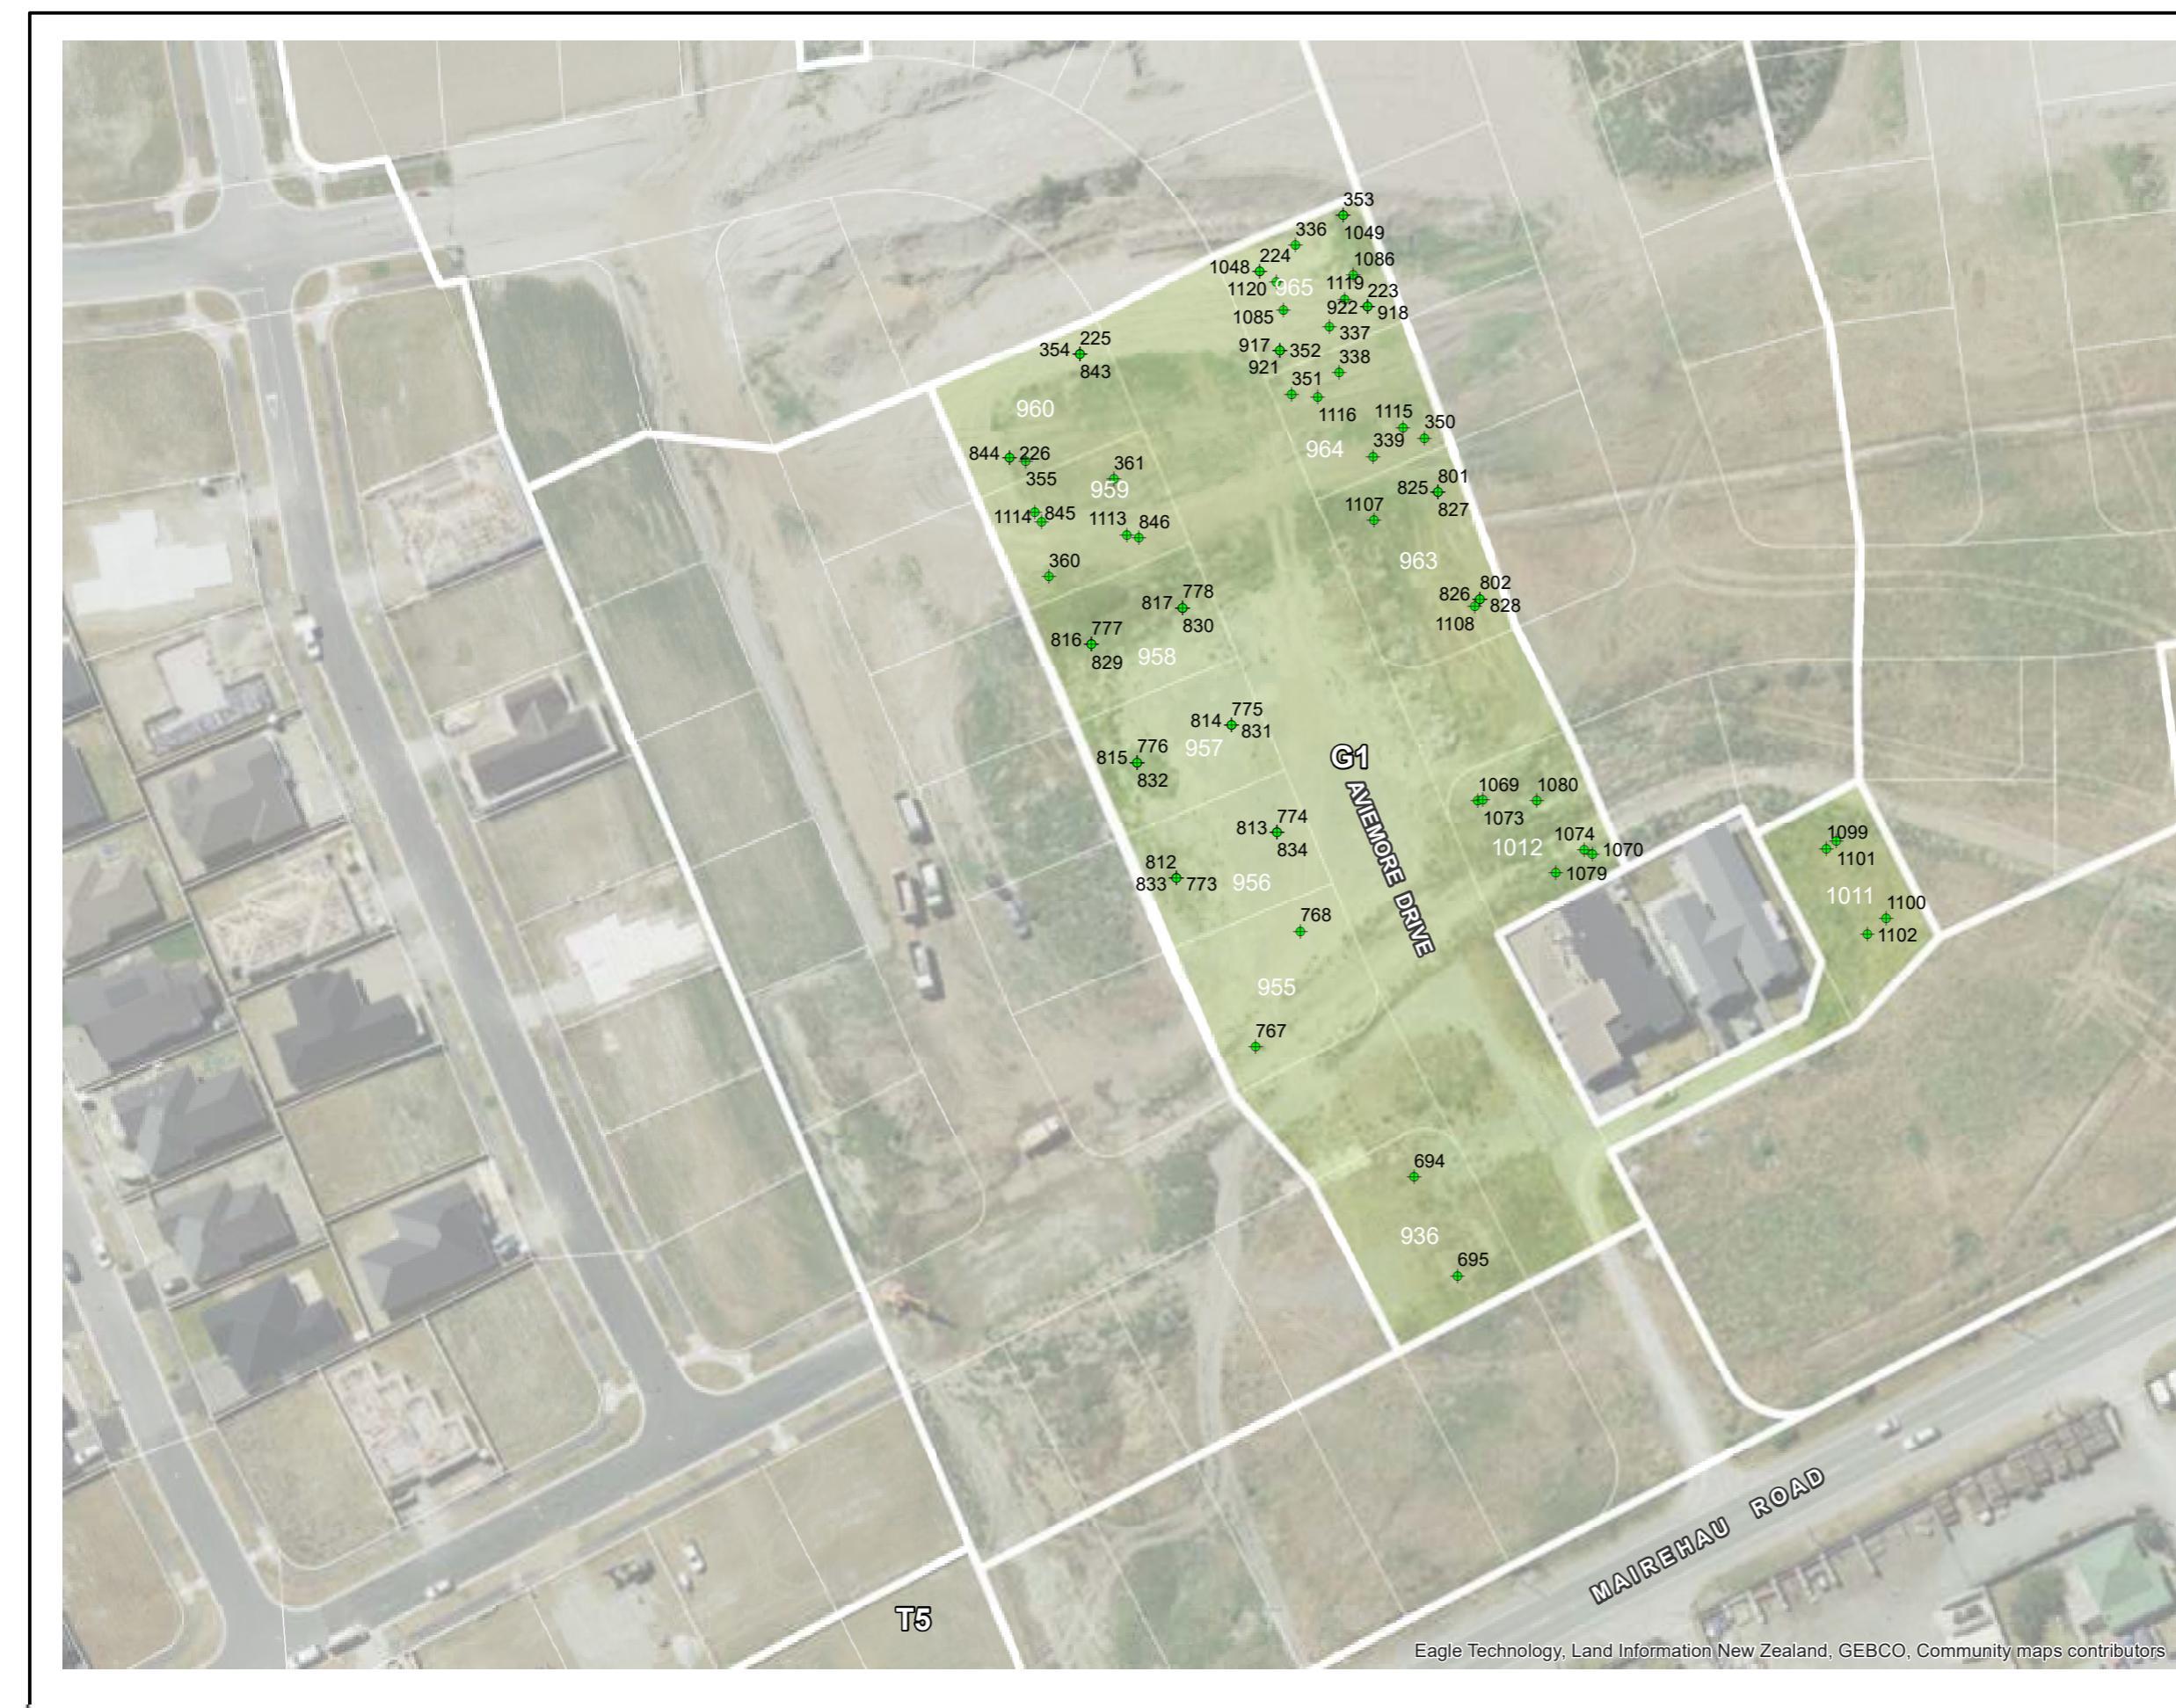
Site earthworks within Stages H1, G1 and G2 have included predominantly filling in comparison to the site subgrade levels with some minor cuts. The fill material comprises site-won sand and pit run gravel overlying a natural sand subgrade. A layer of topsoil overlies the fill material. The extent of filling is shown in AB-PS-S5-EW-03 in Appendix A1, A2 & A3 respectively.

The extent of earthfill on the lots in Stages H1, G1 and G2 is shown on AB-PS-S5-EW-03 in Appendix A1, A2 & A3 respectively.

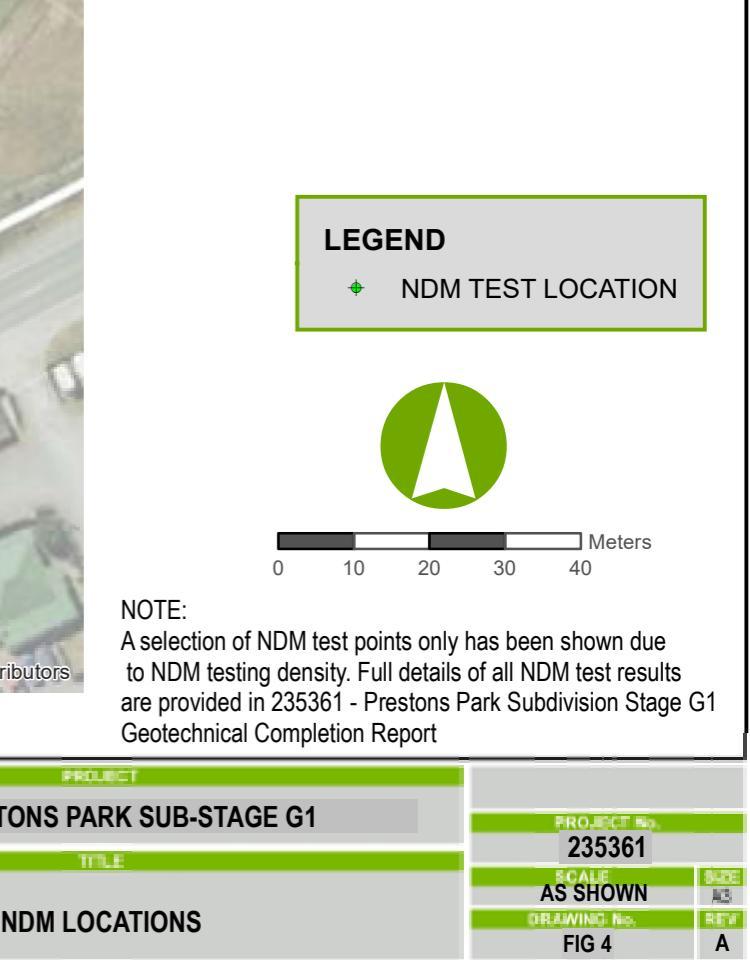
FIG 4

The MDD from the compaction curves were used to determine the level of compaction required for the fill material. A summary of these NDM results is presented in Appendix C and the NDM testing locations are presented in Figure 4 in Appendix A1, A2 & A3 respectively.

The results presented in Appendix C indicate that 95% MDD or greater compaction has been consistently achieved in the areas of bulk fill. Where NDM results indicated the required compaction had not been achieved, the Contractor completed additional compaction effort and conforming NDM results were achieved. From these results and our site observations, we confirm that the earthfill placed within Stages H1, G1 and G2 have achieved the required compaction.
