# **Prestons Park Subdivision**

Geotechnical Report for Lot 8 Cameo Grove

**CDL Land New Zealand Ltd**

Reference: 235361

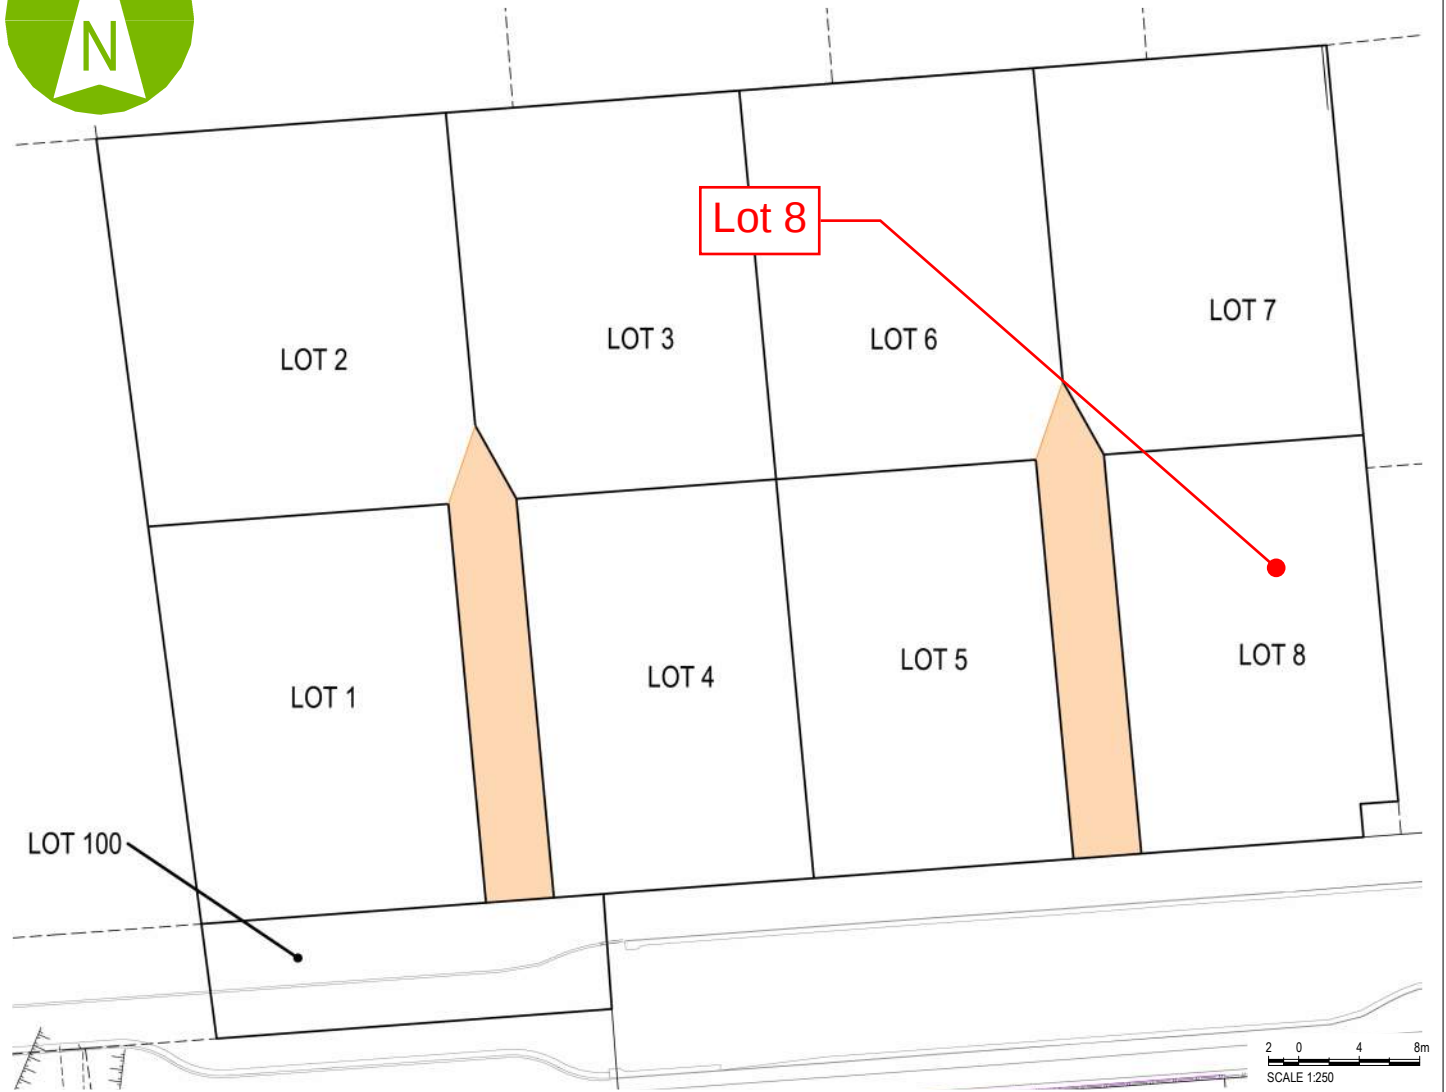
| PROJECT | CAMEO GROVE - PRESTONS |
|---|---|
| TITLE | LOT 8<br>SITE LOCATION PLAN<br>FIGURE 1 |

This building consent report is for Lot 8 which is located in the Cameo Grove extension of the Prestons Park Subdivision development (refer Figure 1 in Appendix A). The lot is bordered by residential lots to the north, east and west, and Cameo Grove roadway to the south.

The logging of recovered hand auger samples was undertaken by an Aurecon engineering geologist in accordance with the New Zealand Geotechnical Society's *Guideline for the Field Classification and Description of Soil and Rock for Engineering Purposes: 2005*. The test location and log are both shown in Appendix A and Appendix B, respectively.

Two DCPs were conducted around the lot as part of the geotechnical investigation to assess the upper soil profile. One of the DCPs was located adjacent to the hand auger borehole, with the second DCP located on the opposite half of the lot. The test locations and logs are all shown in Appendices A and B, respectively.
