Land Information Memorandum

Property address:
50 Prestons Park Drive

Project: Prestons Subdivision
Geotechnical Completion Report
Prestons South Stage M & N

Reference: 235361
Prepared for: CDL Land
New Zealand Ltd
Revision: 0
27 March 2015

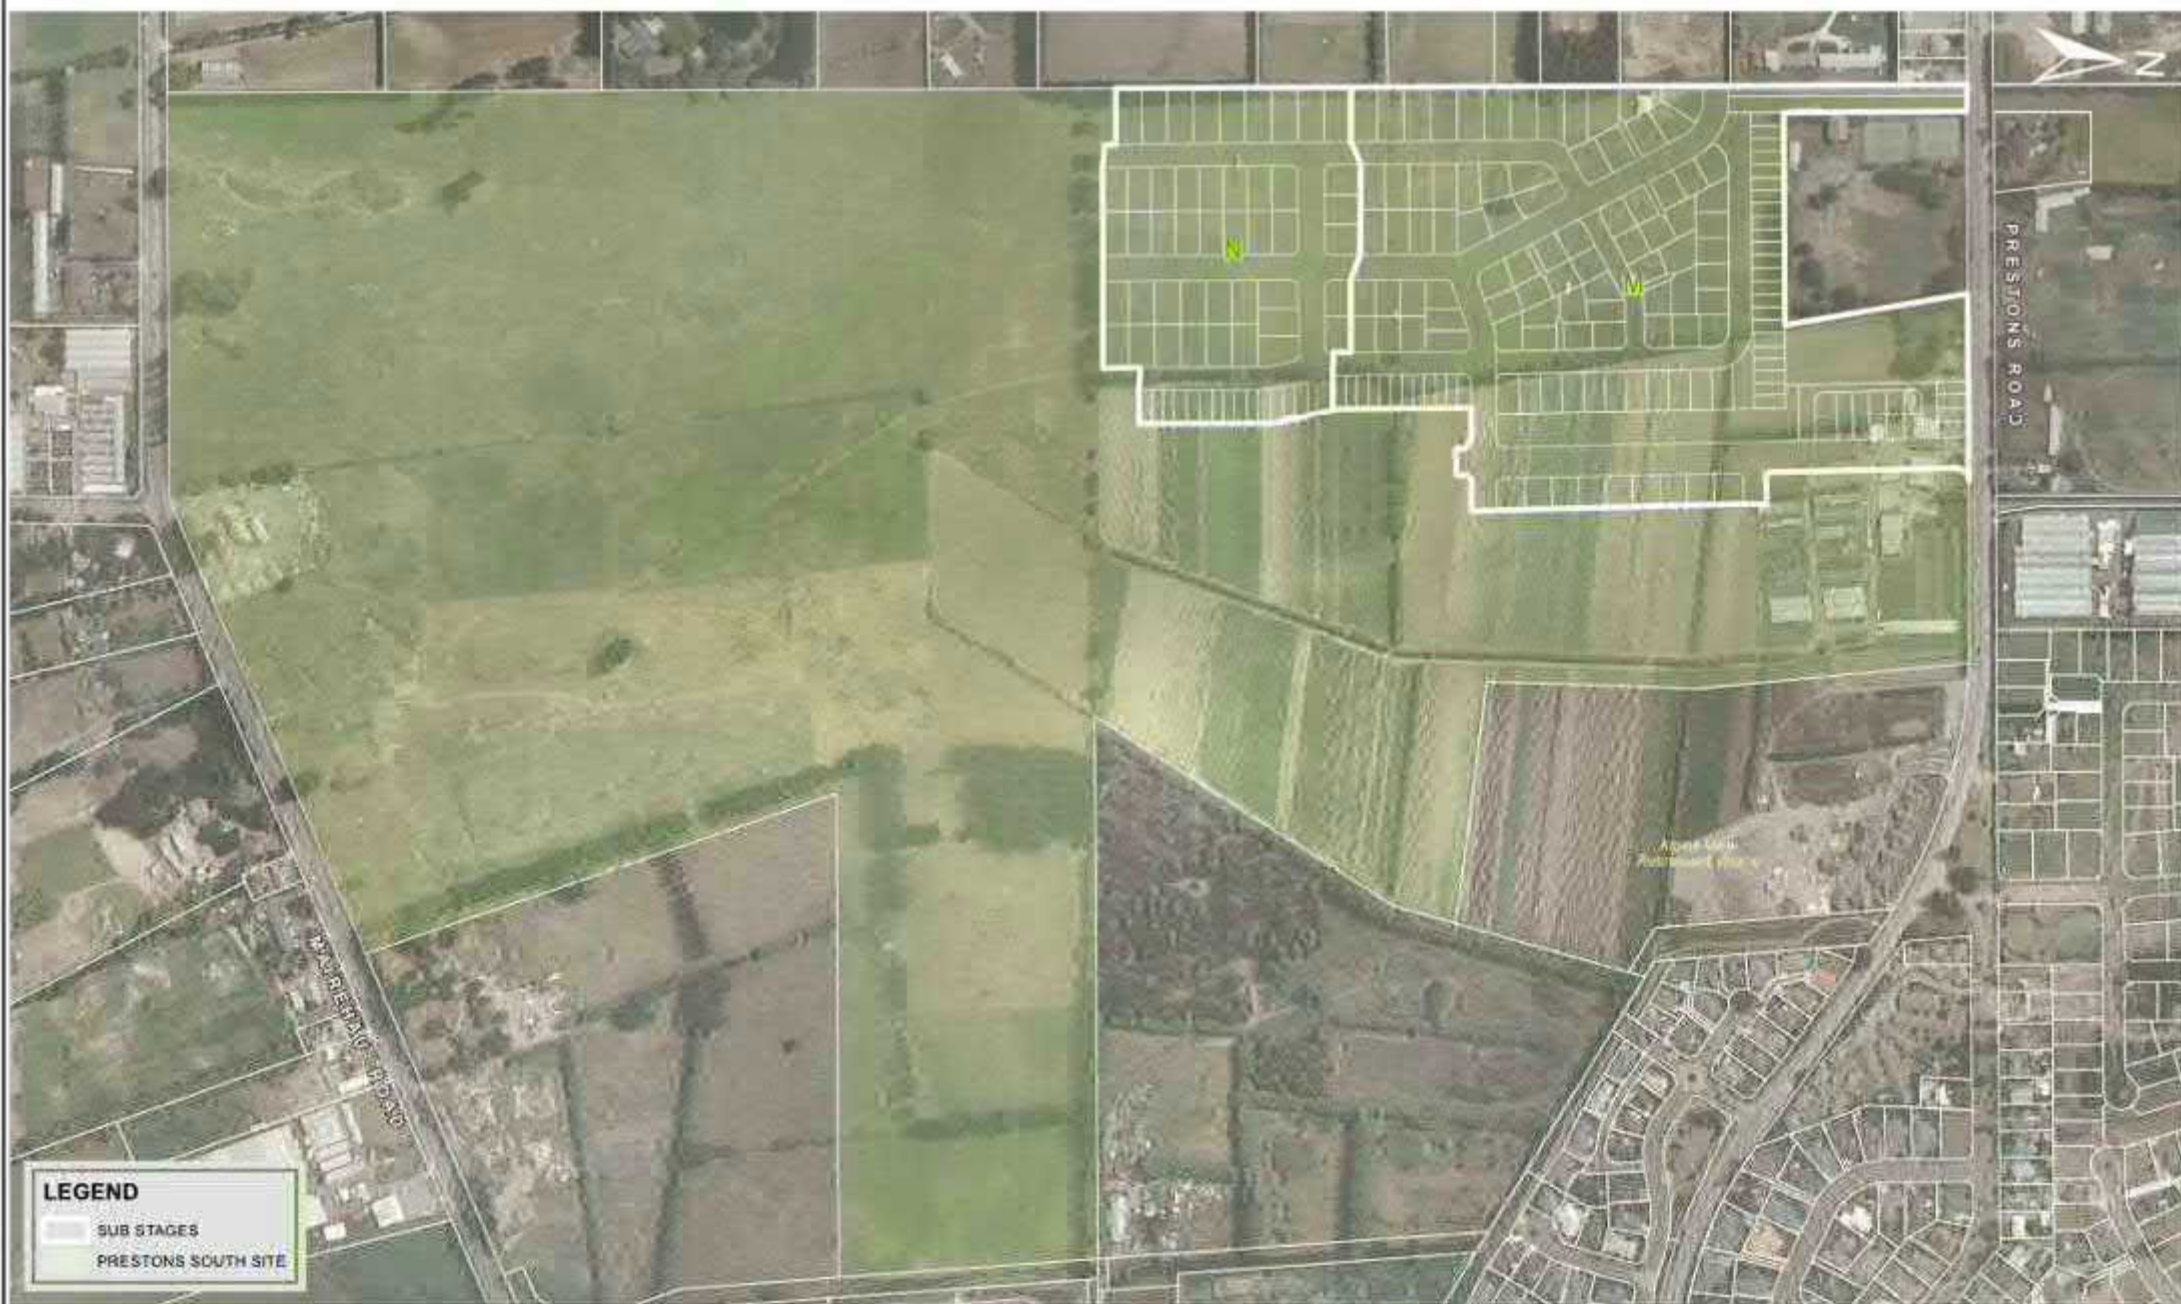
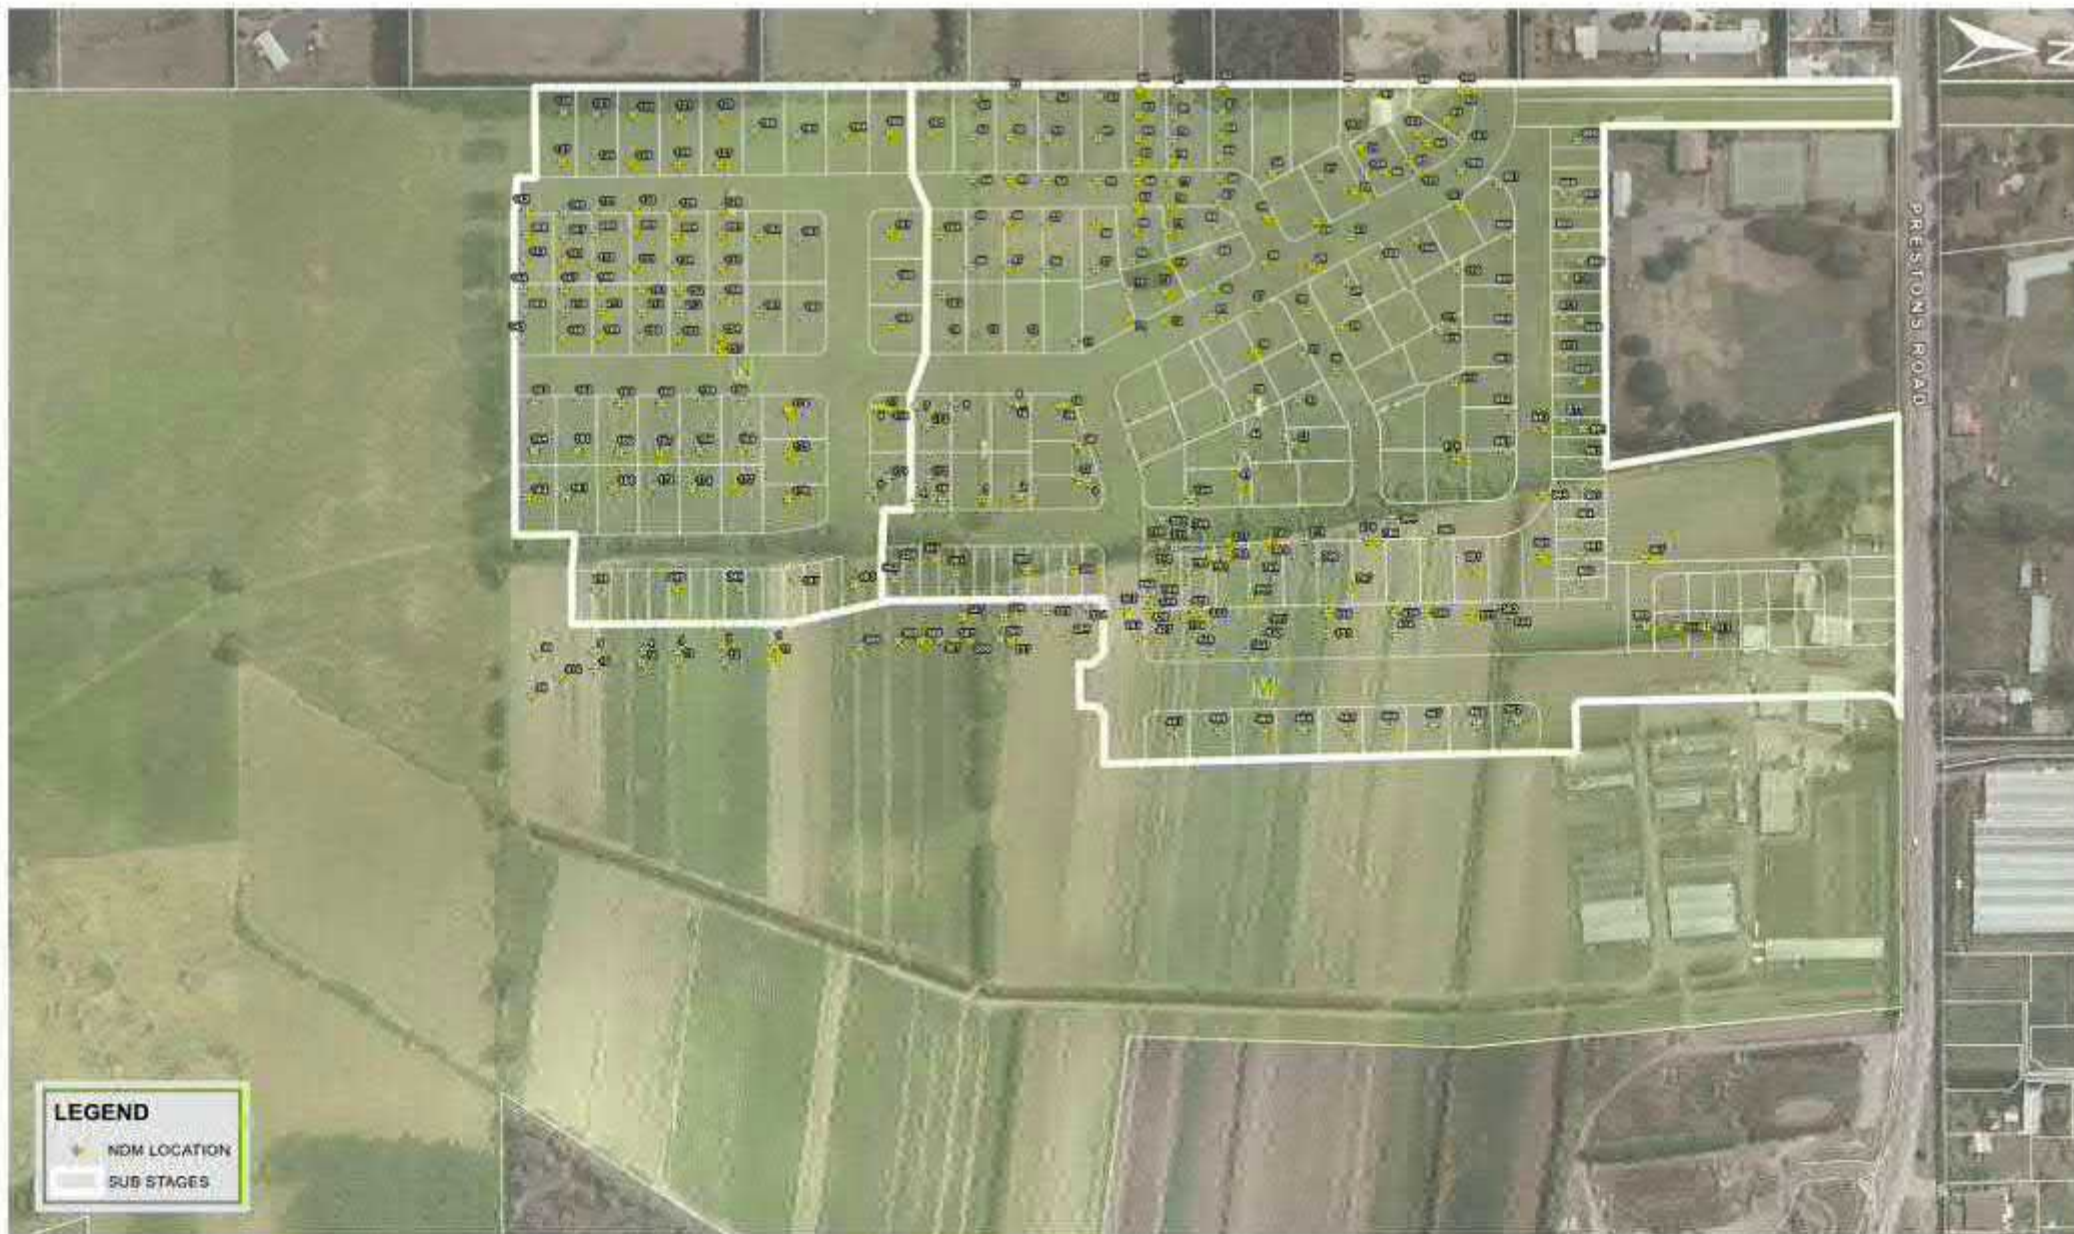
Figures

From the extensive geotechnical investigations the ground conditions within Stages M and N area were defined into various geological areas. The location of the geological area within Stages M and N is presented in Figure 2 in Appendix A. The typical ground conditions in the area are presented in Table 1. We note the geological areas numbering is the same as those used in the geotechnical reports above.

As the depth of influence for the impact compactor is approximately 3m and MBIE Guidelines (2012) recommend technical categorisation should be based on the upper 10m of the soil profile the pre-compaction and post compaction CPTs were taken to a depth of 10m. Pre-compaction CPTs are presented in Appendix C and post compaction CPTs in Appendix D. CPT locations are shown in Figure 3.

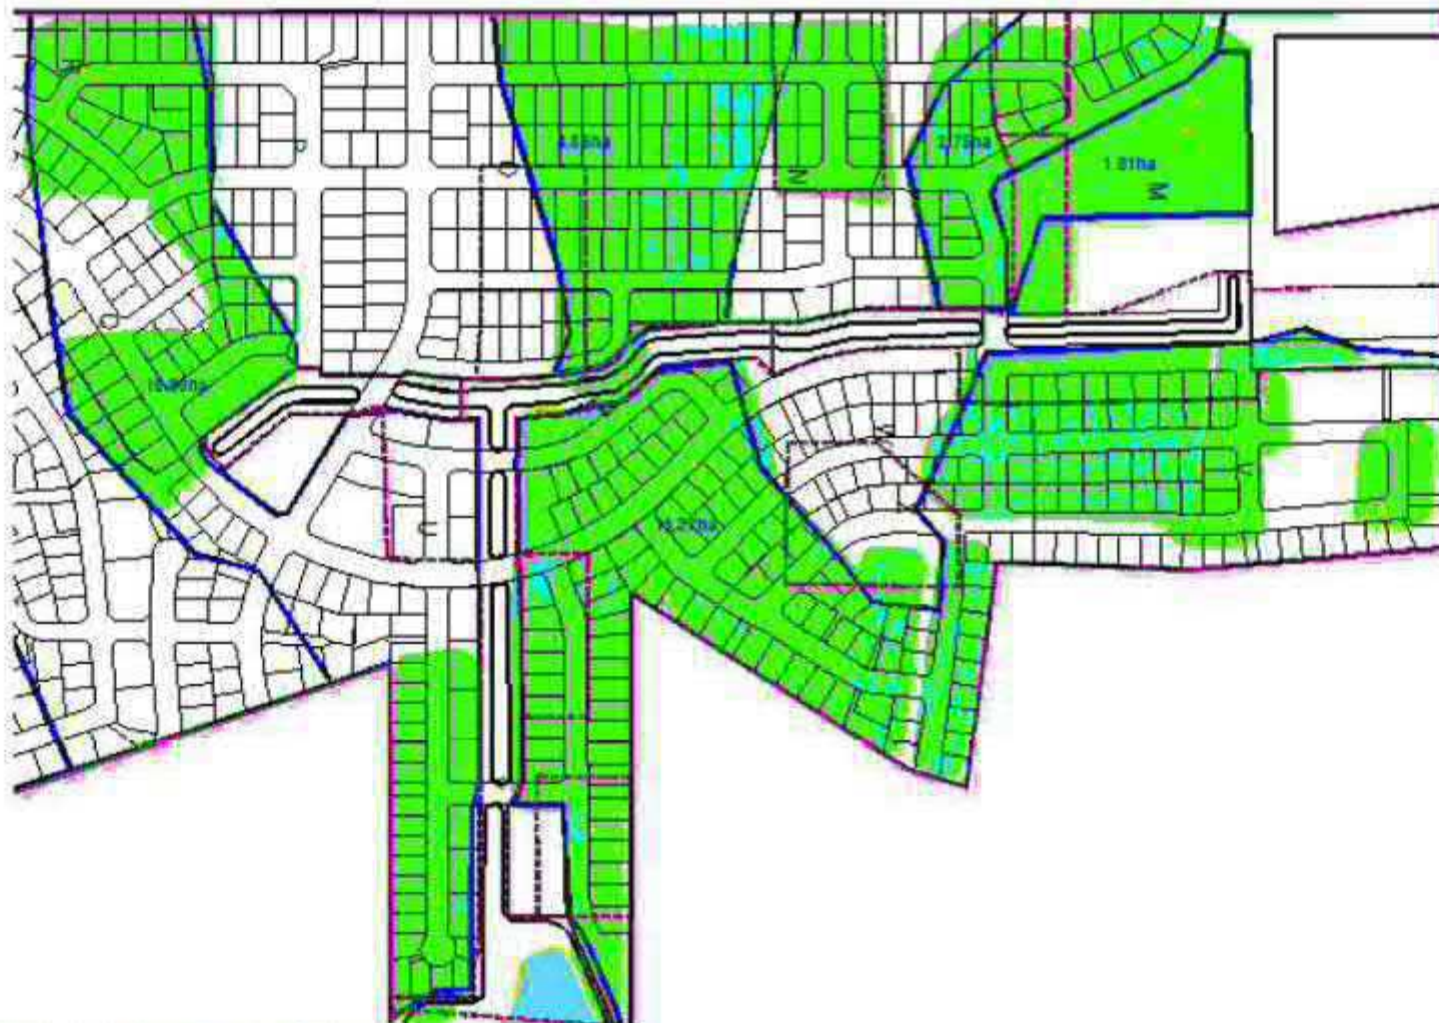
Landpac CIR

CIR SOIL RESPONSE

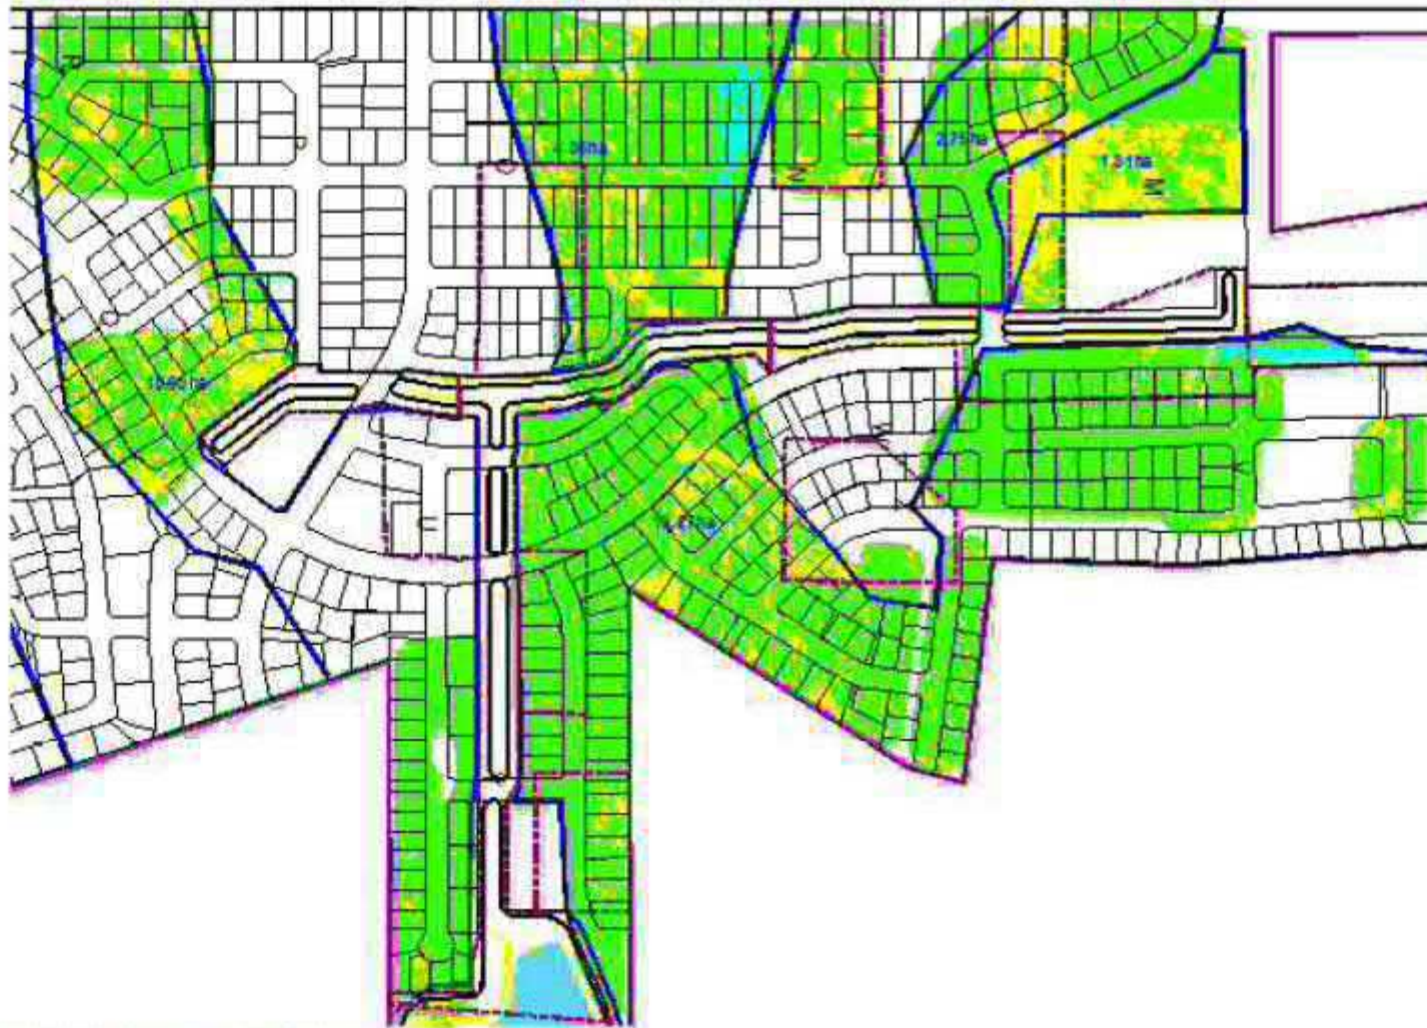
CIR SOIL RESPONSE
