# Appendix D

## Post Compaction CPT Logs

# Appendix E

## Qc Comparisons

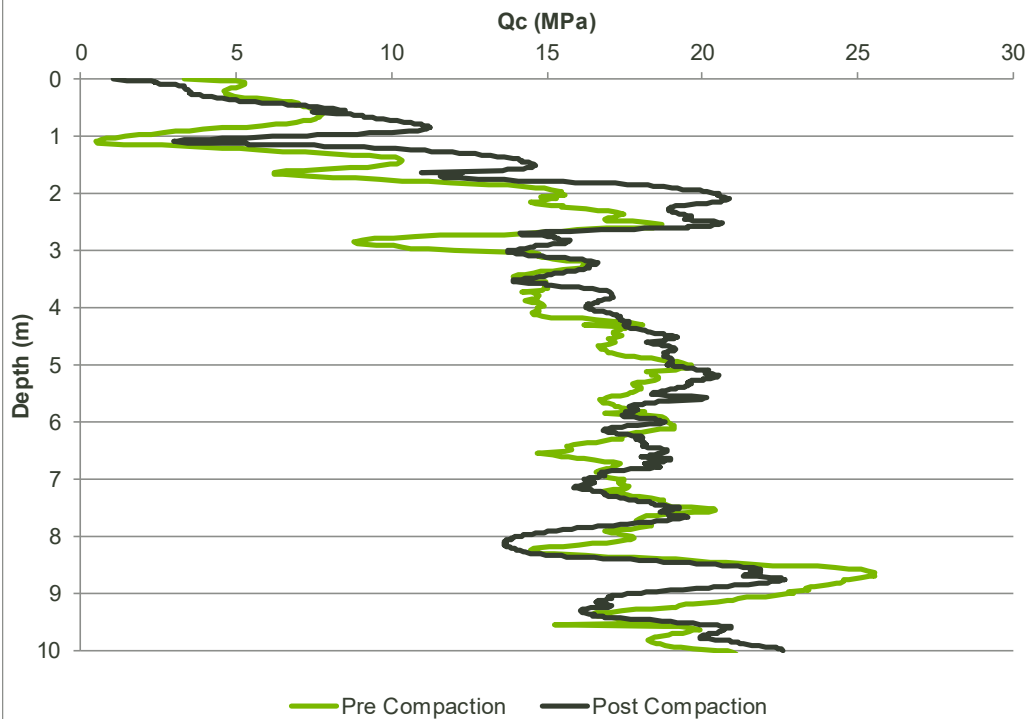
## CPT652 - Qc Comparison Pre & Post Compaction
