Appendix B

Compaction Curves

Maximum Dry Density Report

Project Prestons South Subdivision
Project No. 235361

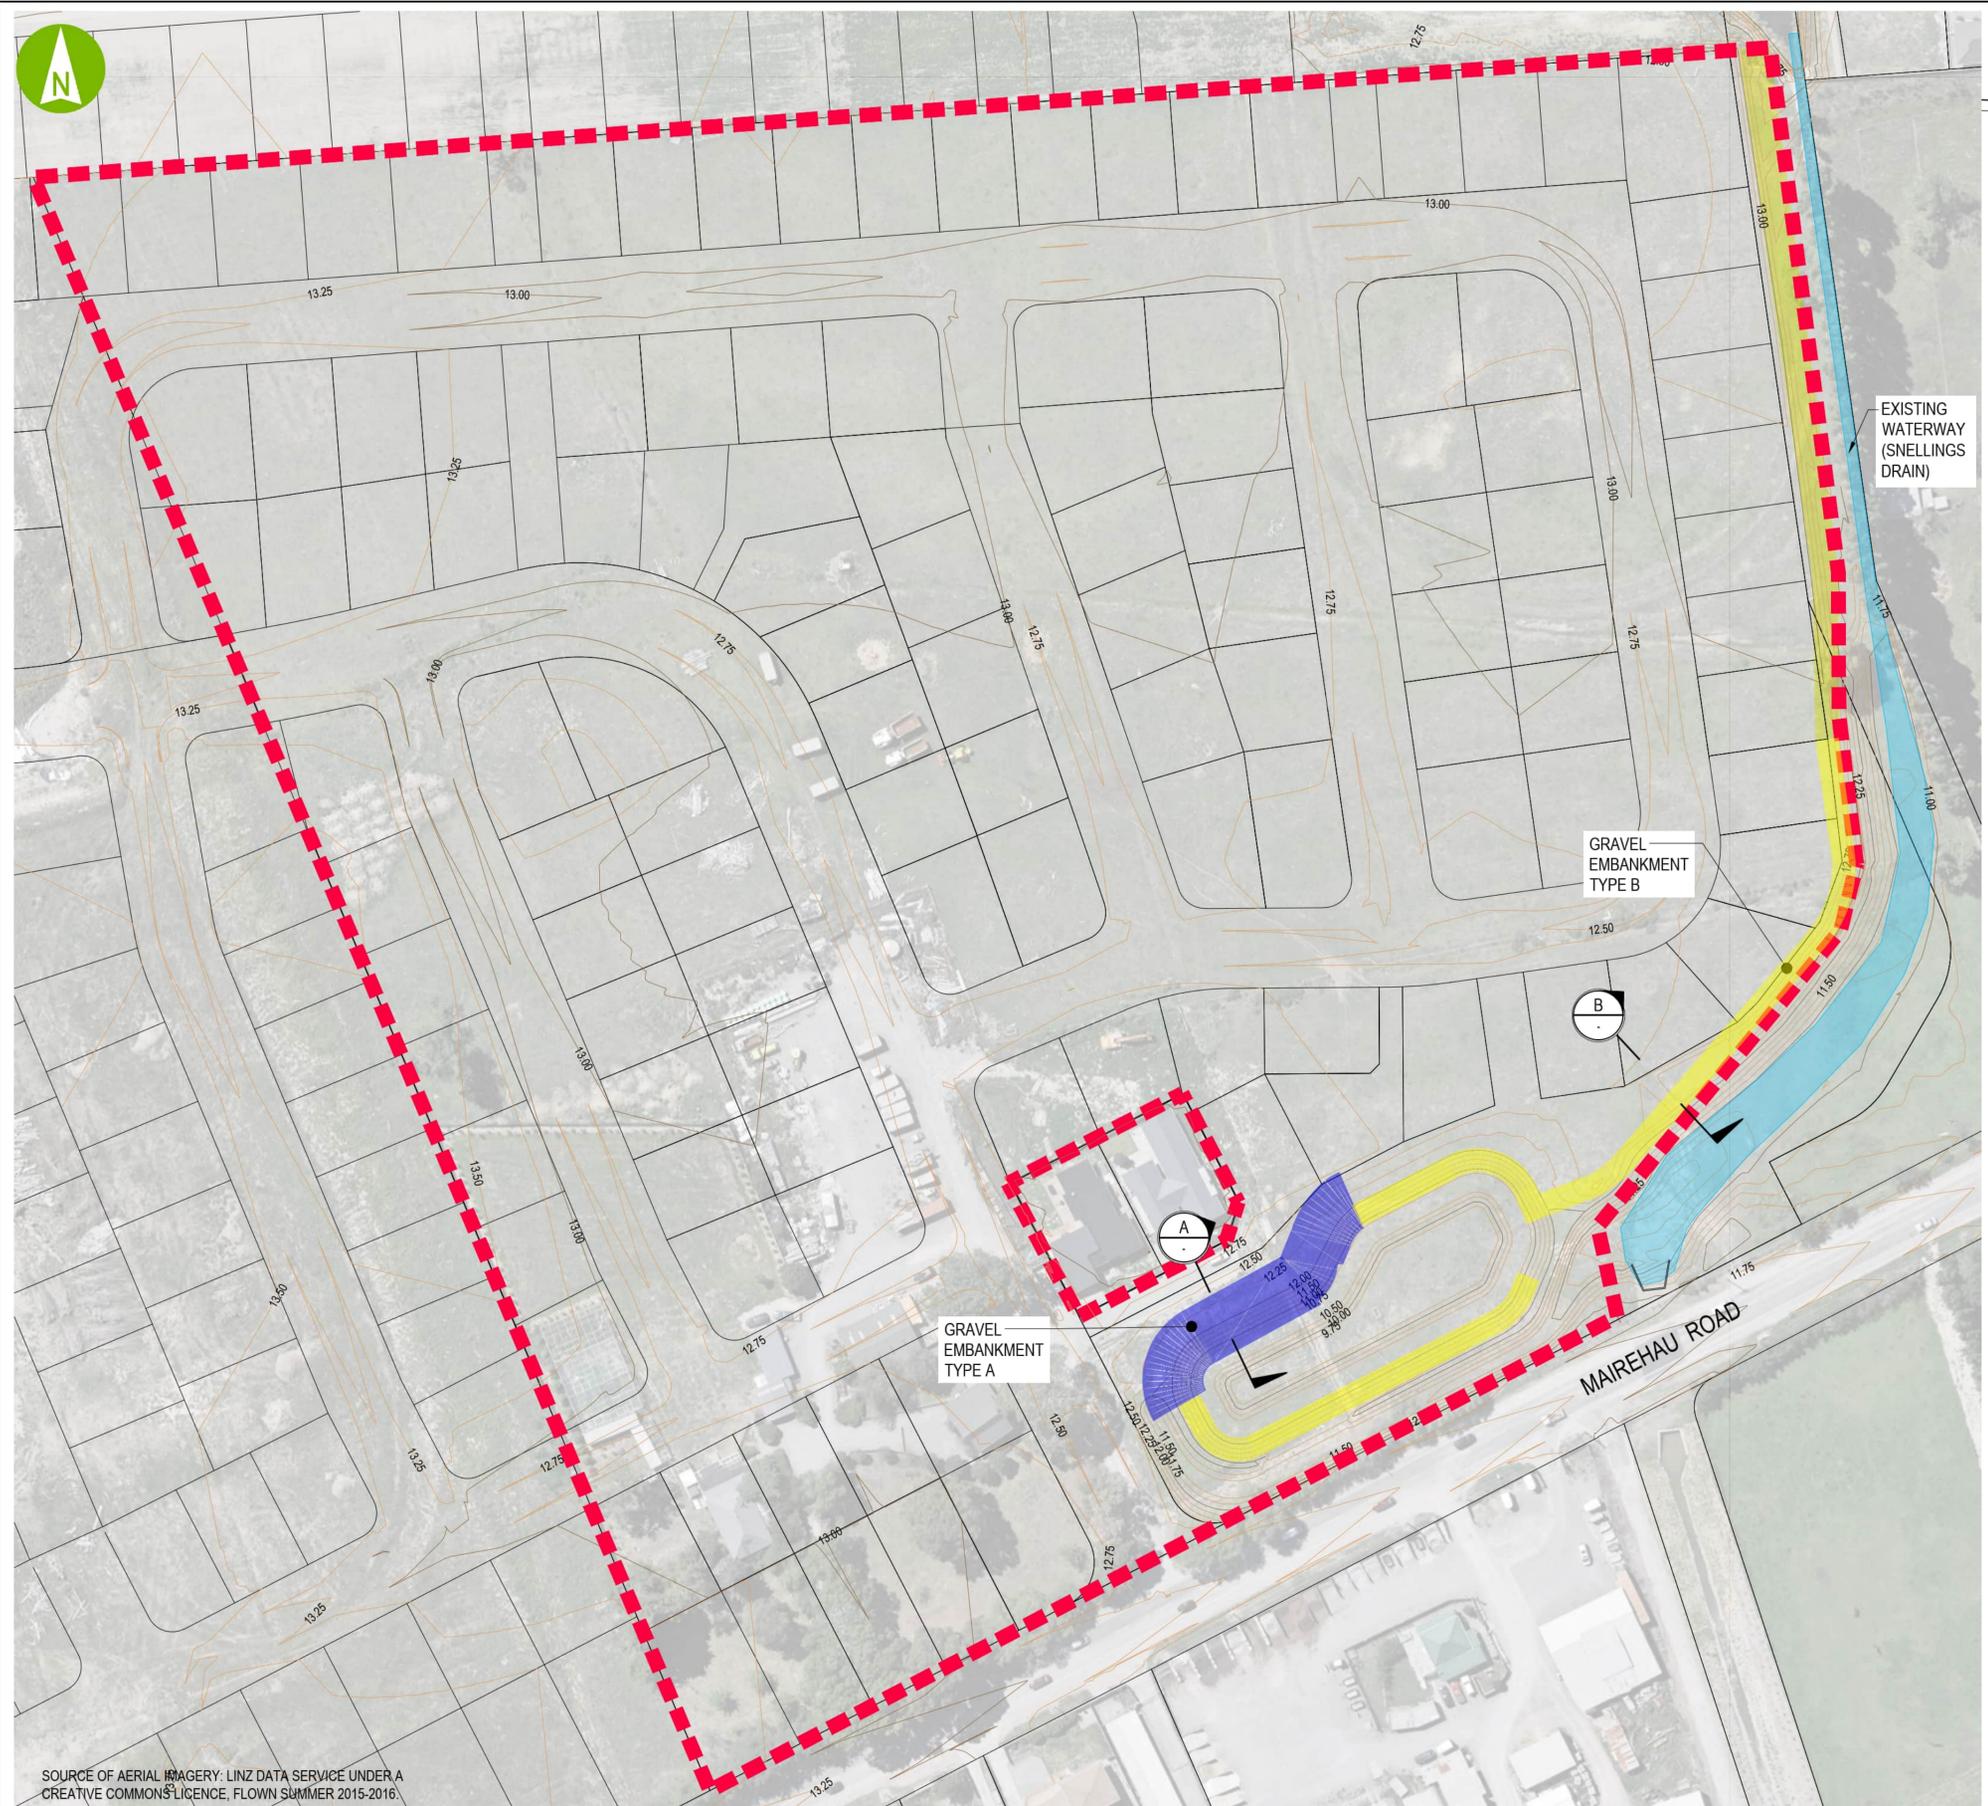
PROJECT	TITLE
PRESTONS PARK	STAGE 5 EARTHWORKS GRAVEL EMBANKMENT DETAILS

- NOTES**
- NO EARTHWORKS OR WORKS ASSOCIATED WITH EARTHWORKS ARE TO BE UNDERTAKEN IN CCC LAND OR WITHIN 5m OF SNELLINGS DRAIN.
 - COMPACTED EMBANKMENT GRAVEL TO BE CCC APPROVED AP65 OR PIT RUN. COMPACTION TO BE COMPLETED TO 98% OF THE MAXIMUM DRY DENSITY IN ACCORDANCE WITH NZS4402 TEST 4.1.3.
 - CUT SUBGRADE TO BE INSPECTED BY SUITABLY QUALIFIED GEOTECHNICAL ENGINEER.
 - ALL EXCAVATIONS TO BE CARRIED OUT IN ACCORDANCE WITH WORKSAFE AND CCC SAFE TRENCHING GUIDELINES.
 - INTERNAL BOUNDARIES ARE INDICATIVE ONLY AND ARE SUBJECT TO CHANGE. BOUNDARIES TO BE CONFIRMED AT TIME OF SUBDIVISION CONSENT.
 - FINAL TOPOGRAPHY OF THE DRAIN AND BASIN VARIES SIGNIFICANTLY ACROSS THE SITE. REFER TO CIVIL DESIGN MODEL FOR FINAL EARTHWORKS FINISHED LEVELS. THIS DRAWING IS TO BE USED FOR DIMENSIONS OF GRAVEL EMBANKMENT ONLY.
